Disastrous Failure of a Carbide-Studded Cutting Disc

Michael Panzenböck, *

* Department of Physical Metallurgy and Materials Testing, University of Leoben, A-8700 Leoben, Austria

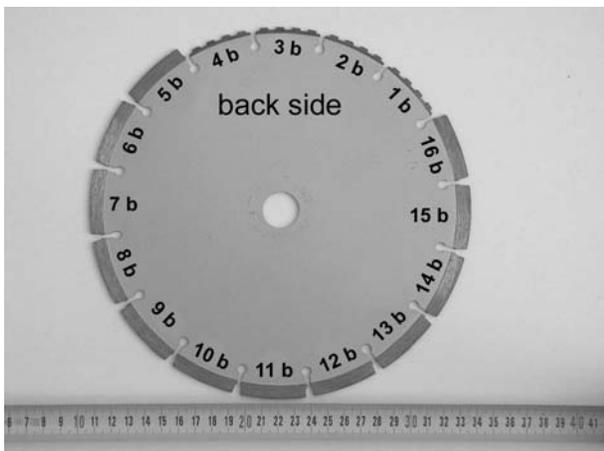
In this case of damage four cutting segments disassociated from the disc when the cutting machine reached its operating speed of 6600 rpm. Eyes and face of the worker were severely injured by the split segments. Figure 1.a shows the disc with the missing segments. Moreover, no additional damage is visible neither on the front side nor on the back side of the disc nor on the remaining segments (Fig. 1b). Latter suggests that there was no contact between cutting tool and concrete or brick wall. To clarify the circumstances which led to the accident SEM investigations (Scanning Electron Microscopy) and microanalysis were done. Furthermore tension tests (with a tensile testing equipment) were carried out to measure the adhesive strength between the remaining segments (Fig. 1a, 5b-16b) and the carrier material. For determining the way of joining between cutting segment and carrier material small specimens were cut out of the disc. These samples were broken in liquid nitrogen. Investigations of the fracture surface were carried out, too.

Tensile tests exhibited that the force to detach the segments from the disc ranged from 310 N to 2760 N. Calculating the acting centrifugal force from the given diameter (see Fig. 1a), the weight of a segment (3.735 g) and the rotation speed of 6600 rpm shows that the force is about 200 N. The calculated load is near the lowest adhesive force (310 N) measured before. Consequently the safety factor is about 1.5.

FIG. 1a. Overview of the cutting wheel

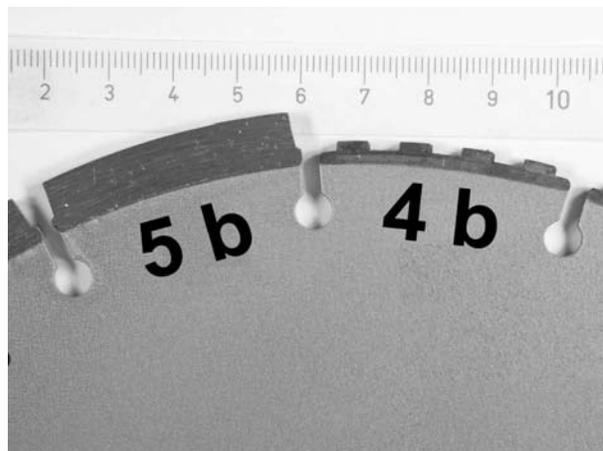
FIG. 1b. Detail of Fig. 1a

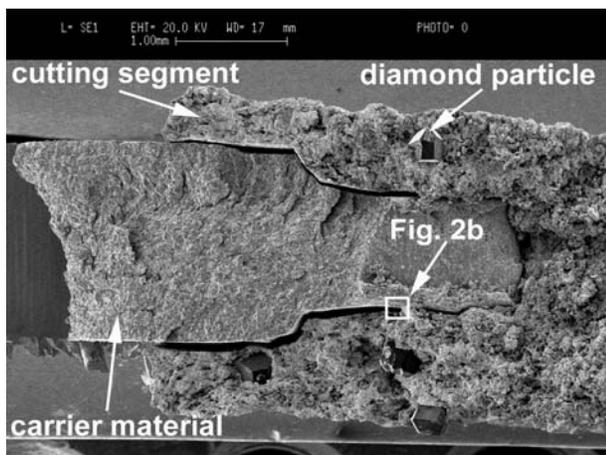
Figure 2a shows the specimen cut out of the cutting disc. Within the cutting segment which is part of the specimen diamond particles (dark spots in Fig. 2a) with smooth surfaces are visible. Furthermore a gap between carrier material and cutting segment can clearly be seen. The joint area exhibits a rippled surface especially on the carrier material (compare Fig. 2b). After pulling off the cutting segment two different surface topographies appear on the carrier material. Basically there is the rippled surface (Fig. 3a) but few areas reveal typical shear structures (see Fig. 3b). In both cases the surface consists of Cu and Sn, which was proved by chemical analysis. Both the rippled surface topography and the chemical composition point out that a soldering process with tin bronze was used to join the cutting segment and the steel disc. Further investigations of the surface of the steel disc reveal a thin copper layer with a few microns of thickness. This layer is important for soldering.

FIG. 2a. Broken part of the cutting wheel

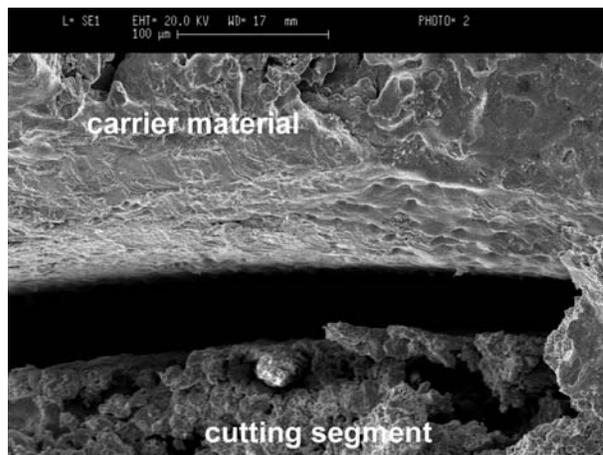
FIG. 2b. Detail of Fig. 2a

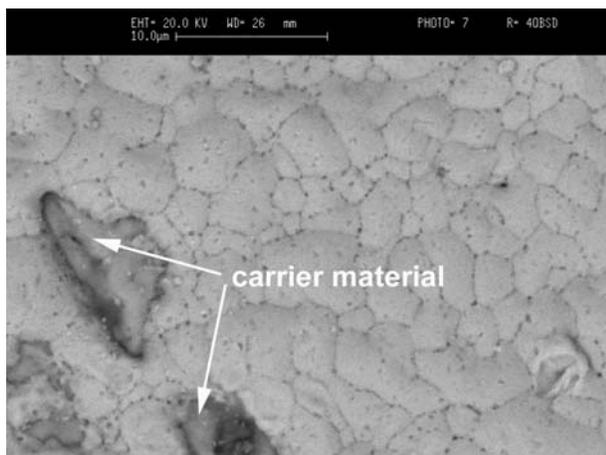
Summing up the disastrous failure was due to an inadequate brazing process.

FIG. 3a. Rippled surface structure of the brazing solder (phase contrast)

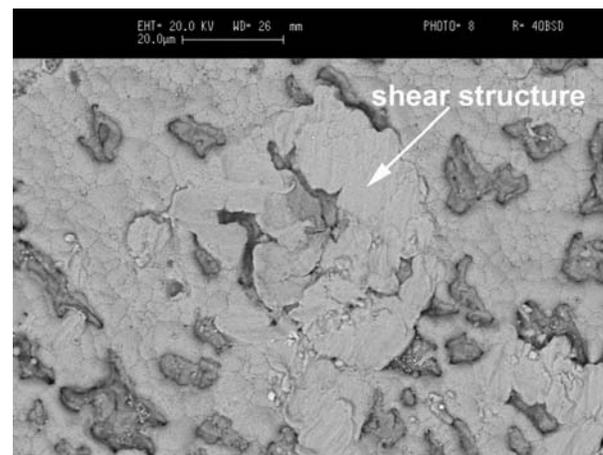
FIG. 3b. Rippled surface structure and shear zones of the brazing solder (phase contrast)
