Black Pad Metallography in Electronics

P. Snugovsky

Celestica, 844 Don Mills Road, Toronto, Ontario, Canada, M3C 1V7

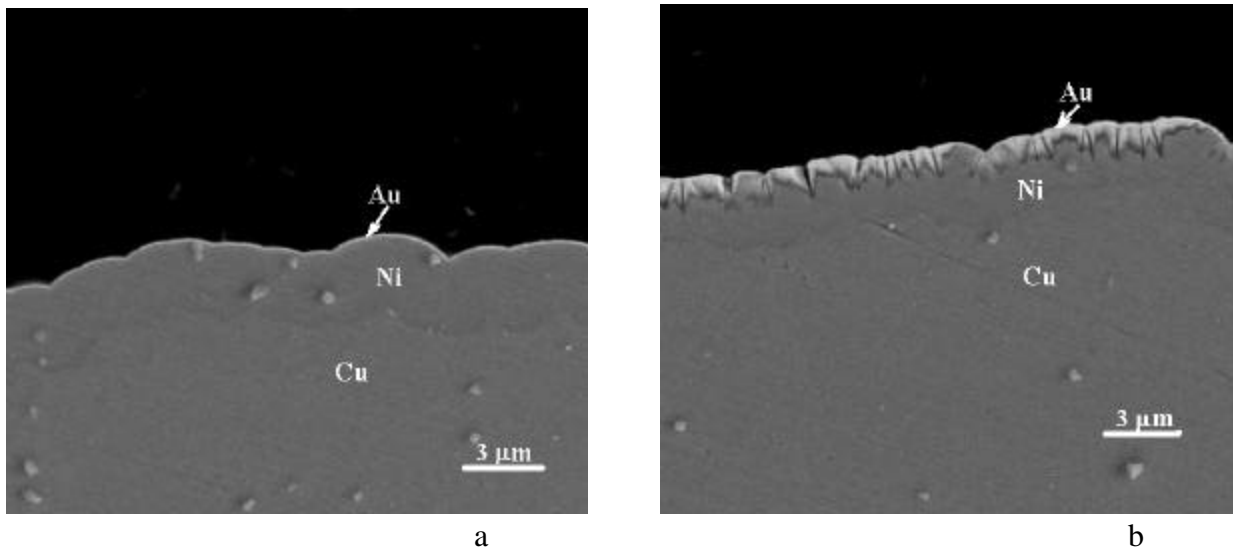
The cross-sectional structure of "normal" interconnects is shown in Fig. 1 a. The pads have a uniform thin gold layer over a nickel layer. Defective ENIG pads in this case created by an anomalous plating process have thick immersion Au on highly corroded electroless Ni (Fig. 1 b). These pads have narrow openings or fissures in the Ni layer, with gold penetration along them. EDX analyses on cross-sectioned pads and XPS depth-resolved analyses showed that the thick Au layer contained Ni, P, and Cu. Au followed the Ni nodules and layers boundaries, revealing the existing Ni structure, and multi layered Ni / Au structure forms. A mechanism for the defective ENIG plating was proposed.

FIG. 1. SEM micrographs showing electroless Ni / immersion Au normal interconnect structure (a) and Black Pad structure (b)

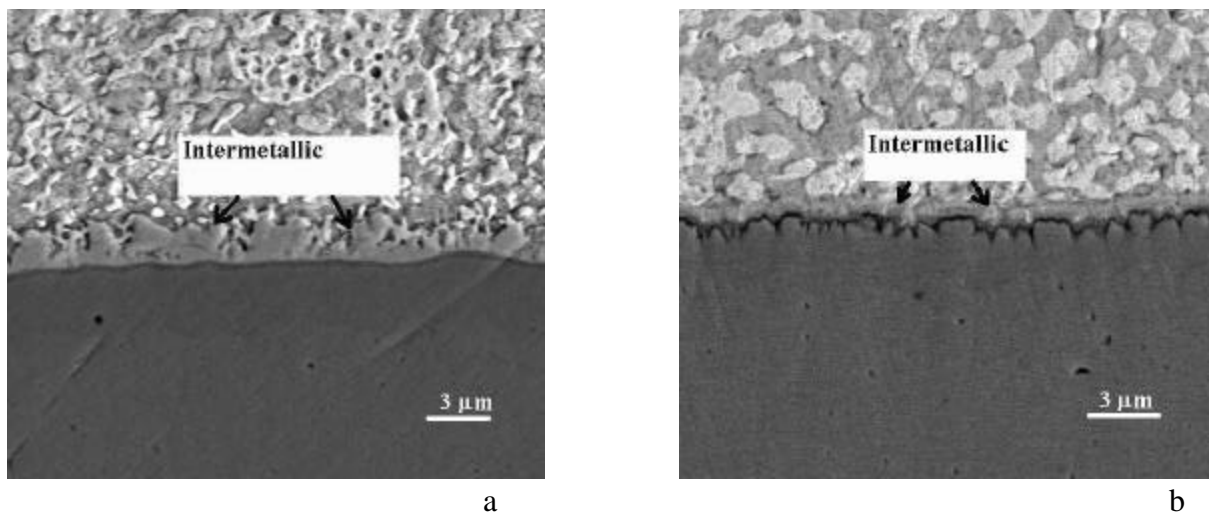
Investigation of intermetallic formation showed that the pads with defective ENIG coating performed differently during reflow compared to non-defective pads. On problem-free pads with thin Au, the Me_3Sn_4 (Me = Ni, Cu, Au) intermetallic crystals originated at the Ni/molten solder interface and grew into solder (Fig. 2 a). Me_3Sn intermetallic and Ni_3P compound were formed inside the defective layer. In extreme cases, with highly corroded Ni, the intermetallic-solder interface was flat with no growth into the liquid solder (Fig. 2 b). Intermediate defective Ni formed two layers: $\text{Me}_3\text{Sn} + \text{Ni}_3\text{P}$ inside the corroded top layer of the Ni and Me_3Sn_4 growing into the liquid solder. The weakness of the solder joints arose from growth of brittle Me_3Sn intermetallic layer inside the Ni and mismatch between the two intermetallics, leading to poor adhesion.

FIG. 2. SEM micrographs showing the differences between intermetallics on pads with normal electroless Ni / immersion Au structure (a) and highly corroded Black Pad structure (b).
