Helium Ion Microscope Analysis of Used JLab Photocathode Samples

V. Shutthanandan¹, Z. Zhu¹, M. Nandasiri¹, S. V. Kuchibhatla¹, S. Thevuthasan¹,
W. Hess¹, Carlos Hernandez-Garcia²

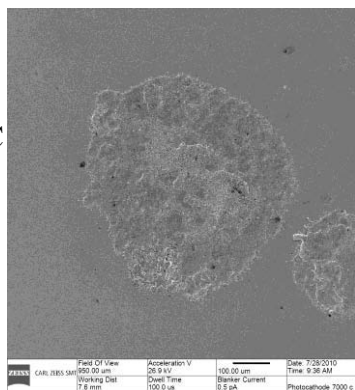
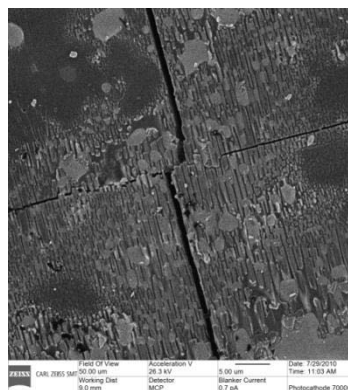
Four different GaAs samples (two control including one as prepared and the other as annealed but not used, and two used to delivered 1000 and 7000 Coulombs) were analyzed using these techniques. Specifically, on control samples, the measurements were made at their geometrical center, while on the used samples, the measurements were made at two different points; one at the damaged spot and the other at a point below the damaged area. HIM images obtained at the damaged spot from the 7000 C sample are shown in Figure 1. Two different fields of view (950 μm and 50 μm , from left to right) are shown in this figure. These images were collected in the normal direction. It can be clearly seen from these figures that the surface at this spot is severely damaged. In addition, some cracks are clearly visible on the surface. HIM images (figure 2) collected at the tilt angle of 20 $^\circ$ clearly show that these damage features are protruding above the surface of the photocathode samples at the center region of the spot. Stylus profilometer measurement on this spot reveals that the spot has peaks and valleys; the height of the main peak is around 7000 nm while the depth of the valleys ranges from 1000 to 3000 nm. It appears that the material in this area is melted and turned into a feature shown in these figures.

Figure. 1 HIM images of 7000 C sample at the damage location (normal direction)

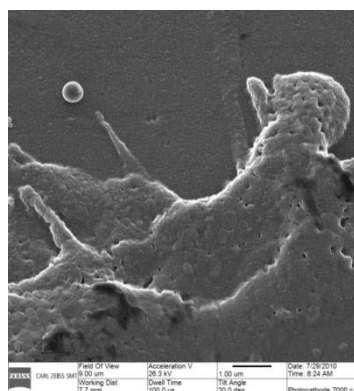
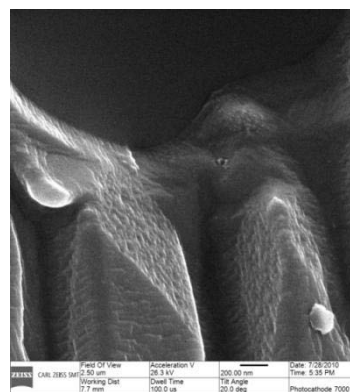
Figure. 2 HIM images of 7000 C sample at the damage location (tilt angle =20°)

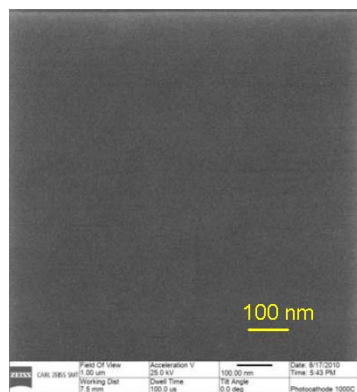
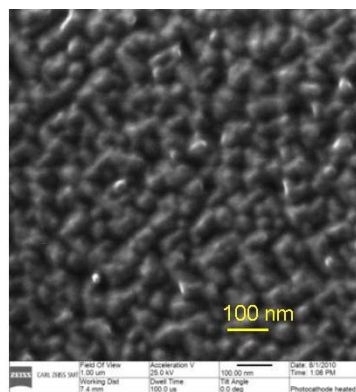
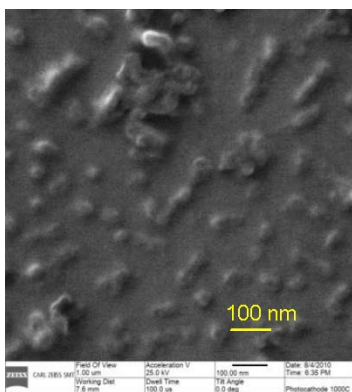
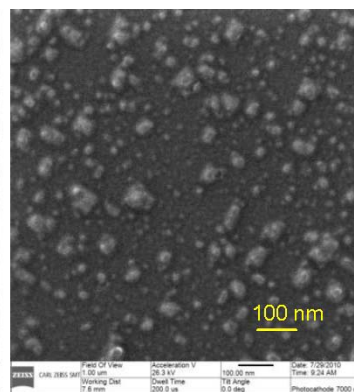
HIM images collected from all four samples (below the damage area on the used cathodes) with a field of view of 1 μm are shown in Figure 3. AFM images obtained from these samples are consistent with these results. The average roughness obtained from AFM measurements on control, 1000 C and 7000 C samples are 0.1 nm, 8.5 nm and 2 nm respectively. It is clear from these results that there is a systematic variation in the topography of the samples as a function of prolonged use of the photocathodes. The larger the usage time the smaller the structures are. Detailed analysis of these samples using RBS, SIMS together with HIM will be discussed.

Figure 3. Comparison of HIM images collected from all four samples
