Microstructural and Fractographic Analysis on Samples of Fractured Bolts

Two fractured bolts from a tank ship were microscopically analyzed by means of optical and scanning electron microscopy in order to determine the actuating fracture micromechanisms. The material of both bolts was characterized by chemical analysis and the results showed that the composition of the samples corresponds to that specified for a SAE 4140 steel (Table 1).

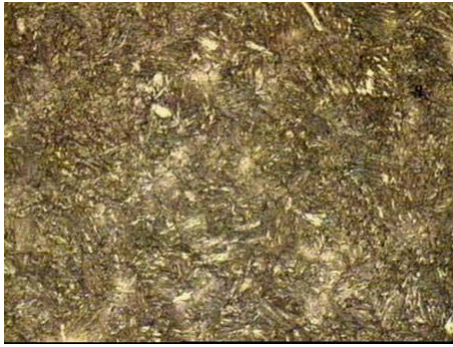
Cross sections of each of the two samples were cut and prepared for optical micrography using standard metallography procedures (ASTM E3 Standard Methods). Metallographic examination of the samples showed a tempered martensitic structure, uniform over the entire cross section (Figure 1). Such microstructural aspects are expected for a 4140 steel quenched and tempered. There were not been observed along the analysed sections decarburized areas or the presence of discontinuities such as cracks and porosity.

FIG. 1. Central area of the cross section, which was characterized by a tempered martensitic structure. 250X.

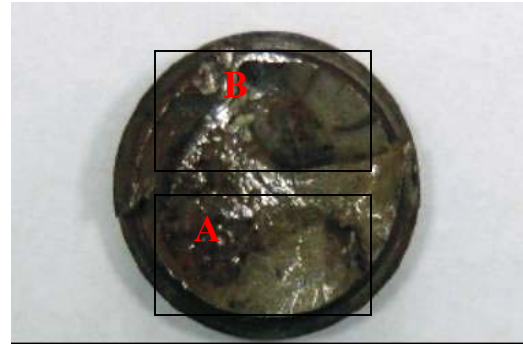
The fractographic analysis was carried out by means of scanning electron microscopy at different points of the samples. Figure 2 shows one of the fracture surfaces after cleaning where the two rectangles *A* and *B* indicate the studied areas.

FIG. 2. Surface fracture SEM examination was carried out in the areas comprised inside rectangles A and B.

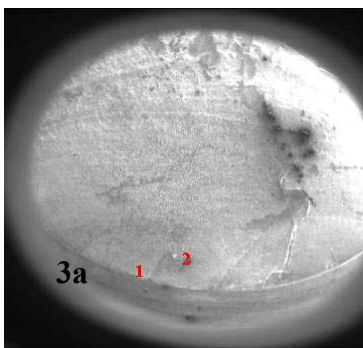
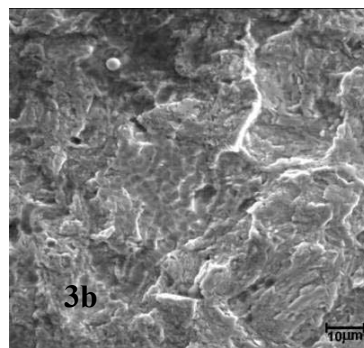
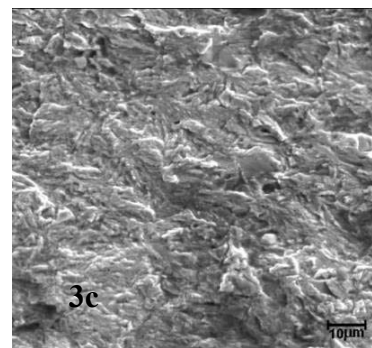
Figure 3a is referent to area comprised in rectangle *A* (Figure 2), where beach marks were visible during low magnification (1,5X) SEM examination. At high magnification, features typical of fatigue propagation were observed. Figures 3b and 3c refer to the analysed areas (Points 1 and 2, Figure 3a) with fatigue striations and the presence of secondary cracks. The area of the fracture surface identified by *B* (Figure 2) is presented in Figure 4a and Figures 4b and 4c show the fractographies relative to the areas 1 and 2 (Figure 4a). The analysis of the area signed by 1 has indicated the predominance of fatigue striations and the presence of some intergranular facets as well as secondary cracks (Figure 4b). The final fracture occurred by the nucleation and coalescence of microvoids that formed as a result of particle-matrix decohesion or cracking of second-phase particles (Figure 4c). By the fractographic analysis, one can conclude that the fatigue crack initiations occurred in two different levels and the two resulting cracks joined by tearing. Final fracture occurred by ductile failure which ended on a plane inclined to the bolt axis.

FIG. 3. (a) Area A shown in Figure 2. Presence of beach marks. (b) and (c) Points 1 and 2, Fig. 3a, fatigue striations are present characterizing the fatigue primary crack propagation.

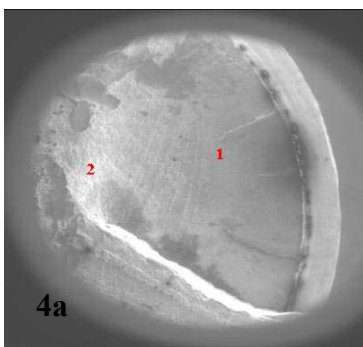
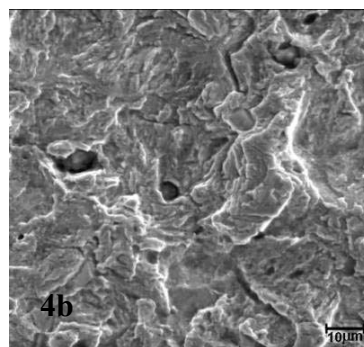
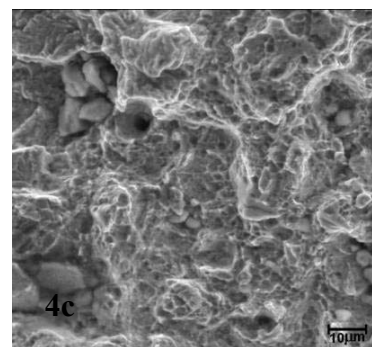
FIG. 4. (a) Area B shown in Figure 2. (b) Point 1, Fig 4a, predominance of fatigue striations and presence of some intergranular facets as well as secondary cracks. (c) Point 2, Fig. 4a, final fracture area. The fracture occurred by the nucleation and coalescence of microvoids.
