## A Site- and Layer-Specific Sample Preparation Technique for Plan View TEM of Laser Diodes

J.Tanimura\*, K.Kawasaki\*\*, Y.Yoshida\*\* and H.Kurokawa\*

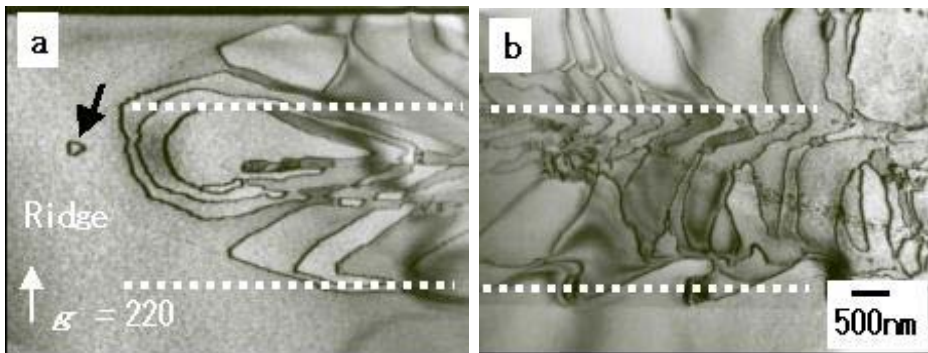
This technique was applied to investigate degradation mechanism of 980nm InGaAs/AlGaAs ridge waveguide lasers. The ridge width and the cavity length of the lasers are  $3\ \mu\text{m}$  and  $900\ \mu\text{m}$ , respectively. Au/Ti metals are evaporated on the ridge top and Au is plated on the metals leaving a distance of  $25\ \mu\text{m}$  from both facets. The lasers investigated here were intentionally degraded under excessive current operation of about 1000mA. Under the operation condition, the degradation of the devices reproducibly occurs at the edge of the Au plating because of the local rise of temperature due to current concentration. Plan view TEM micrographs of degraded region are shown in FIG.2. FIG.2a. was taken at the front of the degraded region and FIG.2b. near the edge of the Au plating. Dislocations are on the (001) plane that is the quantum well layer and no threading dislocation was observed. Neither dislocations nor other defects were observed in lasers with the operating current below 900mA. Therefore, the degradation of the devices was not due to propagation of a threading dislocation reported by others.[5,6] The Burger's vector of the dislocations is found to be of the  $(a/2)\langle 011 \rangle$  type because the dislocation contrast is almost disappeared with a  $\langle 400 \rangle$  reflection. A dislocation loop at the front of the degraded region marked with a black arrow in FIG.2a was identified to be of the vacancy type using the inside-outside contrast method.(FIG.3.) During the device operation, vacancies were supersaturated and aggregated to form vacancy type dislocation loops. It is concluded that the propagation of the dislocation loops originated from the vacancy supersaturation causes the degradation of the lasers under the excessive current operation.

FIG.2. Plan view TEM micrographs of the degraded region. FIG.2a. was taken at the front of the degraded region and FIG.2b. near the edge of the Au plating.

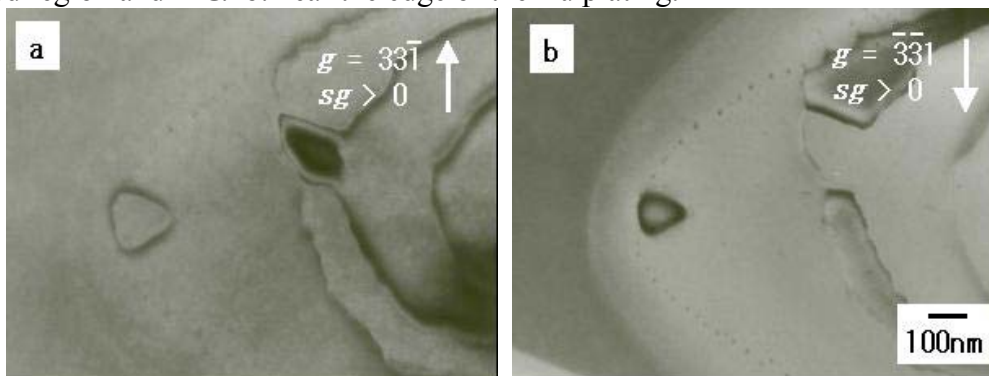
FIG.3. Bright-field TEM micrographs showing a dislocation loop at the front of the degraded region. The dislocation loop was observed as outside contrast in FIG.3a. taken with the reflection of  $g=33-1$  and inside contrast in FIG.3b. with the reflection of  $g=-3-31$ . The deviation parameter  $sg$  was positive in both cases.
