Microscopy of Solder Joint Failures Due to Gold Intermetallic Embrittlement¹

D.F. Susan, P.T. Vianco, R.P. Grant, P. Hlava, A.C. Kilgo, and G.L. Zender
Sandia National Laboratories, Albuquerque, New Mexico

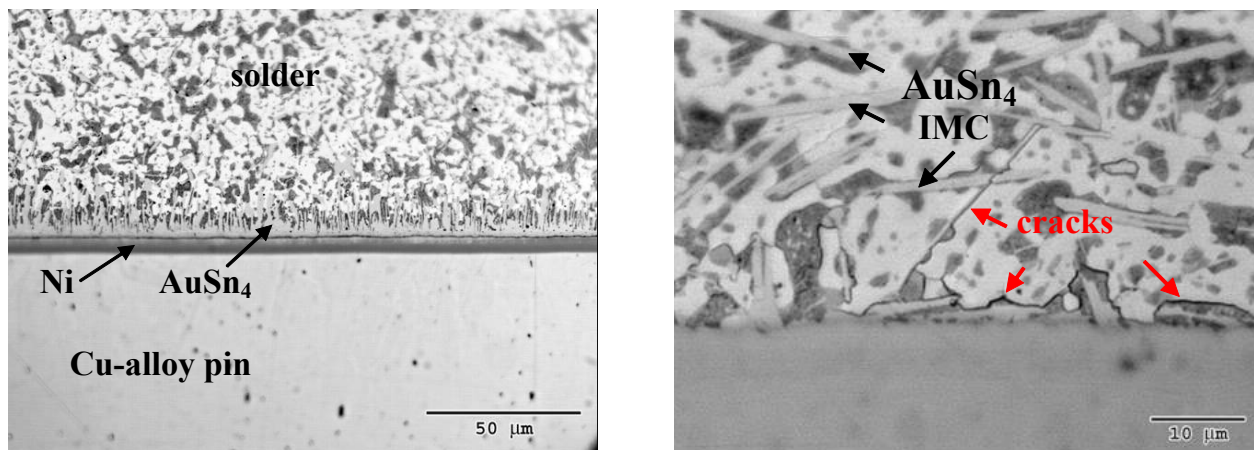
Figure 1a shows the interface between Pb-Sn solder and a part which was initially Ni and Au plated. After soldering, a thick AuSn₄ IMC layer is present indicating inadequate pre-tinning prior to soldering. The layer actually consists of closely spaced needles which grow from the Au-plated region into the solder. Quantitative image analysis (QIA) is commonly applied to determine the thickness of the AuSn₄ IMC layer and degree of embrittlement. If a Au-contaminated solder joint is subjected to mechanical loading or thermomechanical cycling, cracks can develop along the IMC layer or in the solder adjacent to the IMC layer. Figure 1b shows microcracks within and around AuSn₄ particles in a region close to a solder/Cu component interface. Failure can occur if these microcracks link up during mechanical loading or fatigue cycling.

Fig. 1a. Optical photomicrograph of AuSn₄ IMC layer at the interface between solder and a Ni plated Cu-alloy connector.
 Fig. 1b. Microcracks developed around and through AuSn₄ IMC needles adjacent to a solder/Ni-plated steel interface.

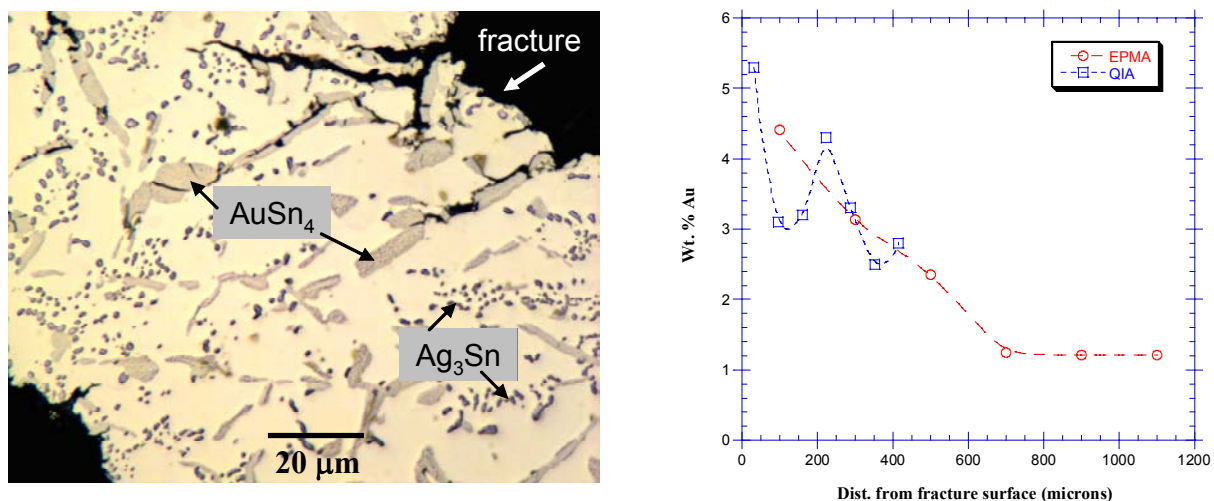
Figure 2a shows the microstructure of a 95Sn-5Ag (high temperature solder) fillet with a high volume percent of AuSn₄ IMC needles/blocks. The solder microstructure also contains particles of Ag₃Sn in the Sn matrix, which is expected for this solder. Failure was discovered in this joint after fatigue testing of the assembly. The region adjacent to the fracture surface was analyzed by QIA and found to contain about 15.2 vol. % AuSn₄. This corresponds to approximately 5.3 wt.% Au in the solder. Other researchers have determined that 3-5 wt.% of Au can cause embrittlement of solders [1-3]. Therefore, the cause of failure in this case was attributed to buildup of AuSn₄ phase and subsequent solder embrittlement. The presence of secondary cracking along the IMC particles adjacent to the main fracture surface also provides evidence for AuSn₄ embrittlement. It is also interesting that a gradient was found in the AuSn₄ content with distance away from the main fracture surface. Figure 2b shows electron microprobe (EPMA) data along with QIA results for a trace from the main fracture surface into the solder fillet. A gradient in Au contamination can occur if only one component in a solder fillet joint is pre-tinned and the other is not. In addition, the extremely fast cooling rates during soldering and the relatively slow diffusion rate of gold at solder eutectic temperatures may prevent full mixing of Au throughout the solder joint.

Fig. 2a. Optical photomicrograph of solder microstructure near the main fracture surface.
 Fig. 2b. Results of Au content measurements by EPMA and image analysis. Each EPMA trace data point represents the average of 20 individual probe data points. Image analysis was performed on seven optical photomicrographs at 1000x magnification.
