Failure Analysis of a Power Steering Torsion Bar

M. A. Neri-Flores, C. Carreño-Gallardo and I. Estrada-Guel.

Centro de Investigación en Materiales Avanzados (CIMAV), Miguel de Cervantes No. 120, C.P. 31109, Chihuahua, Chih., México.

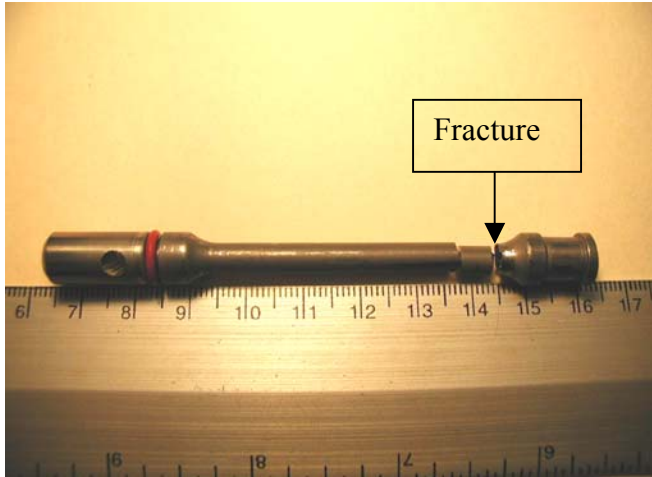
The material under investigation was identified visually. Figure 1, shows the position where the torsion bar was fractured, near to the zone where the diameter changes suddenly. The chemical analysis was performed in a section of the bar, in order to determine the content of C, Mn, P, S, Si, Cr and Mo according to the SAE standard for 4140 steel, the results are shown in Table I. A digital microhardness tester with two scales of hardness: Vickers and Rockwell "C" was used, in order to obtain the microhardness profile. Figure 2 present a graph of hardness profile vs. distance, as we can see in the figure, the hardness values decrease to the interior of the piece and the hardness value is constant at distances $> 30\mu\text{m}$.

Figure 1.- Location where the torsion bar was fractured.

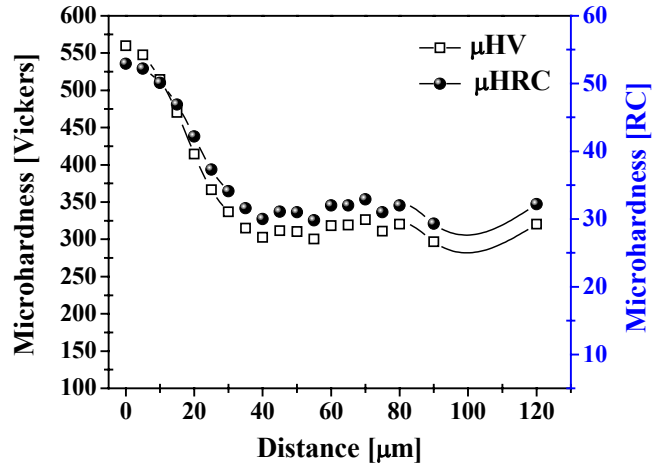
Figure 2.- Microhardness profile of the torsion bar.

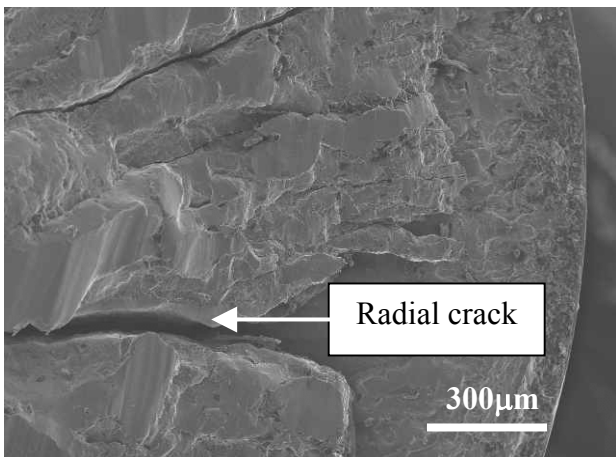
Also we find that the crack detected was of the radial type, and run from the external surface of the torsion bar, to the center of it Figure 3 shows the fractured surface. The chemical composition of the crack zone detecting by EDS, was: Fe (42.55%), Cr (38.85%), C (17.44%), Si (0.46%), P (0.25%), S (0.26%), and Al (0.27%). At higher magnifications we observed cracks oriented at 0° and 45° from the longitudinal axe of the bar, at the external surface of the fractured bar Figure 4 Both cracks initiate at the l surface of the ion-nitrided layer, where the state of stresses is maximum.

According to the previous results, we suppose that the fracture analyzed was of the brittle-type with minimal plastic deformation, and the cracks detected runs from the outer surface of the bar to the center of it, in a radial form. There is not evidence of extrinsic elements in the fractured surface of the bar, the brittle fracture was caused by a torsional overload, presenting cracks oriented at 45° from the longitudinal axe of the bar.

Figure 3.- Fractured surface of the torsion bar, showing a radial crack running from the surface to the center of the bar.

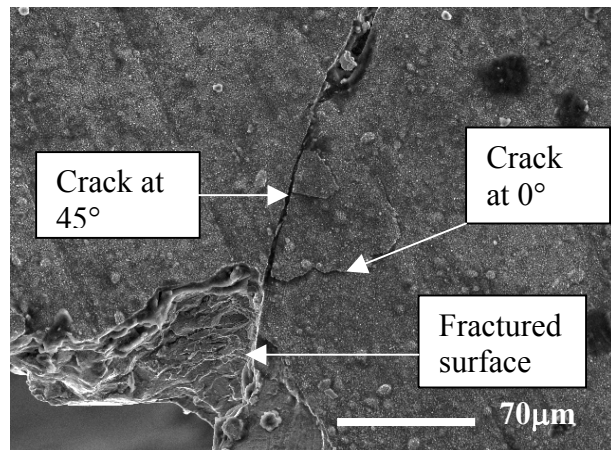
Figure 4.- External surface of the fractured torsion bar.
