The Application of Electron Microscopy Techniques to the Space Shuttle Columbia Accident Investigation

Sandeep Shah and Greg Jerman

Materials Diagnostics Team, NASA Marshall Space Flight Center
 Sandeep.r.shah@nasa.gov, Gregory.a.jerman@nasa.gov

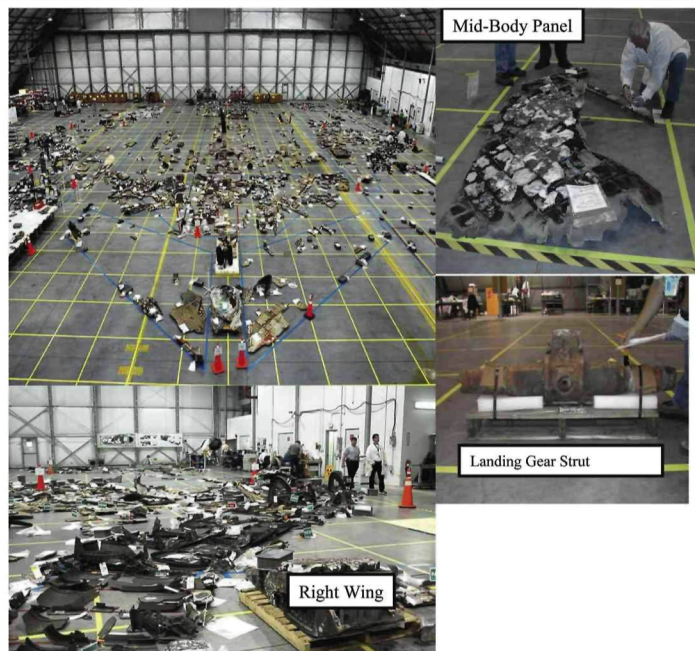
Figure 2: Hardware recovered, identified, and laid in a grid pattern at shuttle's landing facility.

wing, tail, and fuselage debris were laid out on a grid as seen in figure 2.

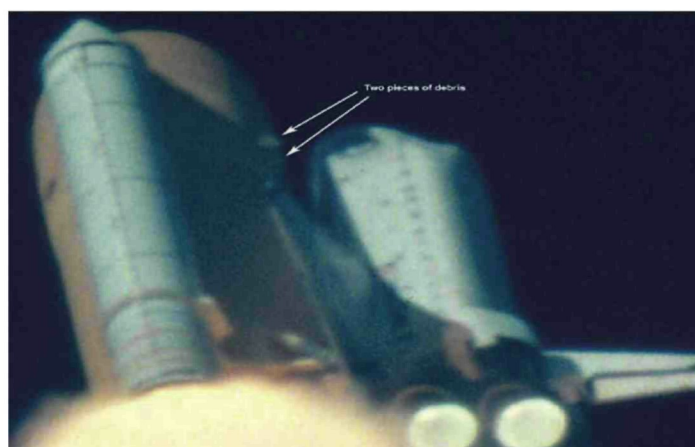
Figure 3: Evidence of foam hitting the shuttle's left wing.

the left WLE RCC panels where launch video indicated foam from the external tank had impacted on ascent as seen in figure 3.

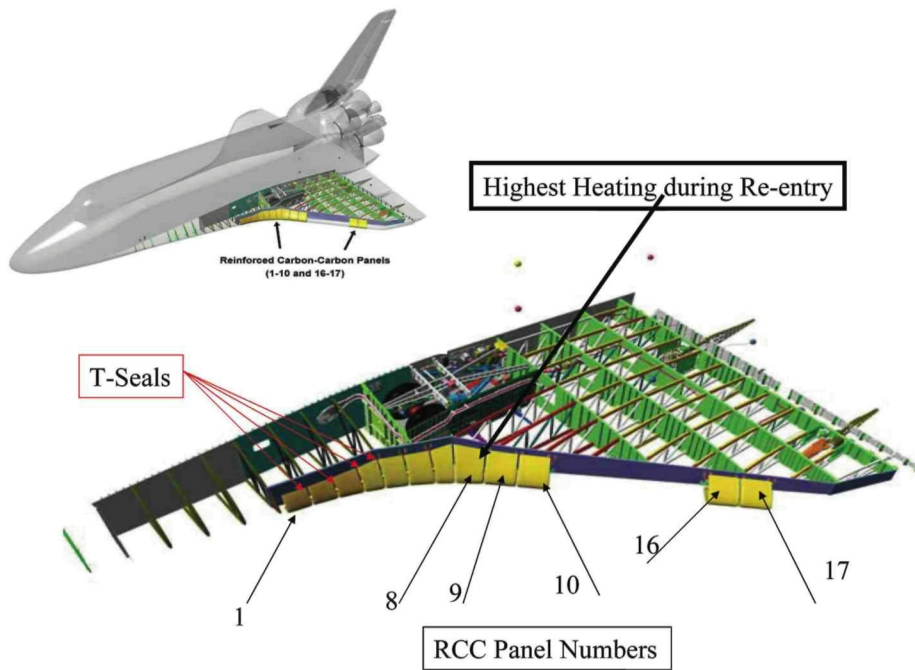
Figure 4: Arrangement of 22 RCC panels and T-seals on the wing leading edge.

There are 22 RCC panels protecting the leading edge of each wing from hot gasses during re-entry. The gap between each panel is sealed with a short T-shaped RCC seal. The arrangement of the wing leading edge is shown in Figure 4. The highest heating during re-entry occurs in panels 7-10, right where the wing leading edge surface changes direction. After recovery and identification, the reconstructed pieces of Columbia’s RCC panels and T-seals were qualitatively examined for damage patterns. The internal surfaces

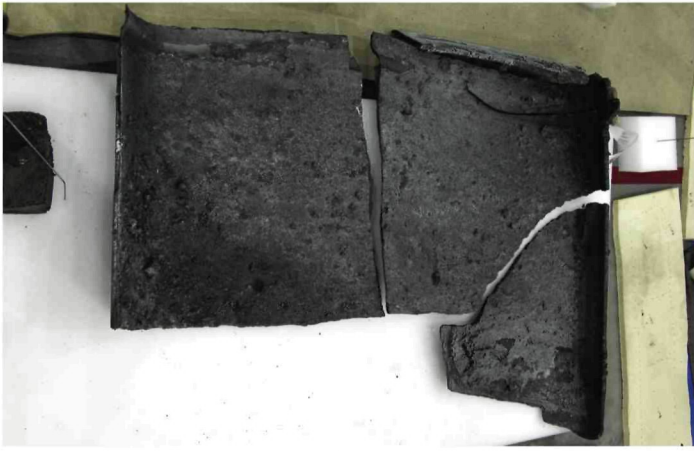
of left wing RCC panels 7 through 10 showed heavy deposition of material that was best described by the metallurgical term slag. The deposits on the RCC panels were expected to originate from Columbia’s metal wing structures. Some RCC panels from the right wing also contained slag deposits although to a lesser degree. Figure 5 shows one example of slag deposits on the inside surface of left wing RCC panel 8. There were other visual signs of significant heat damage including melted RCC attachment hardware and knife edge erosion on broken edges of RCC panels. Most of the slag deposits, molten RCC attachments, and eroded RCC were concentrated between RCC panels 7 through 10 on the left wing.

Figure 5: Left wing RCC panel 8 with slag deposit on the inside.

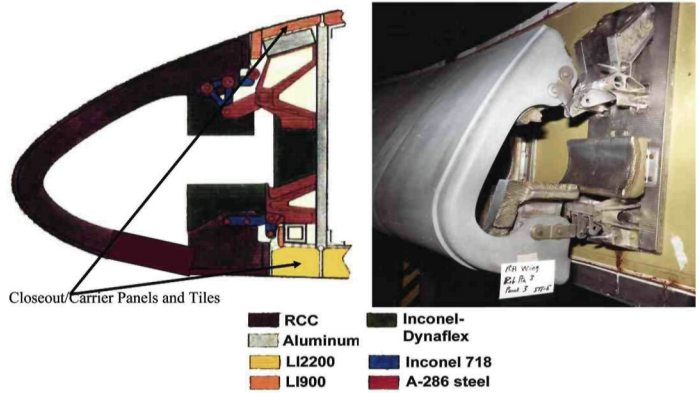
The key to deciphering the sequence of damage events was to understand the origins of the slag deposition. By understanding the composition of the materials in the WLE, it was hoped the origin of the slag deposits could be identified. The major WLE materials and components included RCC, 2024 aluminum wing spar, A286 steel attachment fittings, Inconel 718 spanner beams and bolts, 6061 aluminum carrier panels, Inconel 601 foil around flexible cerachrome insulation, Inconel 625 insulation attachment clips, and silica thermal protection tiles. Figure 6 shows a cross-section of the WLE including material identification. Slag specimens were extracted from many RCC panels from both the left and right WLE with the underlying RCC intact and quantitatively analyzed to determine their chemistry and morphology.

Figure 6: Cross-section through the wing leading edge including major component materials.

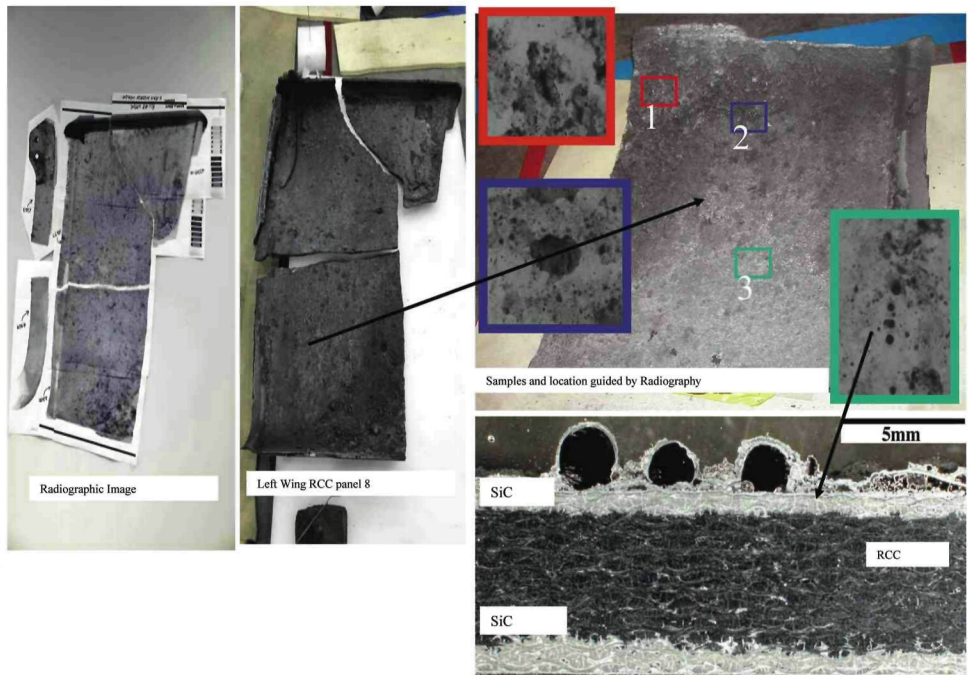
Figure 7: Cross-section through unique spheroids in slag deposits on the left WLE RCC panel 8.

Dozens of RCC cross sections were analyzed for slag deposit chemistry and morphology generating approximately 2000 pages of chemical and morphological data. One sample analysis from the left wing RCC panel 8 is presented here to exemplify the process. In this case, unique metallic spheroids were found that were in direct contact with the RCC surface as seen in Figure 7. Like a layered cake, the first slag deposits represented the first damage event, while the outer slag surface represented the last damage event. SEM x-ray dot maps in Figure 8 shows high concentrations of iron, nickel, and chromium in these spheroids. Backscattered imaging clearly showed metallic deposits versus oxide type deposits in the vicinity of the spheres. Quantitative electron microprobe results identified spheroid compositions that closely matched Inconel 718 and Inconel 601 which correspond to the metallic RCC attachment hardware and the internal insulation foil. The final layers on top of

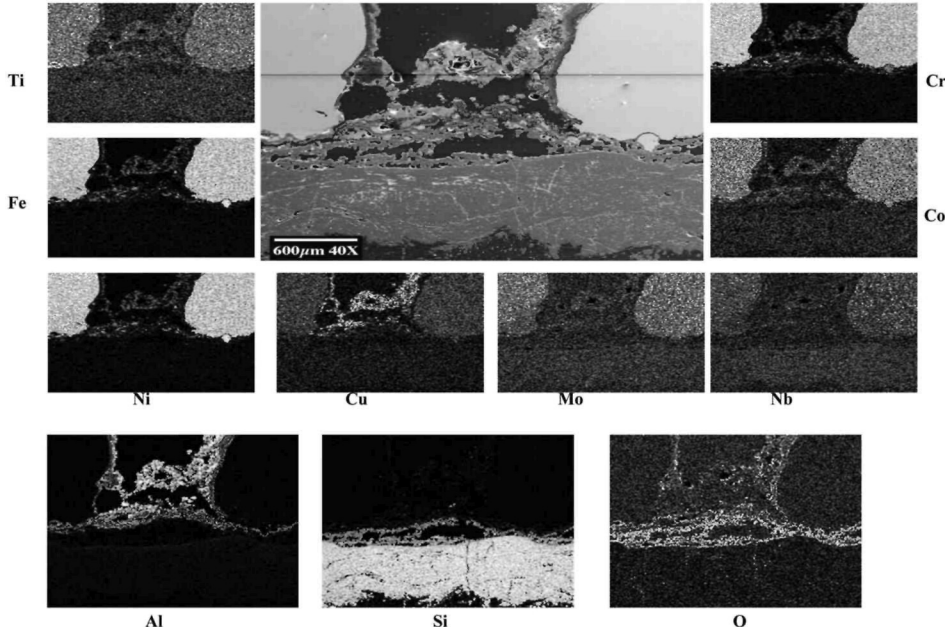
Figure 8: X-ray map showing distribution of various elements in and around spheroids of Figure 6.

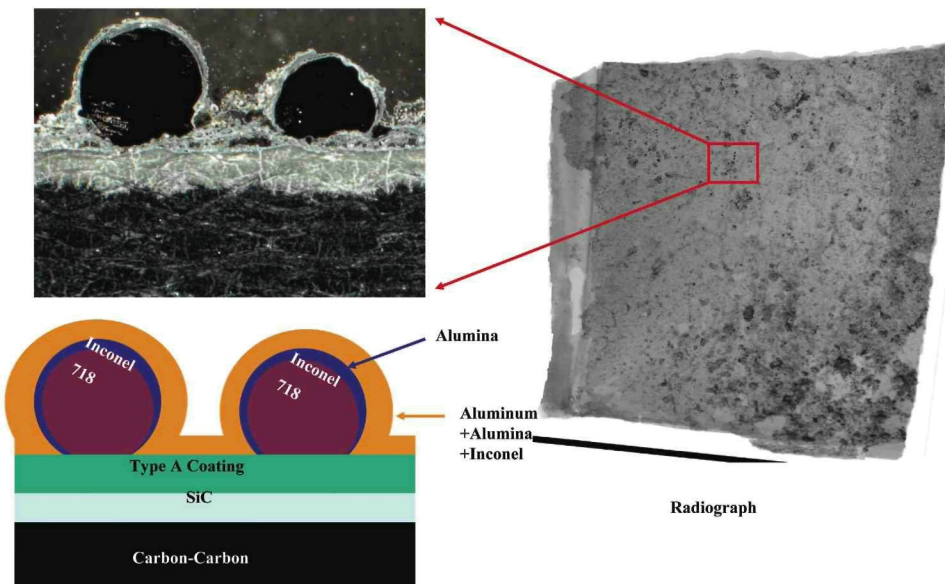
the spheroids contained oxidized and metallic aluminum with copper that uniquely identified the 2024 wing spar as the source for the final deposits as seen in figure 9.

1. In left wing RCC pieces, cerachrome insulation and Inconel 718 or Inconel 601 primarily made up the first deposited slag layer. This suggests the first damage occurred by melting of RCC attachment beams and internal insulation.

2. In left wing RCC pieces, aluminum deposition was secondary suggesting the wing spar melted last.
3. In left wing RCC pieces, there was no indication of A286 wing spar attachment fittings in the first slag deposits suggesting the initial plasma impingement was through a breach near the RCC attachment points and not near the wing spar.

4. In left wing RCC pieces, there is large amount of molten ceramic cerachrome insulation on the inside of RCC panels suggesting temperatures were in excess of 3200 °F.

Figure 9: Layering of slag showing sequence of damage and deposition events.

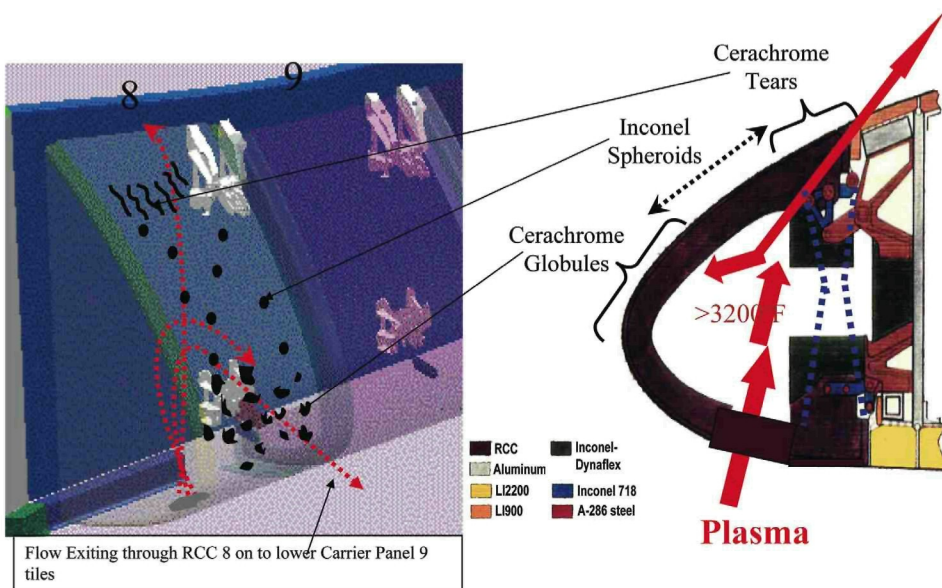
Figure 10: Breach scenario and location based on analysis results.

for the progression of damage in Columbia's wing is depicted in Figure 10. The breach started on the underside of the left wing at RCC panel 8, close to the T-seal between panels 8 and 9. The plasma first impinged on the Inconel 718 attachments that held the RCC in place and insulation that protected the aluminum wing spar from overheating. The flexible insulation was not designed to contain hot flowing plasma, which continued to circulate around inside the left wing at RCC panel 8 creating molten cerachrome tears and droplets. Eventually, the insulation failed between panels 7 and 9 allowing plasma to move both downstream and upstream

from panel 8. Eventually the lower RCC attachment points for panels 8 and 9 collapsed causing massive plasma impingement on the aluminum wing spar at temperatures greater than 3200 °F.
