## Use of Electron Microscopy in the Evaluation of the Bio-corrosion of Interfloor Flagstone.

In the present work it was studied the problems of corrosion observed in the interfloor flagstones of a group of buildings, where it was noticed strong deterioration of the structural elements. The objectives of the work were: a) To study the topography of the diverse materials that compose the flagstone of different areas, looking for any defect and presence of microorganisms; b) To compare the results of the physical-chemical rehearsals with the obtained by elemental analysis by EDX; c) To determine the cause that originated the bio-corrosion in the flagstone to be able to begin with the rehabilitation of the structure.

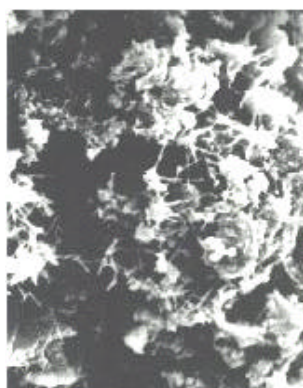
As concrete is isolated it was ruled out that high levels of  $\text{CO}_3^{2-}$  was possible due to the effect of the  $\text{CO}_2$  that spreads from the environment, and probably the microorganisms are responsible for this effect. Figure 1 shows the products of biological metabolism with enrichment of calcium, EDS studies (Table 1) shows the results of the elemental analysis. In figure 2 it is possible to appreciate the zincite formation and simonkoleite as zinc corrosion products in the galvanized steel sheet in the external face of the flagstone. Figure 3 shows the maghemite formation as corrosion product of the steel in the interior face of the flagstone.

Figure 1: Products of biological metabolism.

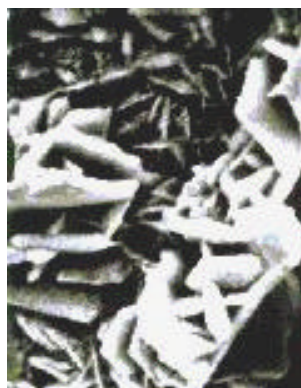
Figure 2

Figure 2: Zincite formation and simonkoleite, external face of the flagstone.

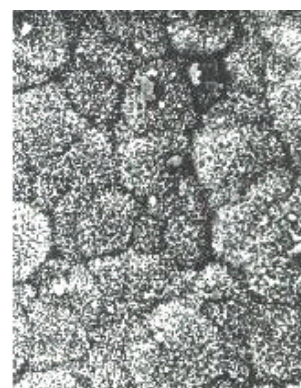
Figure 3

Figure 3: Maghemite formation, interior face of the flagstone.
