## Microstructural and Fractographic Analysis of an Oil Pipeline Failed in Service

A. C. Vidal\*, A. R. Martins\* and F. A. Darwish\*\*

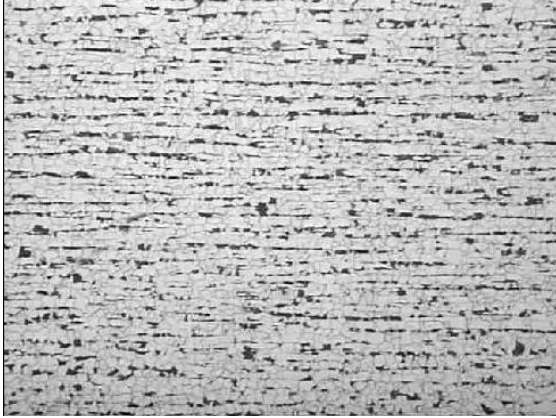
The base metal, an API 5L carbon steel, showed a microstructure consisting of ferrite grains together with strongly aligned pearlite colonies (Fig. 1). The heat-affected zone, close to the fusion line, presented a large amount of Widmannstätten ferrite (Fig. 2), while acicular ferrite was the predominant constituent in the weld metal (Fig. 3). These microstructural observations appear to be consistent with the impact results as well as the fractographic analysis carried out on specimens taken from the fractured part of the pipe.

FIG. 1. Pipeline base metal. Presence of ferrite and aligned pearlite colonies. 25X.

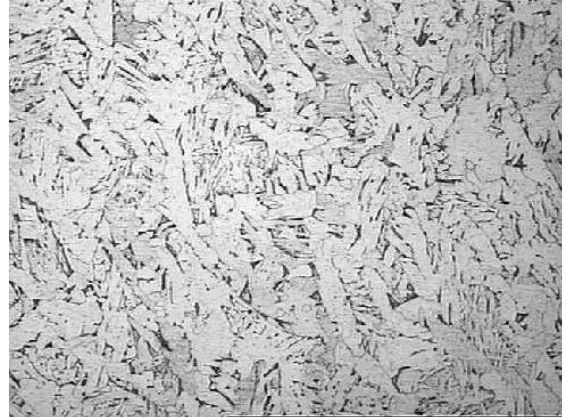
FIG. 2. Heat-affected zone of the welded joint. Widmannstätten ferrite. 100X.

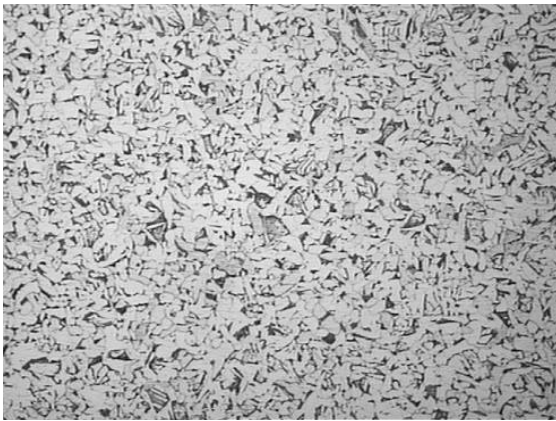
FIG. 3. Fusion zone of the welded joint. Predominance of acicular ferrite. 100X.

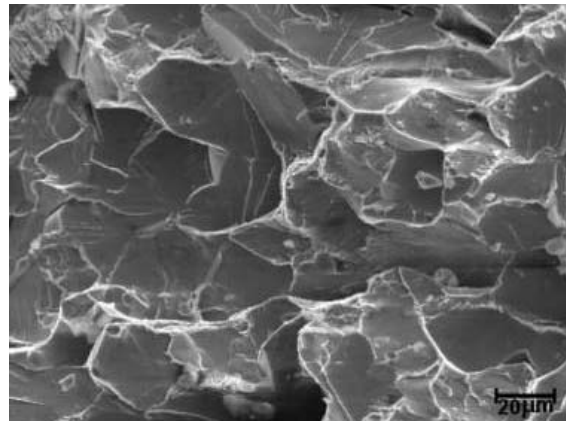
The low impact resistance of the base metal is confirmed by the predominance of cleavage as the operating fracture mechanism (Fig. 4), consistent with the presence of aligned pearlite colonies. The absence of this aligned constituent in the heat-affected zone seems to be in good agreement with its higher impact resistance in comparison with that of the base metal.

FIG. 4. Cleavage features predominating in the base metal fracture surface.

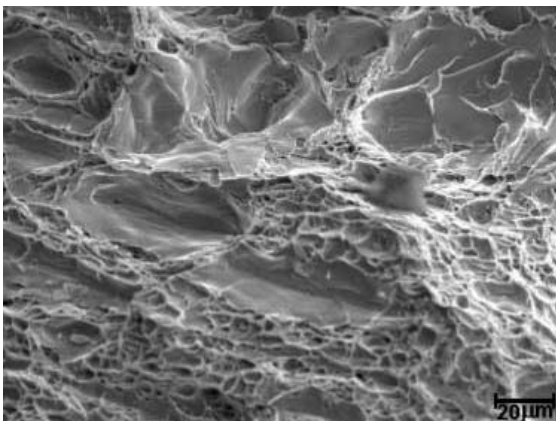
Compared to the base metal, the fractographic results are indicative of the tougher behavior of the heat-affected zone, where one can notice, in Fig. 5, the presence of mixed fracture modes (cleavage facets together with dimples), indicating higher plastic deformation levels during the fracture process. The acicular ferrite phase, predominant in the fusion zone, presents good impact toughness properties, consistent with the high impact energy level exhibited by the Charpy specimens. This is confirmed by the predominance of ductile failure mechanism as shown by the presence of dimples (Fig. 6) on the fracture surface of specimens pertaining to the weld metal.

FIG. 5. Heat-affected zone fracture. Mixed fracture mode. Dimples and cleavage facets.

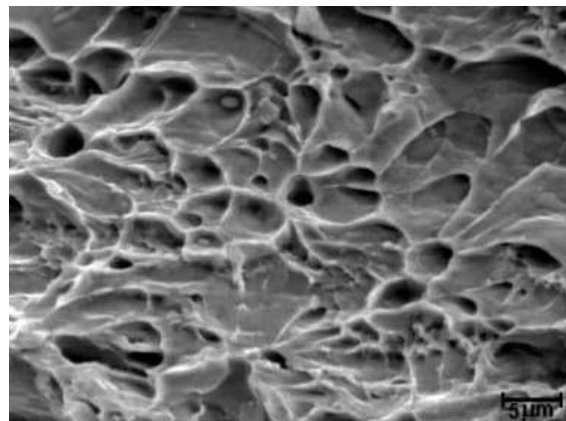
FIG. 6. Fracture surface of the fusion zone. Presence of dimples.
