## Mapping Surface Corrosion Damages of C1018 Carbon Steel When Exposed to High Temperature Environment

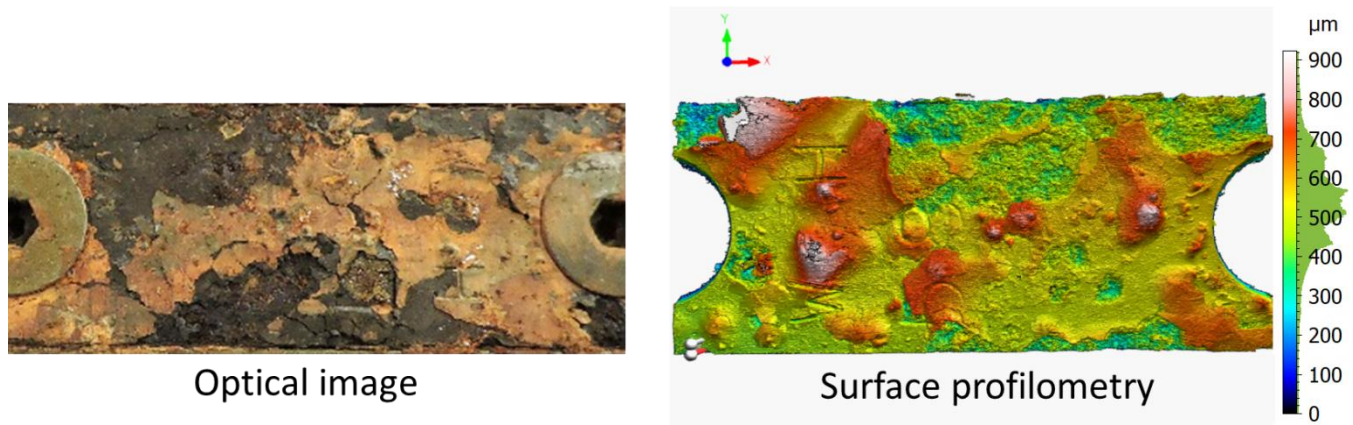
This work describes the corrosion study of C1018 coupon exposed to a high temperature (80 °C) environment. We observed that the coupon suffered severe corrosion damages showing corrosion triggered surface metal loss including corrosion cracking followed by the formation of complex scaling minerals, as evident in the optical image in Fig 1 (left) and the strong contrast in height topography in Fig 1 (right). Formation of iron sulfide, iron chlorides, calcium sulfate, calcium/iron carbonates, iron oxide/hydroxide, magnesium hydroxide and trace of barium sulfate were detected using a combination of XRF and EDX techniques.

**Fig. 1.** Optical images of retrieved C1018 coupon (left). corresponding surface profilometry showing high (red) and low (green) elevations, indicating scale deposition and surface corrosion, respectively.

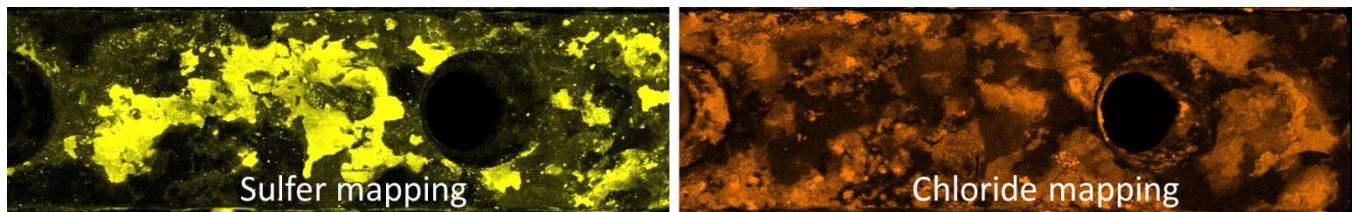
Fig 2 shows the XRF mapping of dominating role of sulfur and chloride components on the deposited scale layers on the C1018 surface. The coupon lost 8.7% of its original weight which means the corrosion triggered metal loss was more dominant over the scale formation leading to a net metal loss. Fig 3 (left) shows the microstructure of pristine C1018 substrate, while Fig 3 (right) exhibits corrosion damages in three layers - (1) a top layer of formed scale on the left side of the image, (2) surface embrittlement and mild cracking on the base substrate with manufacturing cold rolling marks visible, (3) bottom layer of severe metal loss followed by deep cracking.

**Fig. 2.** X-ray Fluorescence (XRF) mapping for elemental compositions on retrieved C1018 coupon. Mapping shows presence of sulfur (left, bright yellow) and chloride (right, brownish) on scale layers.

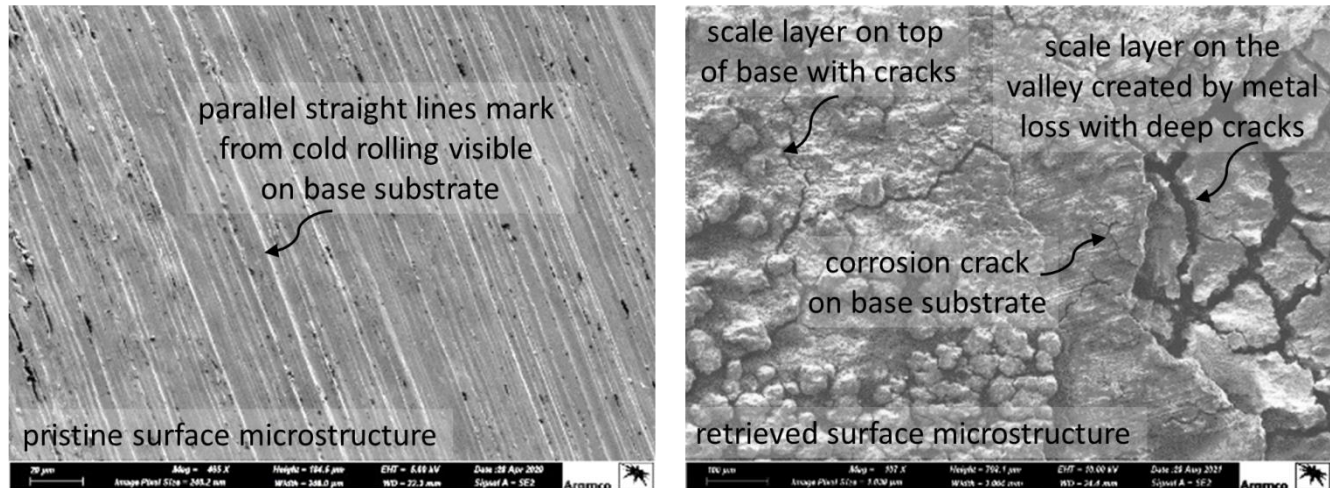
**Fig. 3.** SEM images of pristine (left) and retrieved (right) carbon steel C1018 coupon.
