## Hydrogen Effects on the Failure Mechanisms in Fe-Ni Weldments

J.A. Fenske,\* I.M. Robertson,\* R. Ayer,\*\* M. Hukle,\*\*\* D. Lillig,\*\*\*\* and B. Newbury, \*\*\*\*

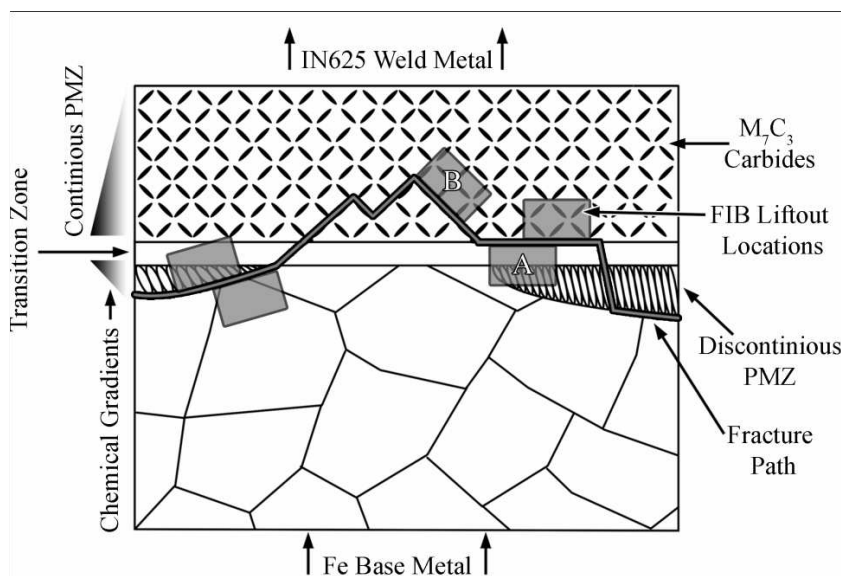
FIG 1. An illustration of the weld microstructure relative to the fracture path and FIB liftout specimens.

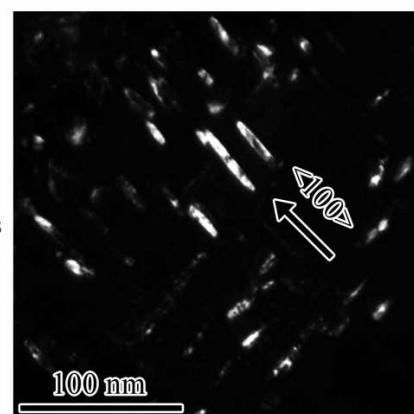
FIG 2. M<sub>7</sub>C<sub>3</sub> precipitates in the non-weld metal Ni-rich continuous PMZ.

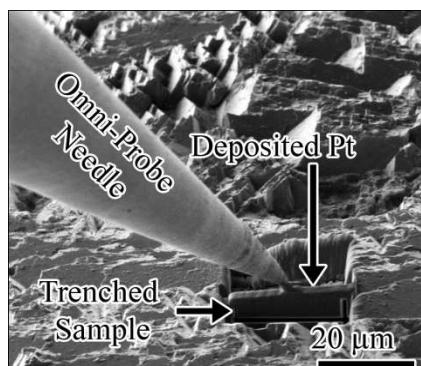
FIG 3. FIB liftout sample from the “cleavage-like” fracture surface.

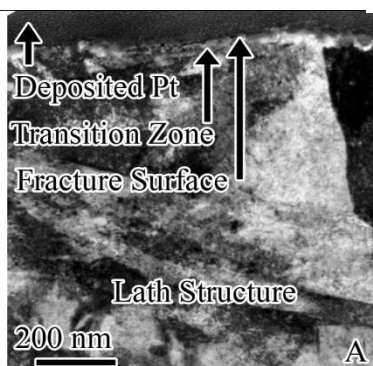
FIG 4. Bright field TEM micrograph of a FIB fracture liftout specimen from the Fe side of the lower flat fracture region.

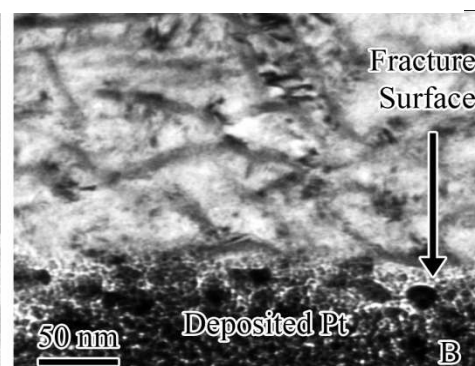
FIG 5. Bright field TEM micrograph of a FIB fracture liftout specimen from the “cleavage-like” fracture morphology.
