## The Role of Computed X-ray Tomography in a Metallurgical Analysis

Noah Budiansky, Joel Forman, and Ockert Van Der Schijff

Exponent, Natick, MA., USA

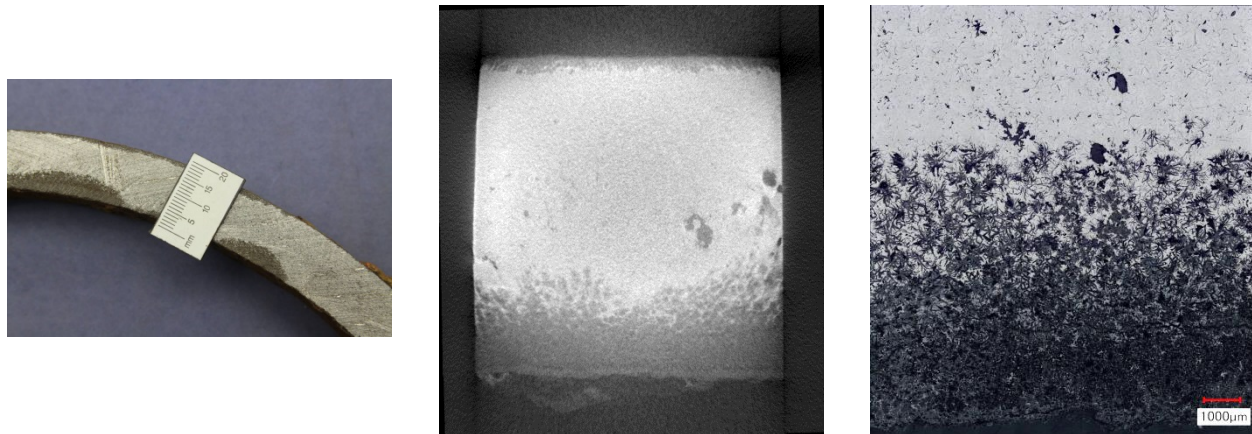
During a failure investigation, the use of CT as one of the initial steps, allows a non-destructive overview of the entire structure of the component and can be used to identify internal features of interest that can later be investigated by metallurgical analysis. For example, the depth of graphitic corrosion penetration of a grey cast iron water pipe may only be superficial in certain locations, but may reach full penetration in other locations. CT can be employed to identify locations of near through wall penetration, which can subsequently be sectioned and prepared for metallographic analysis showing the internal microstructure and confirming that the mode of failure is graphitic corrosion (Figure 1).

**Figure 1.** Overall photograph, CT cross section, and optical microscope image of graphitic corrosion in grey cast iron water pipe. Dark areas indicate the location of graphitic corrosion.

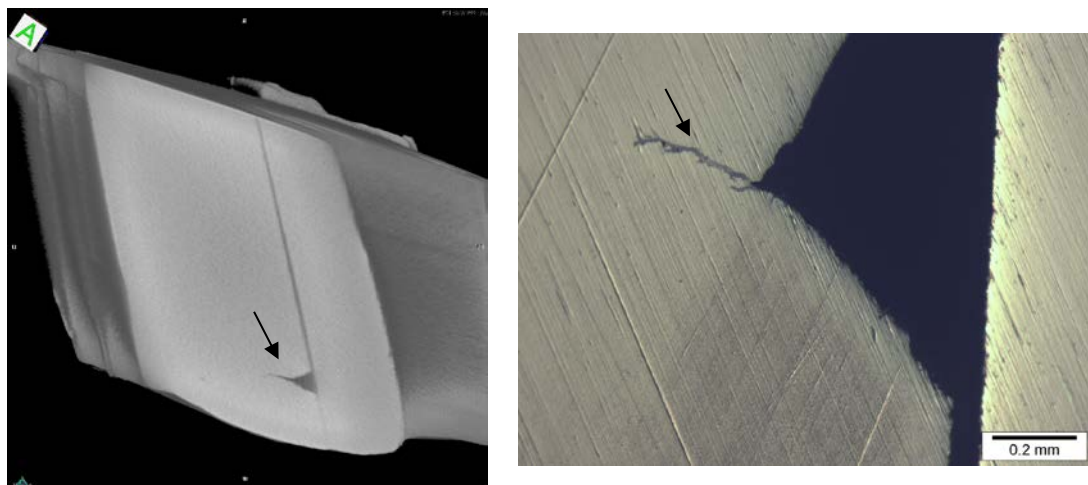
A second example is a carbon steel heat exchanger tube/tube sheet weld area where leaks occurred (Figure 2). On the exterior surface, a large feature was observed where steam likely escaped resulting in erosion and enlargement of the larger initial penetration. CT analysis as a first step in the failure analysis indicated that a crack-like feature could be observed at the root of the weld only in a few isolated locations adjacent to the large eroded area. Cross sectioning through this location showed that the crack was branched and further microscopic and elemental analysis indicated that the crack was filled with corrosion product with evidence of sodium. The investigation concluded that the likely cause of failure was caustic cracking initiating at the root of the weld induced by built up caustic ions from the feed water (Figure 2). Without the use of CT prior to sectioning and metallographic analysis the isolated locations of cracking may never have been identified and the failure analysis may not have been able to identify the failure mode.

**Figure 2.** CT cross section through a three dimension projection and optical microscope image of a roughly polished cross section of a welded carbon steel heat exchanger tube/tube sheet. Arrows indicate the location of observed cracking.
