## Characterization by Scanning Electron Microscopy on Drill Boride and Drilling Performance of Tool Steels

Nowaday the industry demands increasingly resistant materials that meet the needs of manufacturing processes, so they choose to improve tools with coatings to improve the life of the tool. For this investigation a monolayer of iron boride was formed using the thermochemical process of boron, by means of the technique of boring in powder pack with dehydrated paste of reuse; with the purpose of observing the effect of the drill with layer in drilling and to analyze the effect of the wear of the tool on an aluminum alloy, used in the section of aerospace and automotive industry.

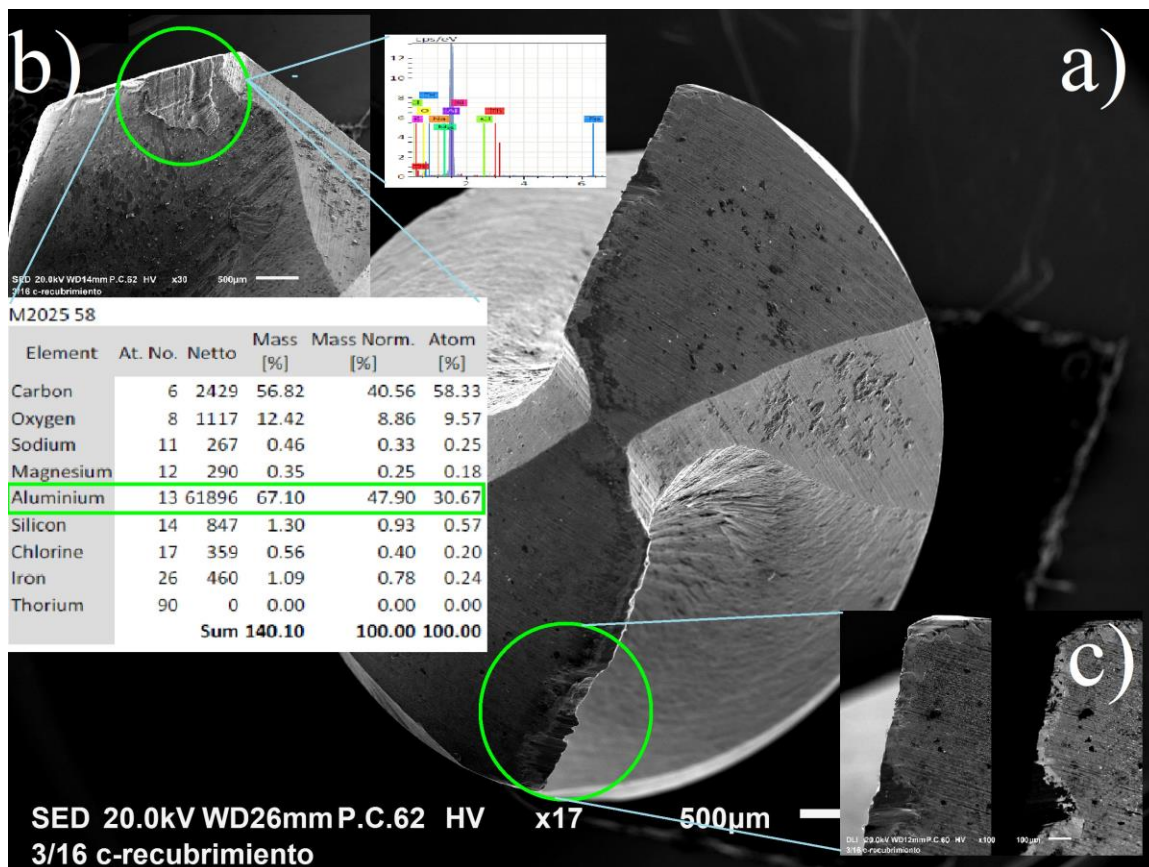
Figure 2 shows the chisel edge of the drill hole with boron atoms after 72 min of machining. Figure 2b shows the wear of the main edge and elemental analysis by EDS reveals the presence of an accumulated edge on the cutting tool. The effect is the presence of an aluminum mass adhesion of 67.1%, which presented failures in the drilling process due to the formation of the built-up edge (BUE) [2]. According to Taylor's estimated lifetime, the drill hole in the boron condition has a 28.12% yield, in the case of the untreated hole, continues without failure. Figure 2c shows the wear on the chisel edge and the presence of a non-uniform raised edge on the cutting tool. These types of wear occur when the coating comes off, leaving the substrate exposed.

**Figure 2.** SEM image of drill borided after of machining a) Drill with boron atoms at the end of 72 minutes of machining, b) EDS on the main edge of the drill reveals the presence BUE of the aluminum alloy 6061 T6, c) Abrasion wear causes the drill to have a raised edge with boron atoms.
