Failure Analysis of a Jet Engine High Pressure Turbine Blade

David Christie¹

¹Senior Failure Analyst, IMR Test Labs, Lansing NY, USA

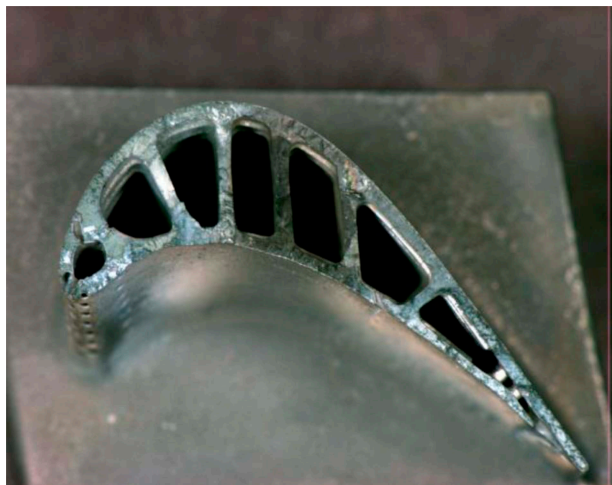
Visual examination of the fracture surface revealed an interesting, three zone fracture morphology. Modern aircraft engine high pressure turbine blades are complex castings, with internal passages and webs to support the airfoil section. The internal passages serve two purposes – they lighten the blades, turning the airfoils into structural “wings”, and they allow the passage of cooling gases to keep the blade material substantially cooler than the external combustion gases flowing over the airfoil surface. In the fractured blade, a region encompassing the fractured internal webs was covered with a high temperature oxide scale. From this darkened surface a second fracture zone extended that exhibited radiating ridges and fan-shaped patterns. Near the leading and trailing edges of the airfoil section a third fracture morphology was present, which was a rougher surface with no radiating pattern.

Figure 1. The fracture surface of the failed HPT blade. The dark region over the 4th and 5th web from the leading edge is oxidation cracking.

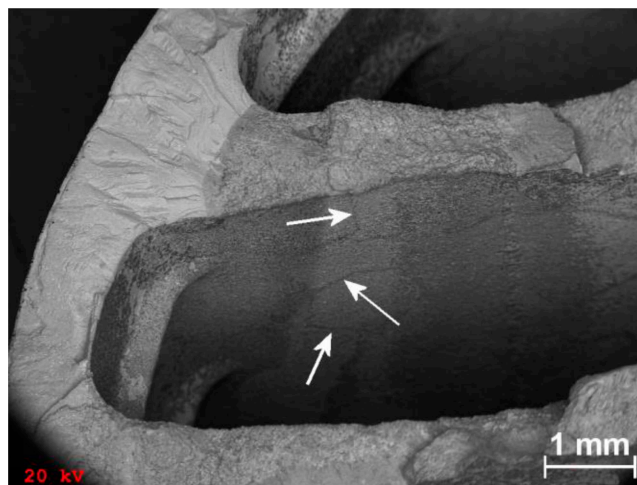
Examination of the microstructure of the fractured and non-fractured blades revealed additional oxidation cracks in the webs. These cracks followed grain boundaries in this relatively large grained material. Large grain size imparts greater creep resistance in nickel superalloys in high temperature service. However, the grain boundaries exhibit increased susceptibility to oxidation and growth of carbides. The prevention of oxidation cracks depends on the formation of a tight, oxygen resistant scale

Figure 3. Additional oxidation cracks were noted in the webs (white arrows).

on the internal web surfaces. The root cause of the fracture of this blade can be assigned to the failure of the internal oxide scale layer to prevent selective oxidation of the grain boundaries. Later revisions of this part number incorporated an aluminide vapor deposition coating on the internal cavities to increase resistance to oxidation. A surprisingly similar HPT blade fracture occurred in an engine on test in Australia in 2006 [1].

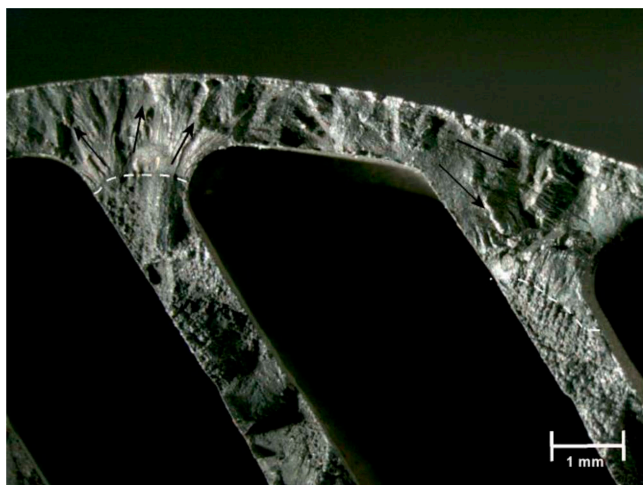
Under low power stereo optical microscope and scanning electron microscope (SEM) examination the story behind the failure was revealed. The oxidized fracture zone clearly had formed or been exposed to engine operating temperatures for a protracted time. This could only have happened during previous service, not during the short engine outgoing test. From this pre-existing crack high cycle fatigue (HCF) initiated at multiple locations. It is not clear when these fatigue cracks started, but the presence of a light high temperature oxide layer over most of the fatigue crack zone suggests that they had grown significantly during previous service cycles. It is likely that only a small percentage of additional fatigue growth occurred during the engine test. The third fracture zone was rapid ductile overload fracture that resulted in liberation of the airfoil section of the part.

Figure 2. The fracture surface at higher magnification. The black arrows show the direction of fatigue crack growth. The white dashed lines show the limits of the oxidation cracks.

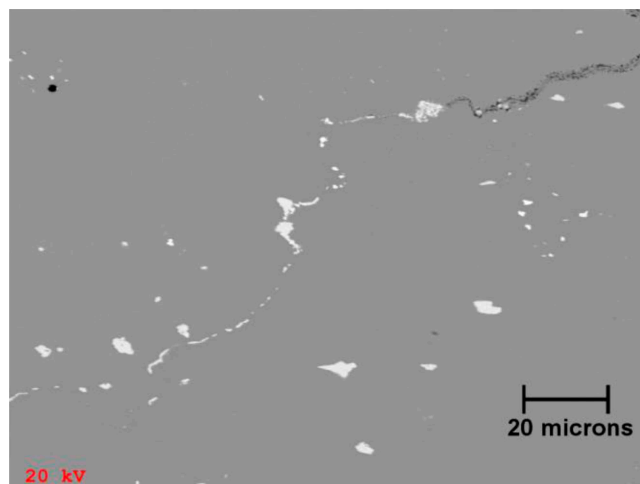
Figure 4. SEM backscatter image of grain boundary carbides and the tip of the oxidation crack.
