## A Case-Study of Bubble Formation Mechanism by Analytical TEM during Evaluation of an Incoming Spin-On-Hardmask at Wafer-Foundries

Physical Failure Analysis, Center for Complex Analysis, Characterization Group, Fab8, GLOBALFOUNDRIES, Malta, New York, USA.

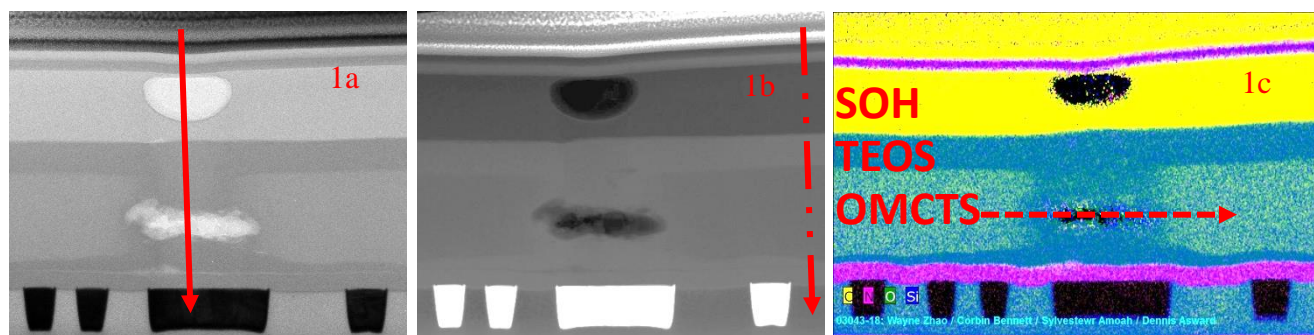
Figures. 1a~1c are transmission electron microscopy (TEM) and scanning transmission electron microscopy (STEM) images, and an X-ray energy dispersive spectroscopy (EDS) map, respectively, on the area of interest (AOI), from the SOH with bubbles; while no bubbles seen in a well-controlled SOH (results not displayed here). Figures. 2a~2c are elemental linescan profiles extracted from the EDS elemental mappings, as illustrated by the arrows (solid, dotted, and double dotted), as shown in Figs.-1a~1c right above of each of profiles.

Voids were seen, one in the carbon rich layer (SOH), and the other in OMCTS, octamethylcyclotetrasiloxane (C<sub>8</sub>H<sub>24</sub>O<sub>4</sub>Si<sub>4</sub>). A bump from the “glue layer” (GL) above NBlok (SiCN) was also noticed. Based on the elemental composition difference, in OMCTS (C<sub>8</sub>H<sub>24</sub>O<sub>4</sub>Si<sub>4</sub>), vs., tetraethyl orthosilicate (TEOS, Si(OC<sub>2</sub>H<sub>5</sub>)<sub>4</sub>), SOH bubble formation and its consequence in transferring to undesired voids during subsequent process was evident. Even if without applying electron energy loss spectroscopy (EELS) quantifications for precise ratio comparison of Si:O:C, the semi-quantitative atomic percentage of Si:O are sufficient, as demonstrated in Fig.2a vs. 2b. Since levels of Silicon and Oxygen were similar in TEOS and the bump adhered from the GL layer, through OMCTS, this indicated a void in

**Figure 1.** (a) TEM; (b) HAADF-STEM; and (c) EDS mapping, on the SOH bubble.

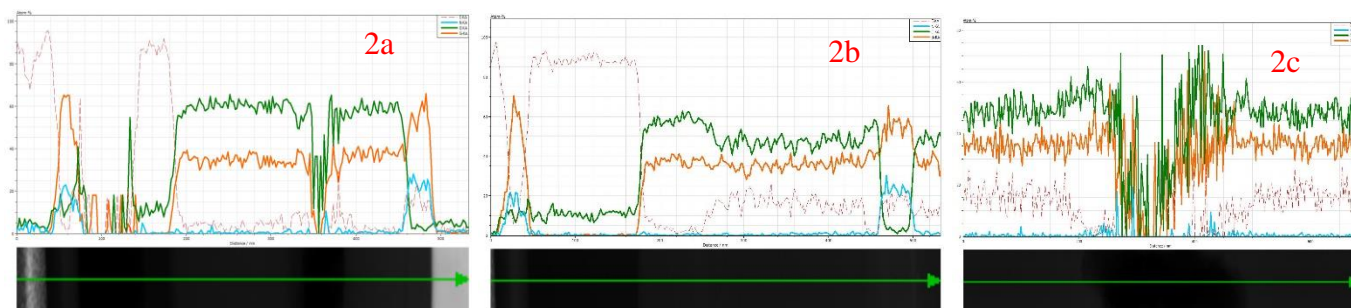
the OMCTS filled with TEOS with delamination under the OMCTS filled with TEOS as well. That meant, TEOS dipped into the voids existing in OMCTS. A hypothesis is that, this defect creates the void in the new SOH layer (Not seen with original SOH or less extensively). These critical PFA findings provided, (1) solid evidence with great details for decision-making on the business case by upper management of the wafer foundries; (2) guideline for further tighten quality control methodology for such incoming materials, and (3) also a great feedback to the vendor, who is willing to improve their SOH quality, but had a lack of clear directions for corrective actions then, before this in-depth analysis.

**Figure 2.** Linescan profiles extracted from the EDS mapping with a path from; (a) top to bottom across the two bubbles; (b) top to bottom across a region without any bubble; and (3) left to right across the bubble in the OMCTS layer.
