The FIB/SEM Technique, Atomic Force Microscopy and Acoustic Microscopy for Detection of Subsurface Defects in Thin DLC Coatings

P. V. Zinin*, M. H. Manghnani*, S. Berezina*, B. Koehler**, K. Bernland**, D. Fei***, and D. A. Rebinsky***

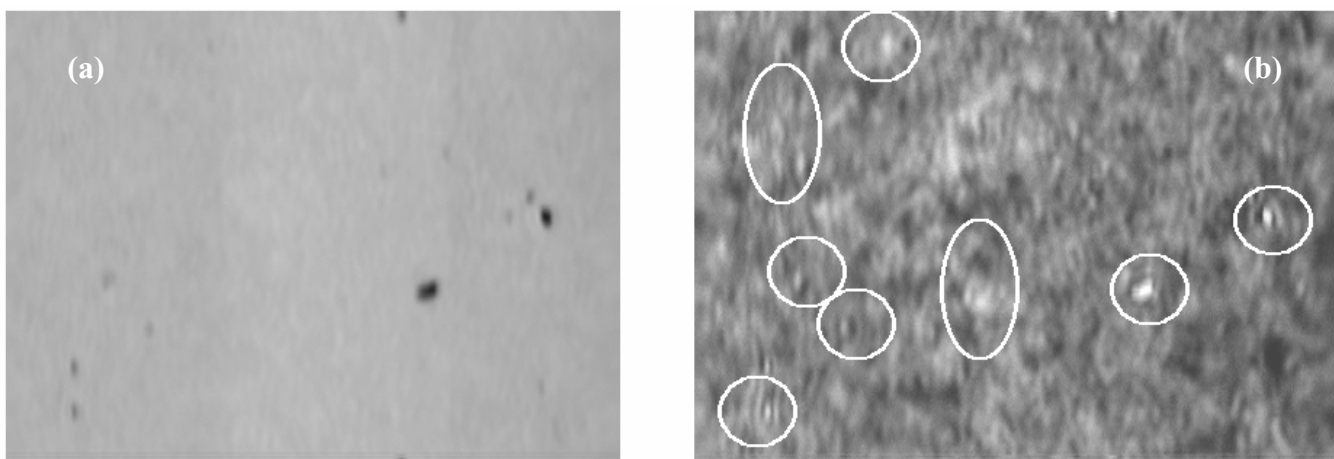
Figures 1a and 1b show the 1.3-GHz acoustic images of a Cr-DLC coated specimen at a defocus of 0 μm and -4 μm , respectively. Defects inside circles can be traced from the surface of the coating. Defects inside ellipses appear only in the image at $z = -4 \mu\text{m}$ and are subsurface defects.

Fig.1. Acoustic image of specimen Cr-DLC #624 at 1.3 GHz where the horizontal image size was 100 μm with (a) defocus $z = 0 \mu\text{m}$ and (b) defocus $z = -4 \mu\text{m}$.

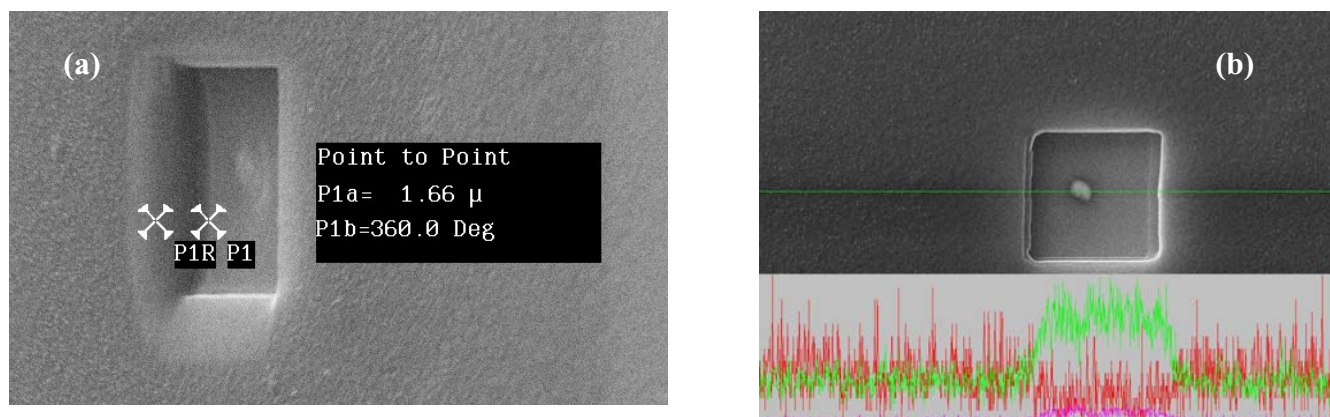
To locate the depth and origin of the defects, the specimen was examined by using FIB/SEM technique. We traced a defect from the specimen surface to its disappearance. The specimen was positioned in a FIB/SEM imaging system. An ion sputtering process was applied from above the specimen to do fine milling of the coating. The specimen was then imaged with high resolution by SEM (Figure 2). With repeated sputtering and imaging, the 3-D microstructure of the coating was examined without removing or repositioning the specimen. The images obtained with the FIB technique showed that defects visible by SAM are located mainly at the interface between the DLC coating and steel substrate (at a depth of 3 μm). It was found that while being sputtered away subsurface defects do not follow the same pattern as surface defects, which suggested that the underlying defect has different sputtering properties than the surrounding material.

Fig. 2. SEM images of the Cr-DLC coating. (a) defect after 106 minutes of sputtering. The depth of the trench is approximately 1.9 μm. P1a is the distance between markets. (b) EDX-analysis results of the sputtered area, with no tilt of the image. Green = chrome, purple = iron, red = carbon.

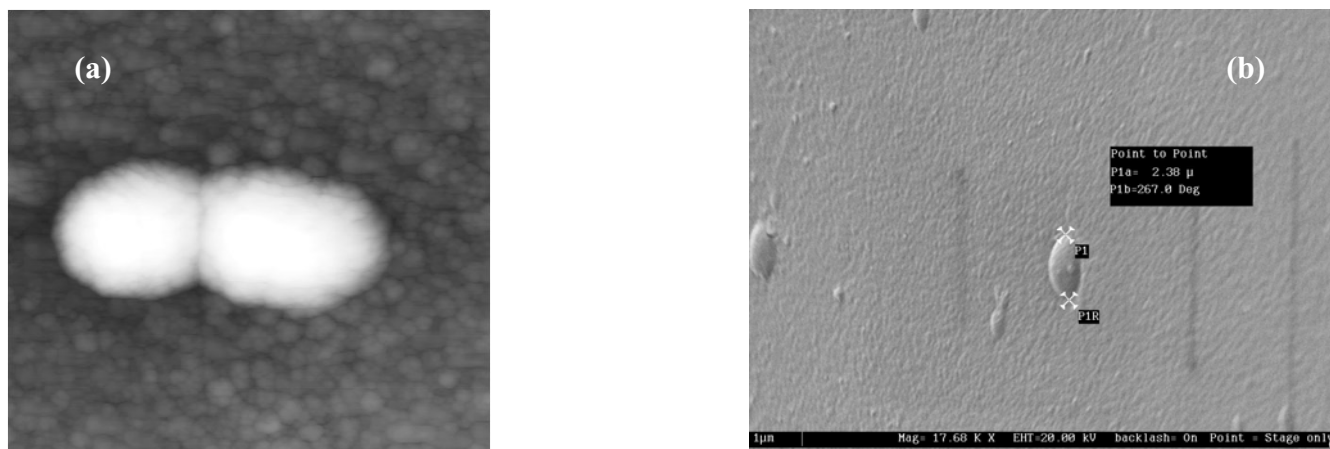
A model for bump-like defects is proposed based on the SAM, EDX and FIB analysis results. The coatings have delaminations/voids between the Cr bond layer and steel substrate. These defects cause bump-like surface defects (Figs. 3a and b) that have a larger diameter than subsurface defects.

Fig. 3. Images of the Cr-DLC specimen (a) AFM image, deflection mode contrast with a field of view of $6 \times 6 \mu\text{m}^2$; (b) SEM image showing the defect prior to sputtering.
