The Space Shuttle Columbia Accident Investigation and Reconstruction: Two Years Later

S. J. McDanel,^{*} Richard W. Russell^{**}

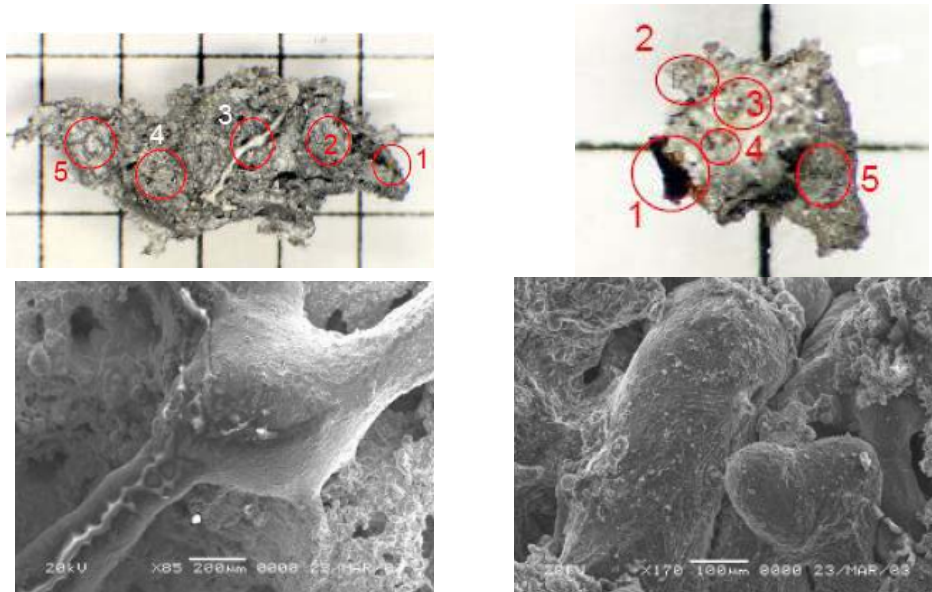
During the initial stages of the investigation, samples as shown in Fig. 1 were harvested from selected pieces of debris and subjected to further examination. Ultimately, the information derived from the sampling and analysis was used to determine the most likely location of a breach in the left wing leading edge of the Columbia, as shown in Fig. 2. Similarly, the information was used to determine the path which the impinging plasma followed once inside the wing structure.

FIG. 1. Macroscopic views of typical slag samples (magnification of top photos approximately 5X) and scanning electron micrographs (magnification of bottom photos 85X (left) and 170X (right)) of selected areas.

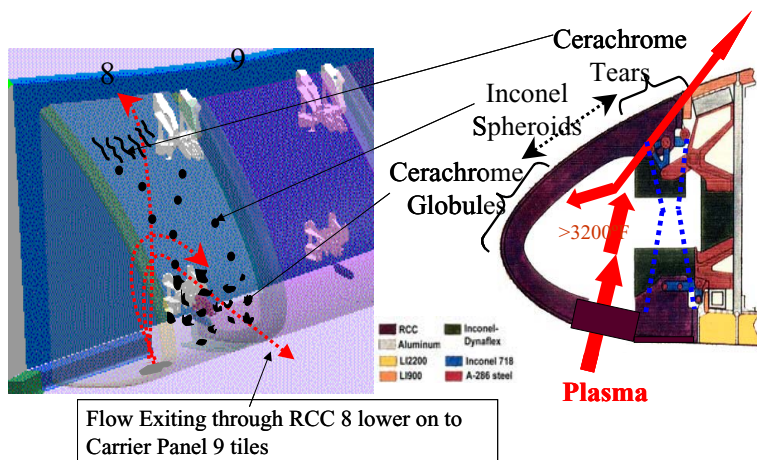
FIG. 2. Schematic representation of the suspected breach location and plasma flow path. Taken from the STS-107 Columbia Reconstruction Report, NSTS-60501, National Aeronautics and Space Administration, June, 2003.
