SCC Failure in Vent System on Radioactive Waste Storage Tank

C.F. Jenkins

SRNL, Westinghouse Savannah River Company, Aiken, SC 29808, USA

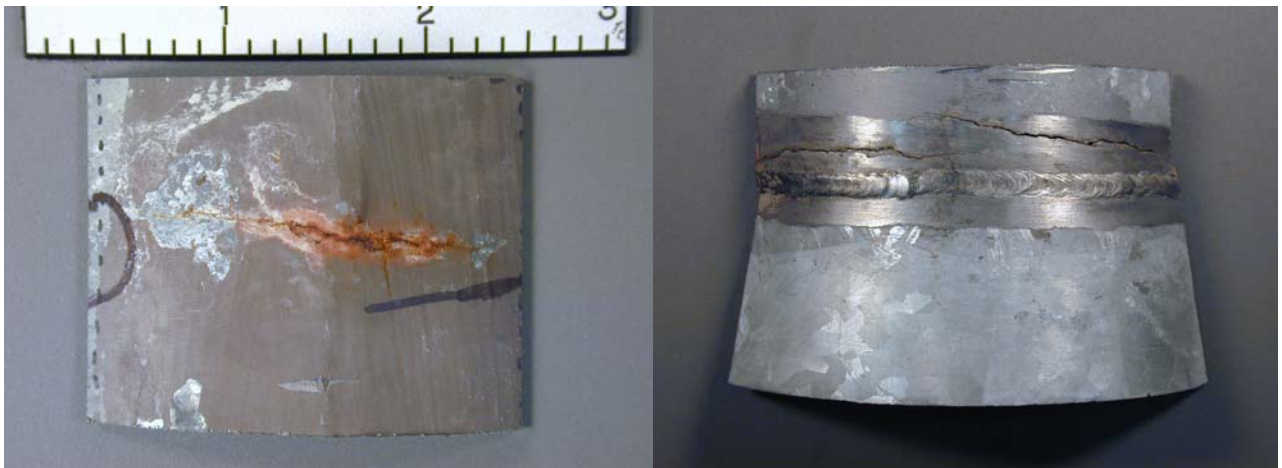
One very large crack midway in the assembly nearly divided the assembly in two. A 1/8 inch separation existed at a girth weld joining two straight lengths of pipe. The break actually consists of multiple cracks at a toe of the weld, and the parallels the weld in the fusion and heat affected zones. A similar break with less separation or parting occurred in a girth weld at a fabricated reducer.

In addition to two cracks at girth welds, there were six cracks on axial seam welds along the pipe. All were oriented circumferentially, were ~2.5 inches long, and had nearly equal lengths on each side of the seam weld. The crack lengths are mostly within the rust resistant paint strip on the outer surface, but all the cracks extend well beyond the anticipated HAZ - 1 to 3x sheet thickness [1].

Residual stresses in the pipe due to weld shrinkage result in tensile loading in the axial direction within the weld zone of the seams. Moreover, the residual tensile stress and mechanical drive for cracking at the girth joints is also axially oriented, as a result of axial constraints in the fabrication process. The large gap occurring at the center girth joint indicates prior existence of a very large strain and stress, related to fit up between the fixed flange locations on the tank. The direction of crack growth is driven by those residual stresses.

Fig. 1. Sections of pipe from vent system on waste tank. Cracks are in heat affected zones of welds.

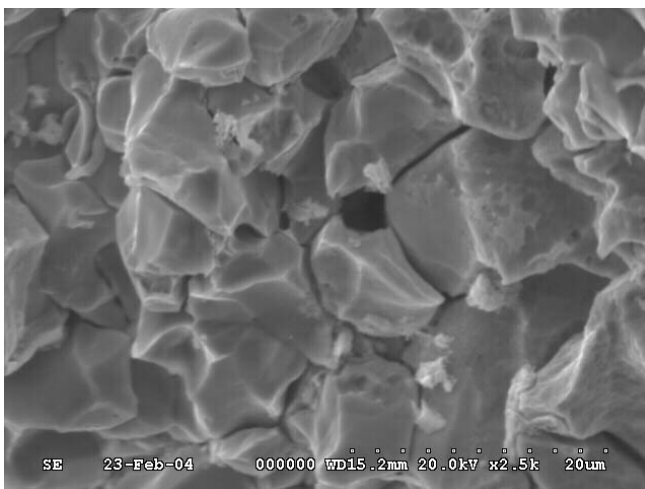
Study of the fractured surfaces in the SEM did not reveal any peculiarities at the crack origins, though the cracks did initiate in the HAZ. No striations related to fatigue were observed. A macro-shading phenomenon on the fractures suggests large step crack growth from inside to outside across the thickness. The fractured surfaces had been exposed in chemical baths designed to remove rust. Some longer exposures could possibly have affected this shading.

Evidence of IGA in the fracture is seen in the SEM work, but stress definitely plays a role and IGSCC is possible. There are a limited number of chemical species that may lead to the effect in carbon steel, including nitrate and hydroxide. These are principal constituents of the waste in the tanks, and they are present in the vapor space above the bulk solution. Slight corrosion occurs in the

Fig. 2. IGA in fracture of seam weld on steel pipe.
