Failure Analysis and Quantitative Image Analysis of Leaded Brass Components

D.F. Susan, A.C. Kilgo, R.P. Grant, and G. Grimm Sandia National Laboratories, Albuquerque, New Mexico

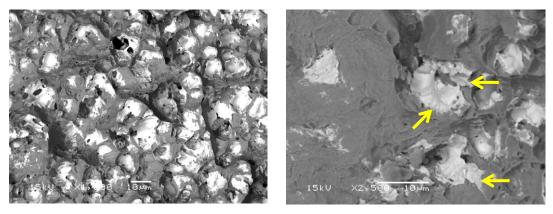
Figure 1 shows backscatter SEM photomicrographs of the fracture surface of leaded brass (Alloy C36000: 61.5 wt.% Cu, 35.5 wt.% Zn, and 3 wt.% Pb). If the Pb concentration is measured by energy dispersive spectroscopy (EDS) of the fracture (not recommended) or by image analysis of the fracture surface (also not recommended), approximately 25% Pb is found. However, as shown in Fig. 2, the material contains only about 2 vol. % Pb which is consistent with the expected Pb concentration of the alloy. There are two reasons for the dramatic difference between the fracture surface and the bulk material. First, the fracture occurs preferentially through the Pb phase. Each soft Pb particle nucleates a microvoid and the voids link up to connect nearby Pb particles as the fracture progresses. And second, as the ductile microvoids grow the soft Pb phase is stretched across the inside of the voids as shown by arrows in Fig. 1b. The enhanced straining of the Pb phase results in a thin film of Pb across many of the microvoids and a much higher *surface area fraction* than volume fraction within the material. The effect is prevalent in bending failures as well -- the Pb is essentially smeared across the elongated dimple rupture fracture surface, Fig. 3.

Fig. 1. Backscatter SEM photomicrographs showing high amount of Pb (bright phase) on the fracture surface due to the formation of thin Pb films during straining.

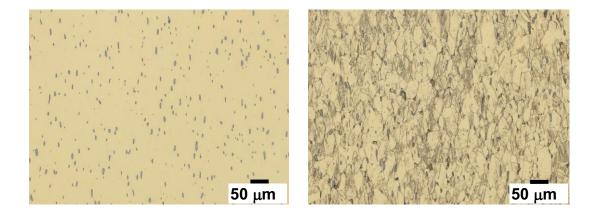
Fig. 2. Color light optical photomicrographs of Pb particles distributed in the brass matrix. (left) as polished, (right) etched to show deformed grain structure, "half-hard" condition.

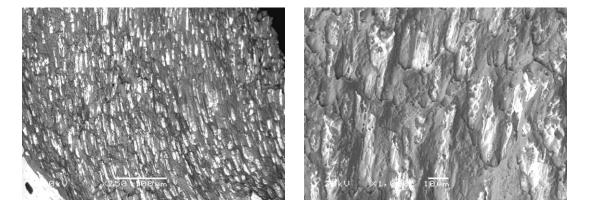
Fig. 3. Backscatter SEM images of bending fractures of free-cutting leaded brass. The Pb particles are smeared across the "elongated dimple rupture" surface.
