Root Cause Failure Analysis of Polyethylene Tubing Utilizing Microscopy

Eddy Garcia-Meitin¹ and Mark Jablonka²

¹ Analytical Sciences, HHD Building, The Dow Chemical Company, Lake Jackson, TX.

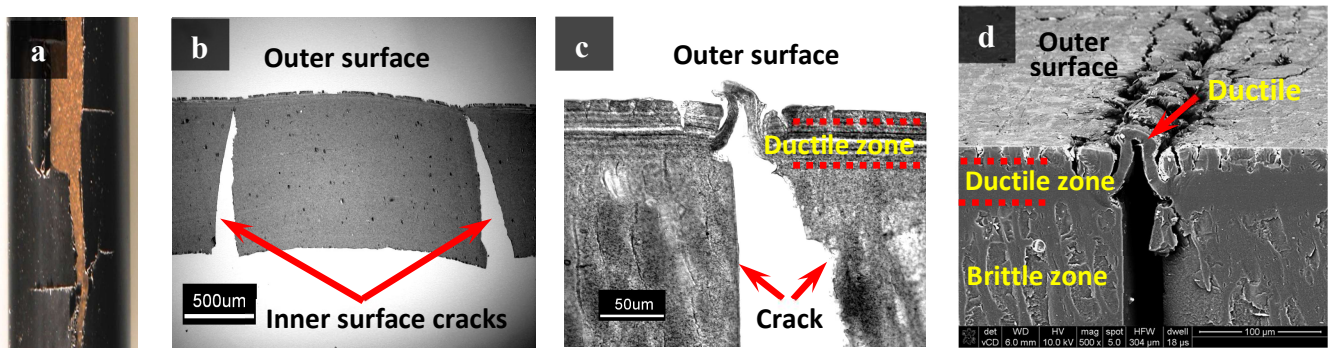
The first case study identified the root cause of premature field failure in black agricultural micro-irrigation tubing produced from linear low density polyethylene (LLDPE) containing carbon black (CB). The client indicated that tubing was produced using LLDPE tubing grade resin and had prematurely failed after 5 years of service. It was hypothesized that environmental stress cracking (ESC) from chemicals used for pest control and fertilization had accelerated failure. Visual examination of the tubing showed severe surface embrittlement and micro-cracking consistent with ESC (Figures 1a). To investigate the root cause of failure, a Leica UC7 microtome was used to collect 5µm thick cross sections at -80°C along a crack arrest. An Olympus Vanox compound optical microscope used under transmitted brightfield and epi-fluorescence illumination determined that cracks initiated along the inner tubing surface and propagated outward (Figure 1b). A thin ductile layer of approximately 70µm thick, displaying a more oriented CB pigment dispersion, was present along the outermost tubing surface (Figure 1c). The presence of a ductile layer suggested that a co-extruded structure was used to produce the tubing. Backscatter SEM images collected on an FEI Nova Nano600 SEM verified the presence of a ductile surface layer and showed extensive surface mud-cracking consistent with ultraviolet oxidation (Figure 1d). The tubing manufacturer verified that LLDPE tubing grade resin had been co-extruded as a protective outer surface layer on the tubing. The bulk of the tubing was produced using a combination of LLDPE tubing grade resin and regrind containing tubing with emitters from the manufacturing process, and was depleted in UV stabilizers required for extend service life.

Figure 1. (a) Failed tubing (b) LM cross section of inner surface, crack initiation (c) LM cross of crack and ductile outer layer with streaked pigmentation (d) backscatter SEM of crack and ductile outer layer.

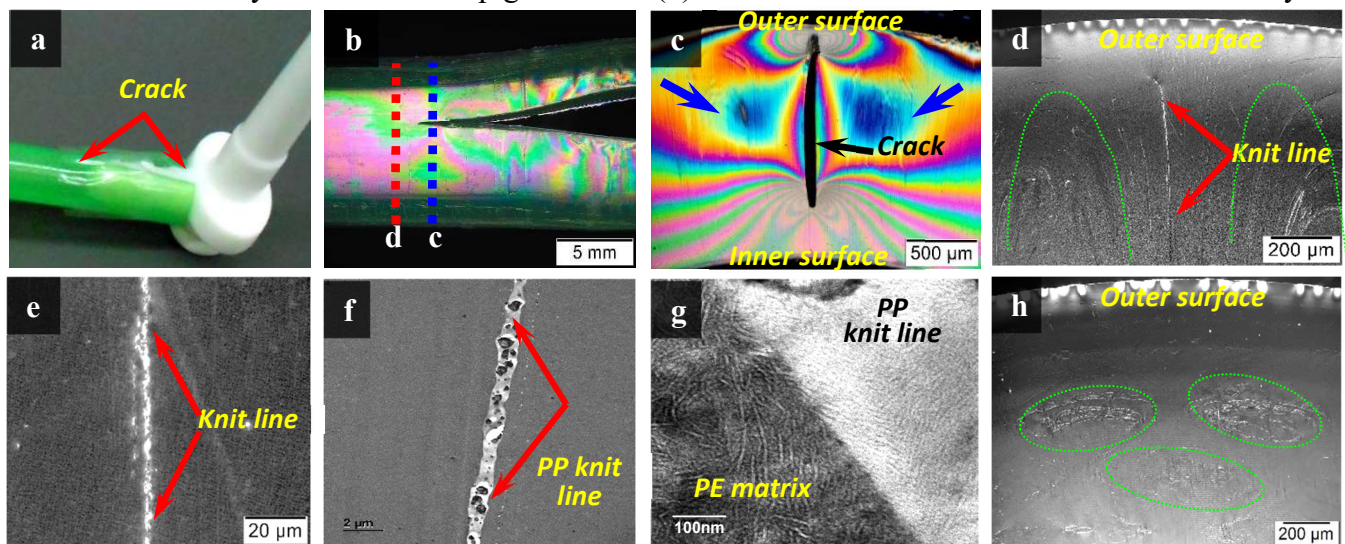
A second case study dealt with flexible tubing produced from a polyolefin elastomer (POE) resin. The tubing manufacturer had installed a new feed die and experienced linear cracks along barbed tubing connectors (Figure 2a). Prior to die modification, failures did not occur along tubing connectors. This study focused on identifying the root cause of linear cracks in tubing produced using a new die. A Leica MZ-16 stereo microscope was used under cross polarized light to locate and examine tubing cracks and stress fields around connectors (Figures 2b). Tubing cross sections were cryogenically sectioned at -80°C to approximately 300µm (Figure 2c) and 5µm (Figure 2d) in thickness, and examined using a compound LM under transmitted cross polarized light. Stress fields and parabolic polymer flow fronts (blue arrows

in Figure 2c) were observed on both sides of a crack which developed internally within the tubing wall. Examination of a 5µm thick cross section 2-3mm directly ahead of a crack arrest (red dotted line in Figure 2b), identified a linear birefringent streak forming a knit line between two parabolic flow fronts (red arrows in Figure 2d). The greater birefringence associated with the knit-line suggested a higher density, more crystalline material. Transmission electron microscopy was used to examine the knit lines and determine they were comprised of an impact modified polypropylene (PP) resin that was not part of the tubing formulation. The PP-based knit-lines were not miscible with the POE tubing matrix and formed sharp interfacial boundaries (Figures 2f and 2g). A control tubing produced with the original die also showed evidence of resin contamination, however, the oval-like flow patterns produced with the old die (green ovals in Figure 2h) did not form linear knit lines in the thickness direction which induced failures.

Figure 2. (a) Tubing crack over connector (b) Linear crack and arrest under cross polarized light (CPL) (c) Tubing cross section under CPL showing internal crack and stress fields (d and e) CPL images ahead of a crack arrest showing parabolic flows and knit line (f and g) TEM images of knit line morphology and interfacial boundary (h) CPL image of control tubing cross section showing oval flow patterns.
