## Thermal Fatigue and Failure Analysis of Cu-Plated Through Hole Solder Joints

D.F. Susan, A.C. Kilgo, P.T. Vianco, and M.K. Neilsen

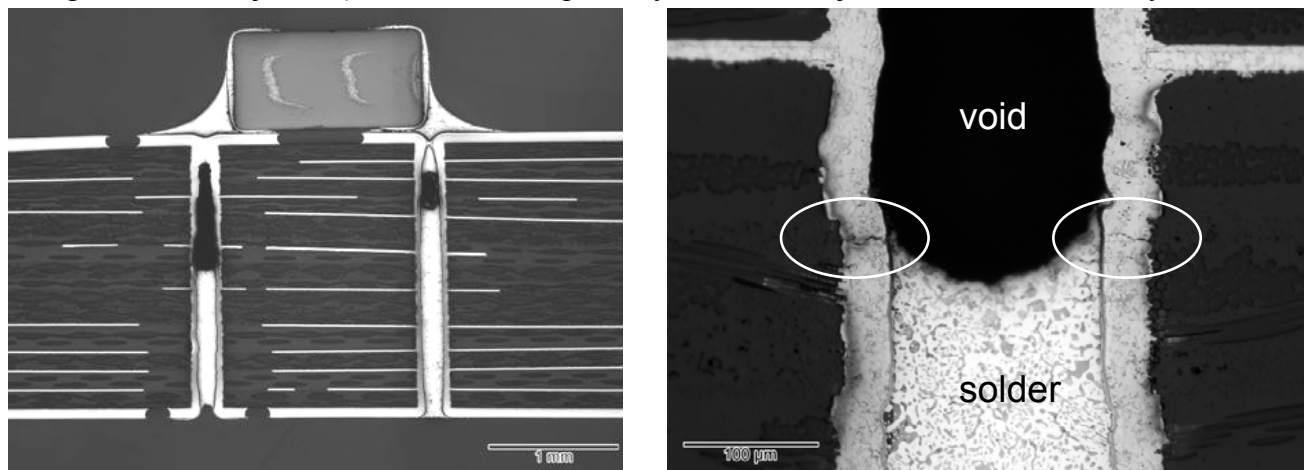
Fig. 2. a) Low magnification optical micrograph of a surface mount device with underlying solder-filled vias (no pins). b) Via cracks in a partially filled solder joint after 100 thermal cycles.

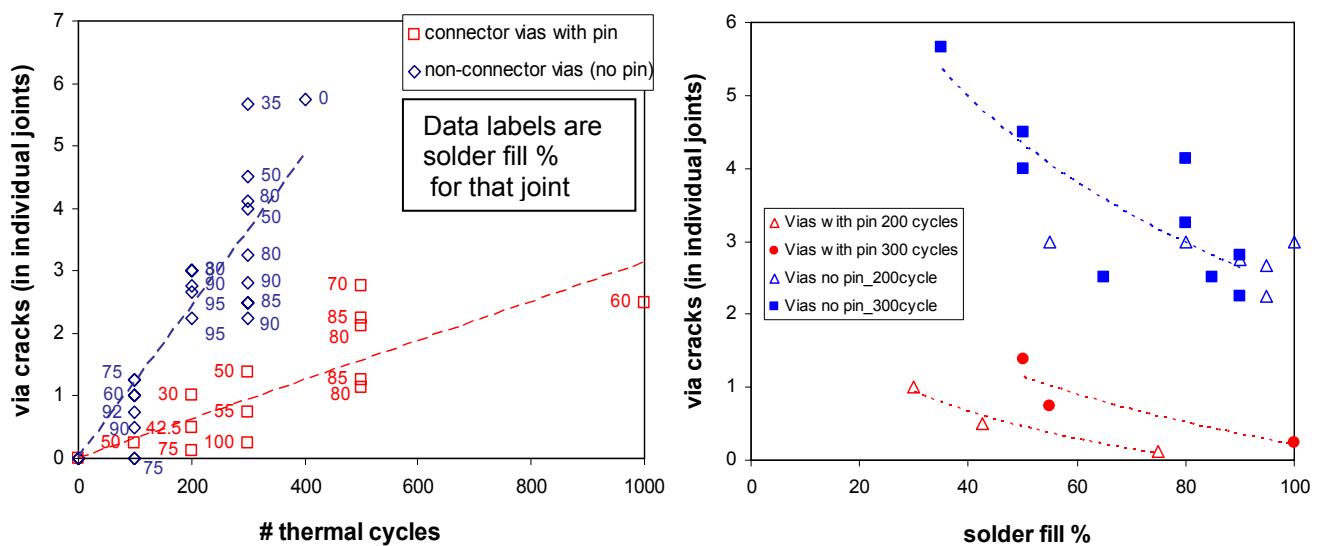
Fig. 3. a) Measured number of via cracks as a function of thermal cycling. b) Number of via cracks vs. solder fill level of individual joints for samples subjected to 200 and 300 thermal cycles.
