## SEM Evaluation of Advanced Refractory Failures

\*US Department of Energy, Albany Research Center, Albany, OR 97321

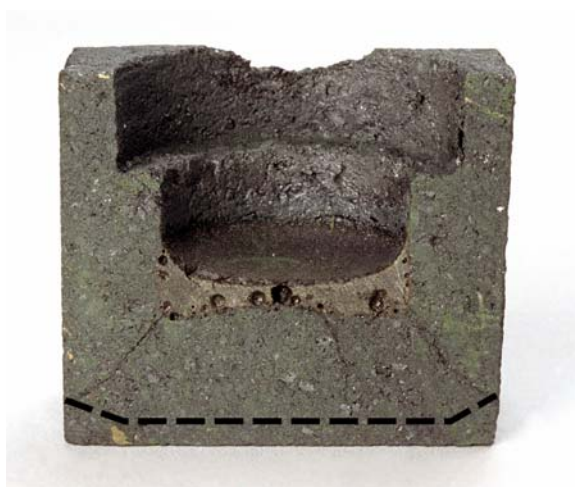
FIG. 1: Fired cup test with slag penetration.

The SEM is an invaluable tool in the evaluation of advanced refractories and their failure. A reaction vessel's refractory liner, at minimum, must protect the reaction vessel from elevated temperatures, corrosive slag and thermal cycling. To understand the failure mechanisms ARC staff had first to determine how an advanced chrome rich refractory was attacked by various components that make up a slag. Refractory cups were made from the refractory of interest and various compounds that can be found in a slag such as CaO, SiO<sub>2</sub>, Fe<sub>2</sub>O<sub>3</sub>, NaCl were placed into the test cups and fired for 24 hours at the required temperature with the desired atmosphere. Fig 1.

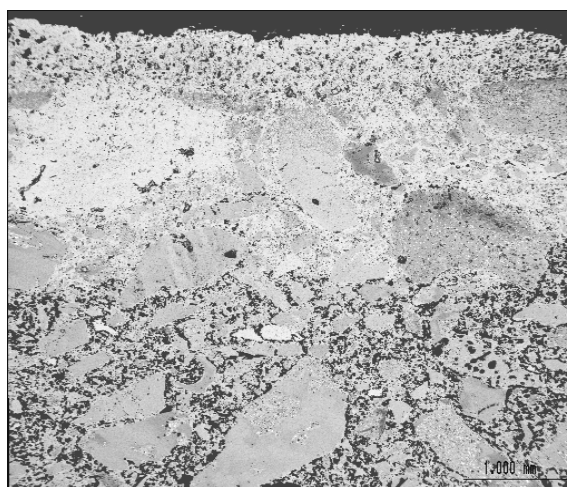
FIG. 2: BSE micrograph of CaO cup test CaO severe attack of the refractory.

The cups are prepared for examination by embedding in epoxy and cross sectioning. SEM examination revealed how various slag compositions attacked and penetrated the refractory. The slag could corrode, free refractory grains or react with the refractory and form a new compound. Fig. 2. It was found that the only way to measure slag component penetration was with multiple elemental X-ray maps. SiO<sub>2</sub> penetrated deeply and in many instances moved through the cup. Fig 3.

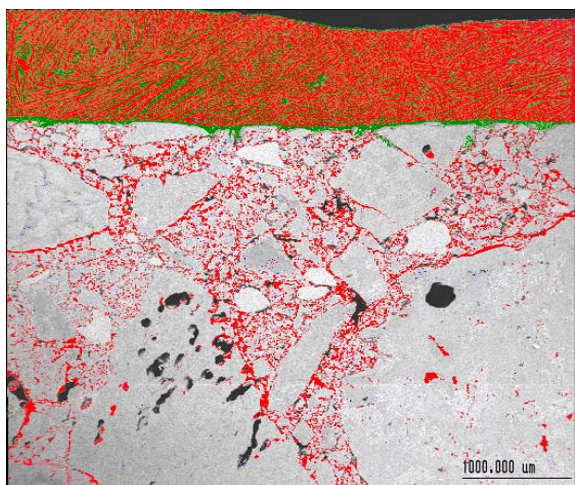
FIG 3: Si and Ca K $\alpha$  elemental X-ray maps overlaid. Note how deep the Si penetrates.

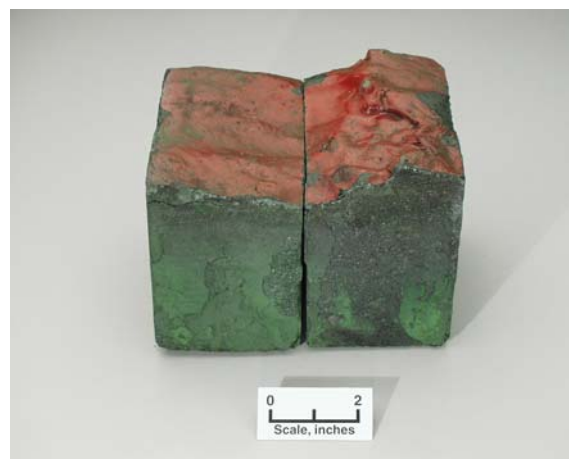
FIG. 4: Spent refractory

The knowledge of slag refractory interactions gathered during cup testing was applied to actual spent refractory from reaction vessels. Obtaining samples from the reaction vessel itself proved difficult due to time constraints imposed in relining. Samples were selected based on spent brick shape, color or location in the heap of spent refractory Fig. 4. Sample preparation affected the results dry, water or oil coolant during cutting may dissolve reaction products. The complex reactions between the slag and refractory made for very interesting and time consuming evaluation. Elemental X-ray maps at low and high magnification combined with point analysis aided in locating regions of interest. Crystals were found growing in voids and appear to be from vapor deposition Fig. 5. Other crystal structures are from the slag refractory interaction. Knowledge gathered from this and other supporting research resulted in a new patented refractory composition that resists slag penetration.

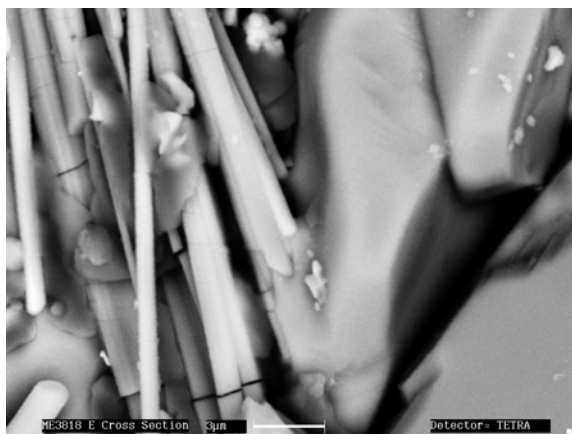
FIG. 5: Crystal growth from vapor deposition.
