Research Article

The archaeology of a Nazi synthetic-fuel plant and its legacy: the Hydrierwerke Pölitz AG

Grzegorz Kiarszys^{1,*}

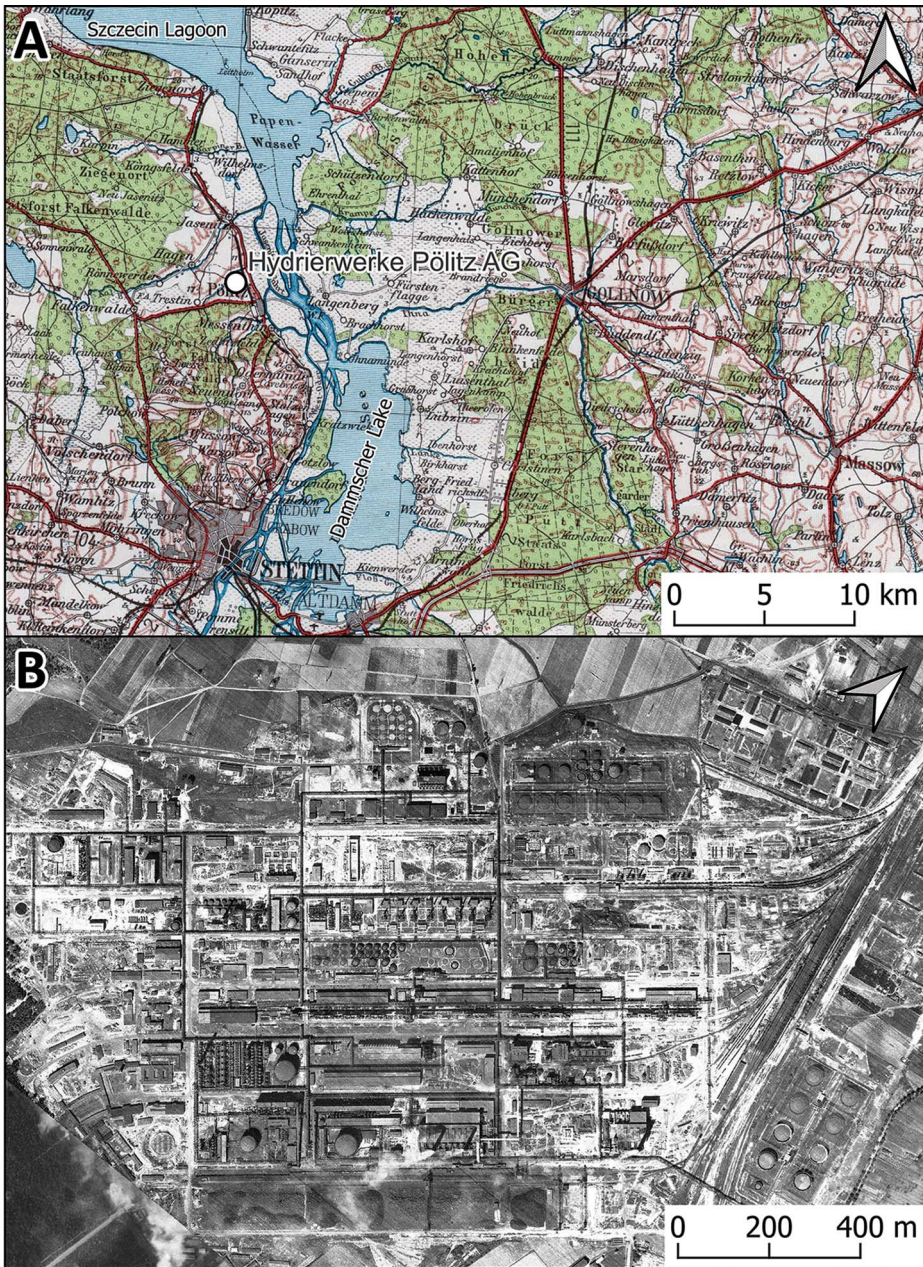
Figure 1. The Hydrierwerke Pölitz AG: A) location of the plant (detail from the map: *Ubersichtskarte von Mitteleuropa 1942*); B) image of the plant from the aerial photograph taken 26 July 1943 by the 8AAF (figure by G. Kiarzsys).

One of the main factors that determined the location of the new synthetic fuel plant was the proximity of waterways (Figure 1A). The facility had a convenient connection with the Baltic Sea through the Szczecin Lagoon and with distant Silesian coal mines in the south via the Dammacher Lake (Jezioro Dąbie in Polish) and the Oder River and its tributaries. A fresh water supply was also essential for the production process (Ciechanowski *et al.* 2011: 131; Socha 2015: 16–17). Far from future theatres of conflict, and from airfields in enemy territory, the factory was deemed to be relatively safe.

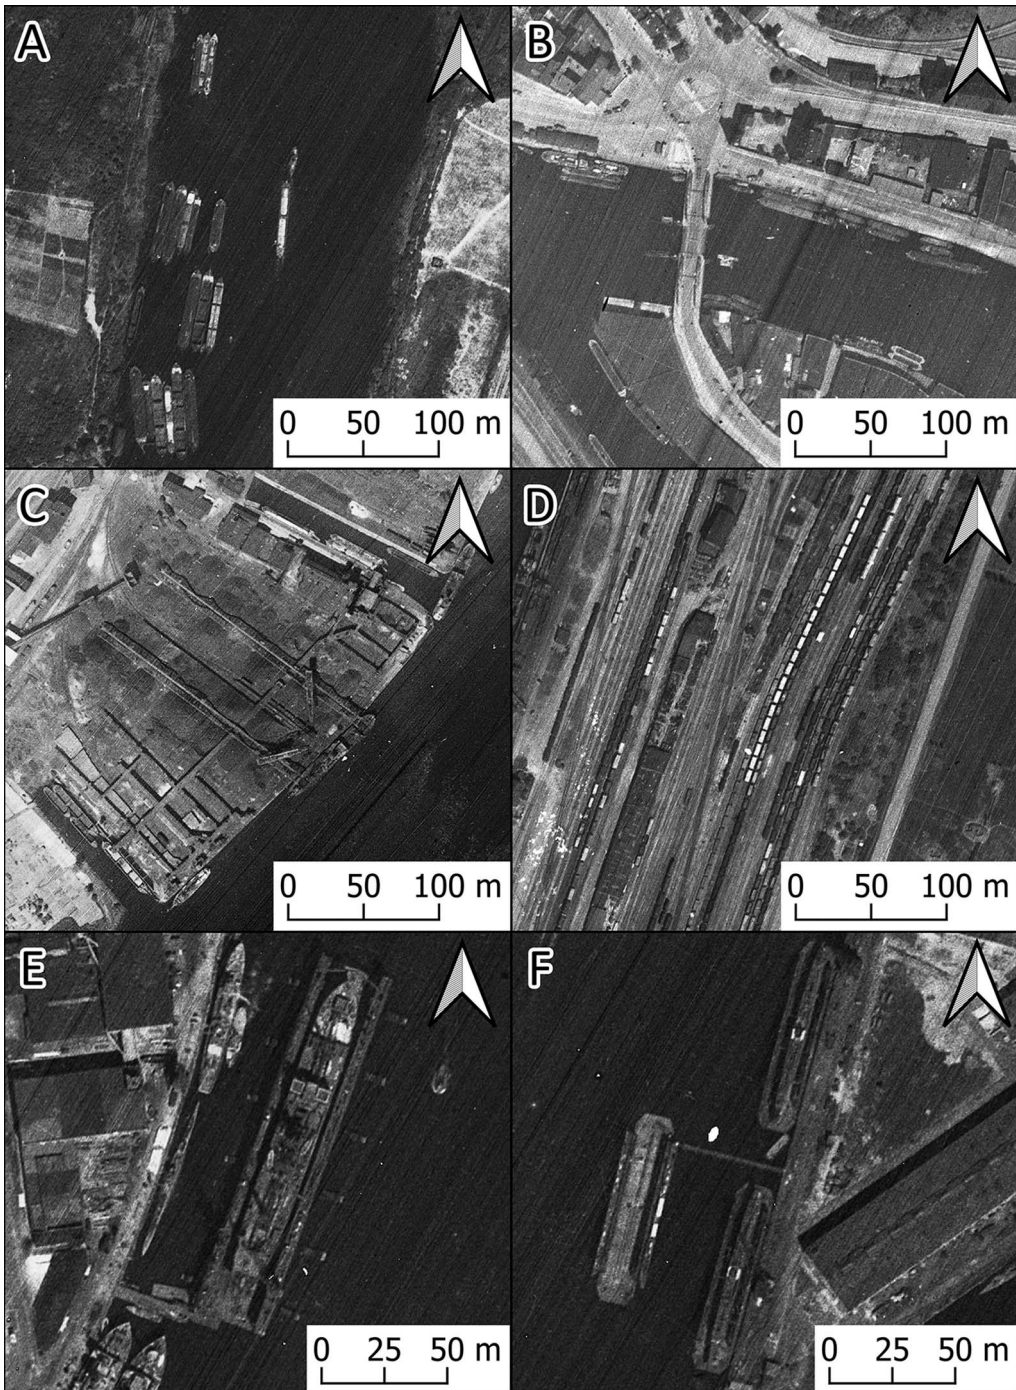
Figure 2. The subsidiary infrastructure and activities related to the Hydrierwerke Pölitz AG: A) & B) the coal barges on the Oder River, 26 July 1943; C) the river coal terminal, 20 May 1943; D) the railway junction with the coal railcars, 26 July 1943; E) Kriegsmarine ships waiting for resupplies and undergoing repairs in the floating docks, 26 July 1943; F) U-boats under construction in the Vulcan shipyard, 26 July 1943 (figure by G. Kiarszys).

The development of the plant required investment in new infrastructure along the Oder River, especially for handling of raw materials. Hundreds of thousands of tonnes of coal and other carbonaceous materials had to be supplied to the plant every month to ensure uninterrupted operation. Aerial photograph series taken by the 8AAF record the numerous coal barges that made their way down the river to the plant (Figure 2A & B). Several sizable coal terminals were built on the Stettin quay (Figure 2C), where the barges were unloaded. The coal was subsequently trans-shipped to trains (Figure 2D) and transported to the plant.

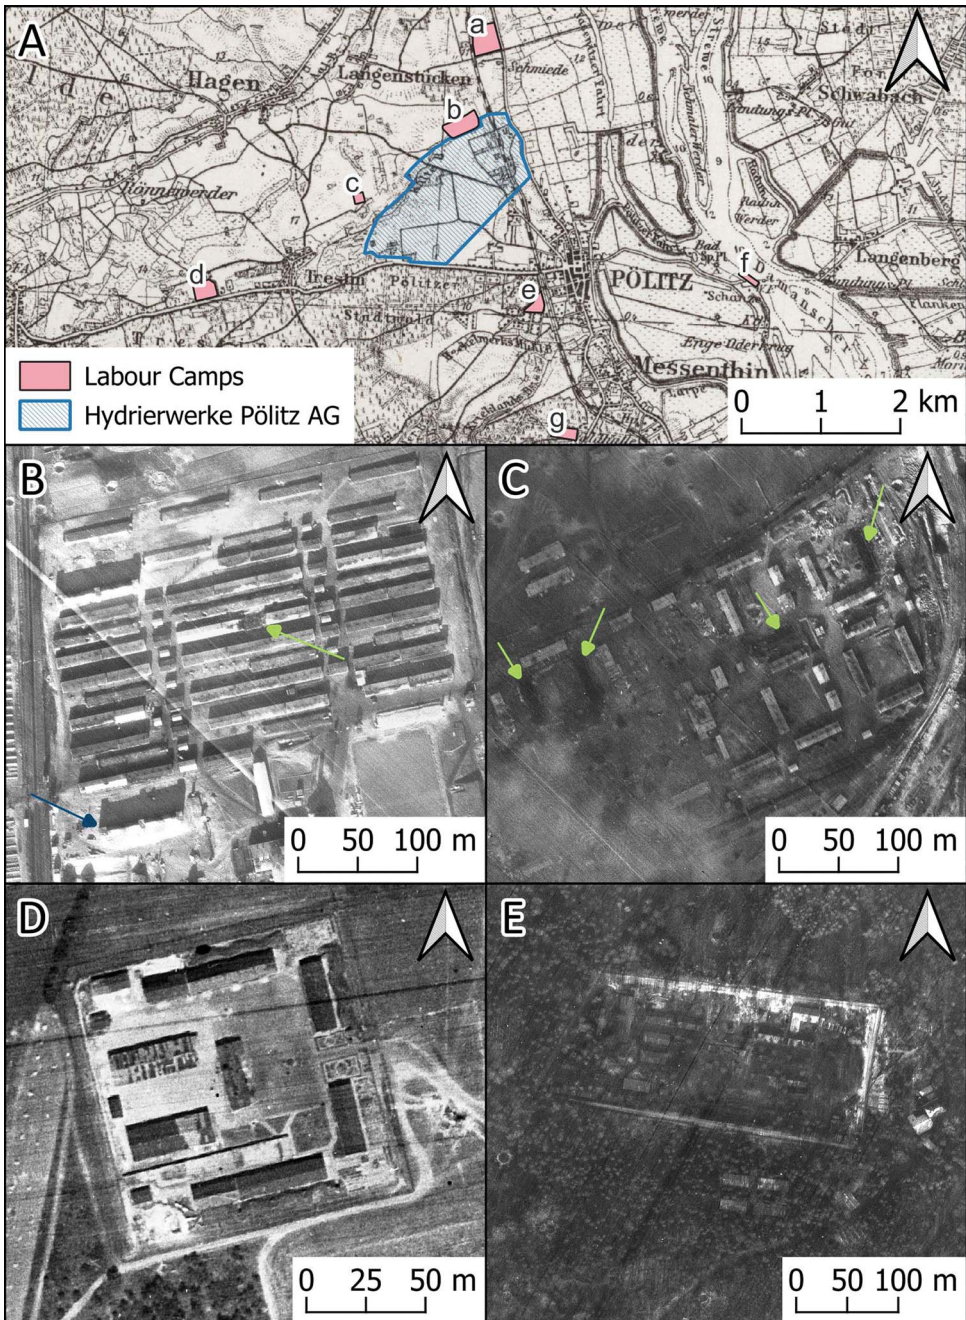
Figure 3. A) The locations of identified labour camps in the Hydrierwerke Pölitz AG area: a. Tobruklager; b. Pommernlager; c. Hägerwelle; d. Dr. Dürrfeldlager/Nordlager; e. Wullenverlager; f. Wohnschiff Bremerhaven; g. joined sub-camps of Stutthof and Ravensbrück concentration camps. Close-ups of selected camps: B) Tobruklager—the green arrow marks a barrack destroyed in the bombardment and the blue arrow points to an air raid shelter, 22 December 1944; C) Pommernlager—green arrows mark barracks burnt during the air raid, 22 December 1944; D) Arbeiterziehungslager Hägerwelle penalty camp, 26 July 1943; E) the joined sub-camps (concentration camps) of Stutthof and Ravensbrück, 22 December 1944 (figure by G. Kiarszys).

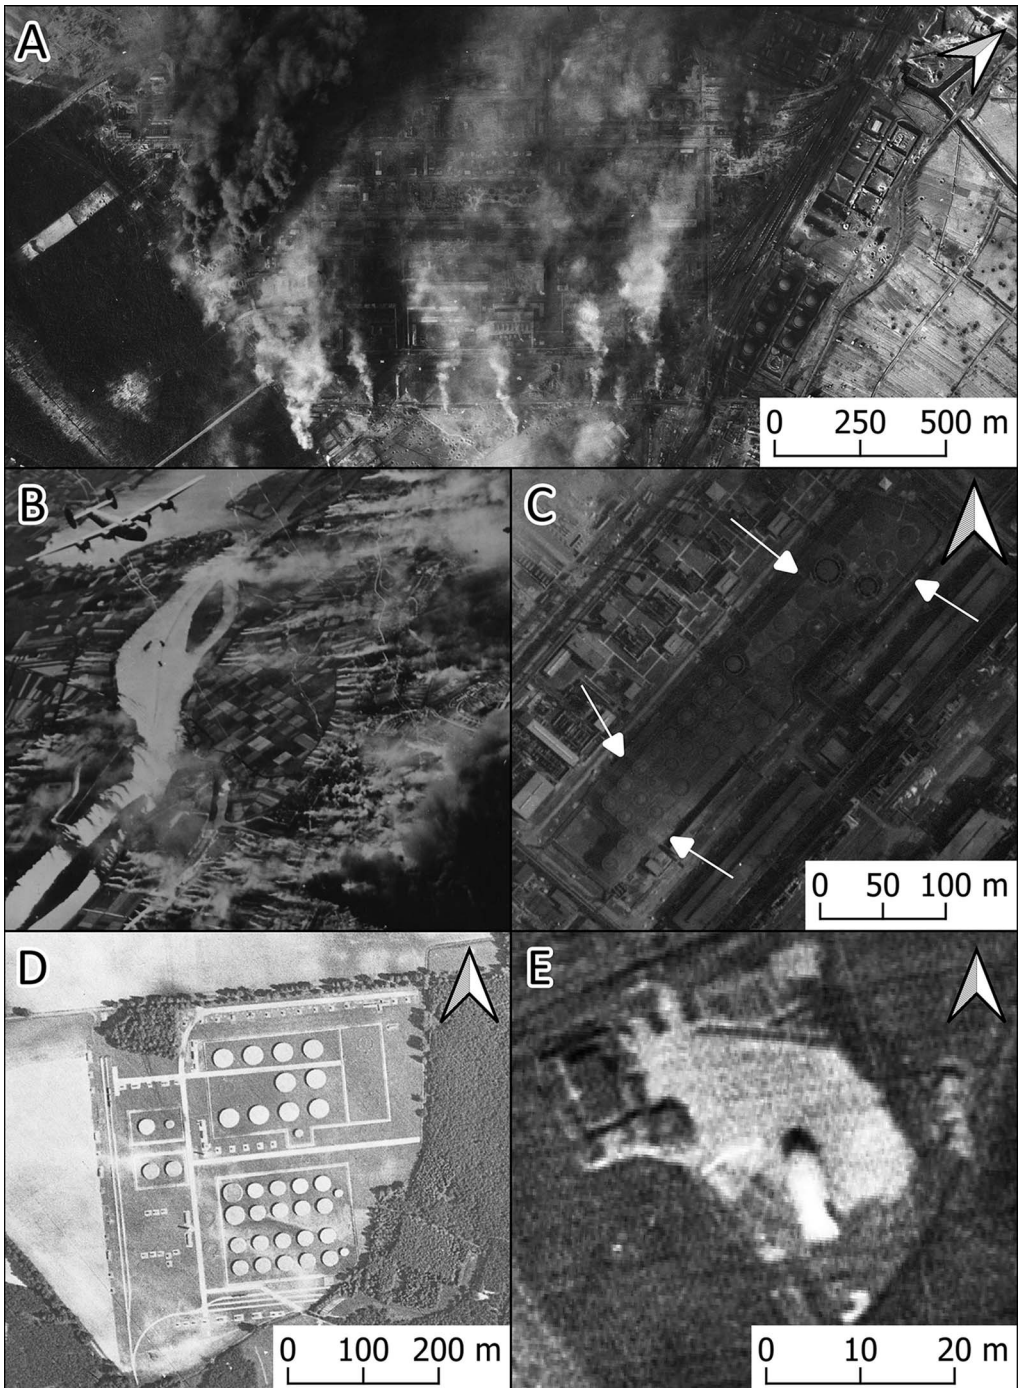
Figure 4. Countermeasures to the Allied air raids: A) dense white smoke screen over the plant, dark smoke indicates fires caused by the recent bombardment, 22 December 1944; B) a B-24 Liberator over the plant and smoke generators working on the ground, 24 July 1944; C) camouflage netting covering fuel tanks, 23 June 1943; D) dummy fuel tanks at Neu Jasenitz, 26 June 1943; E) barrage balloon, 26 July 1943 (figure by G. Kiarszys).

Other means of deception included three dummy refineries built approximately 10km to the north and north-west of the factory (Figure 4D). During daylight, these were easy to recognise and avoid. To create a convincing effect, the dummy refineries were accompanied by active anti-aircraft artillery emplacements. During the night, fires were lit around them imitating bomb explosions to draw the attention of the Allied pilots. It seems, however, that these decoys were ineffective. The aerial photographs of the time show no evident signs of damage to these sites over the following months. Nor are there any bomb craters visible in the ALS data—this is especially notable as the dummy sites are today surrounded by old forest in which any such craters would likely be preserved if present.

In the early stages of the war, the plant was protected by barrage balloons (Figure 4E) spread across the nearby fields. Balloons were used from 1940 to late 1943 but were removed when it became obvious that they posed no threat to the Allied aeroplanes that flew at far higher altitudes.

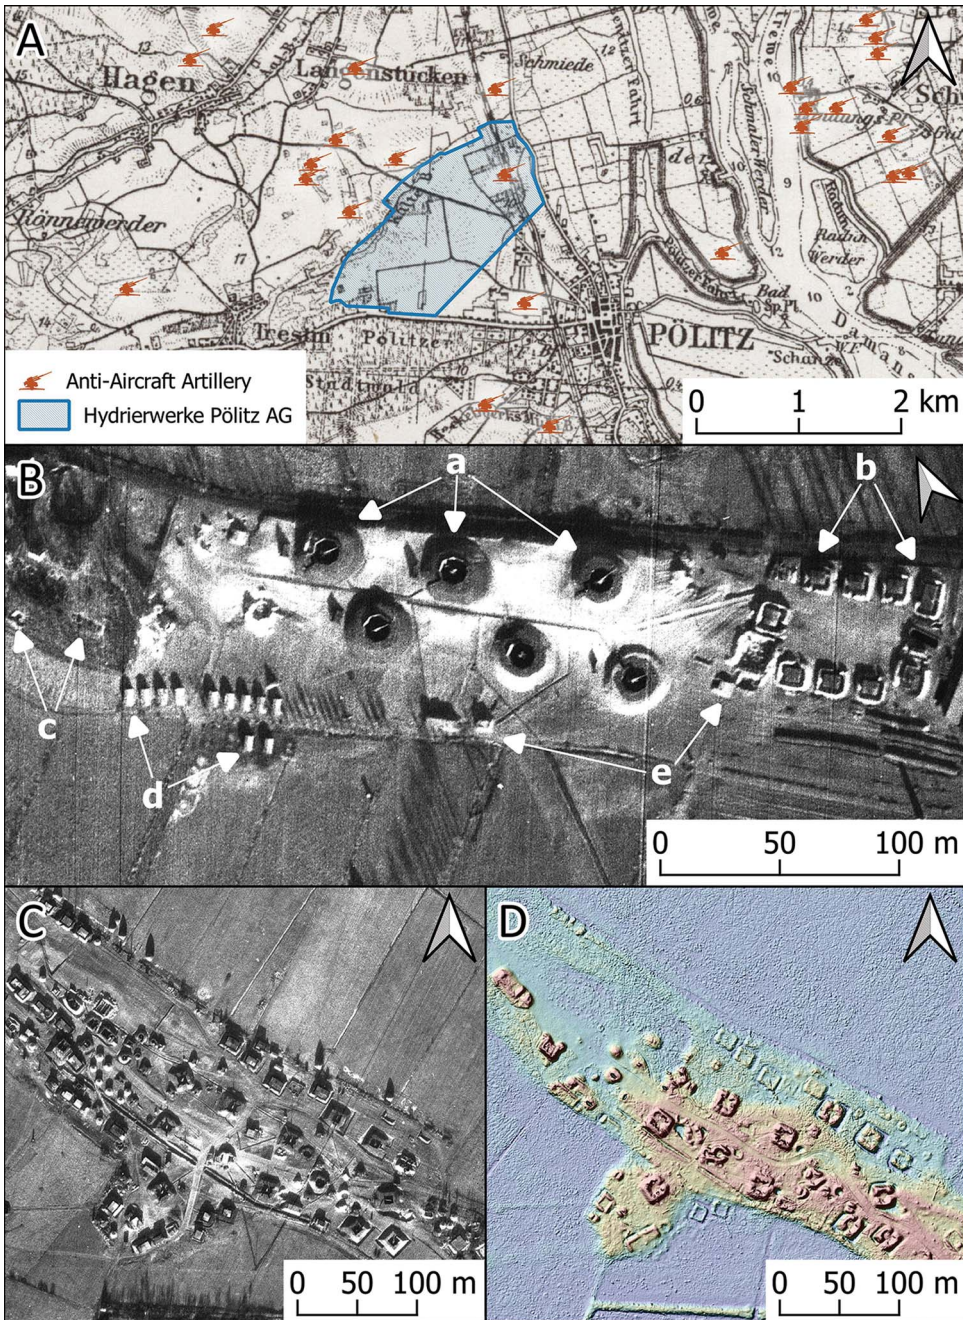
Figure 5. Anti-aircraft artillery emplacements recorded on aerial photographs and ALS derivatives: A) locations of the recorded anti-aircraft emplacements; B) an example of anti-aircraft battery organisation, 22 December 1944: a. anti-aircraft guns; b. ammunition storage; c. shelters; d. accommodation; e. communication and command posts and auxiliary generators; C) large emplacement with several batteries of different calibre anti-aircraft guns located on a sandy hill, 22 December 1944; D) preserved earthworks of the same site in ALS derivative (composition of digital terrain model and hillshading) (figure by G. Kiarzszy).

The core of the active defences around the plant consisted of hundreds of anti-aircraft guns (Figure 5A). Analysis of the historical aerial photographs demonstrates that these guns grew in number until the middle of 1944. The operation of the German anti-aircraft artillery was based on the new technological solutions involving the use of the Würzburg fire control radars, range finders, communication systems, searchlights, gun data computers and efficient logistics able to deliver large quantities of ammunition to the field (Figure 5B). Anti-aircraft emplacements were often located on sandy hills within marshland and in fields within the forest. Many of the earthworks created for the protection of the guns and the ammunition depots still survive (Figure 5C & D).

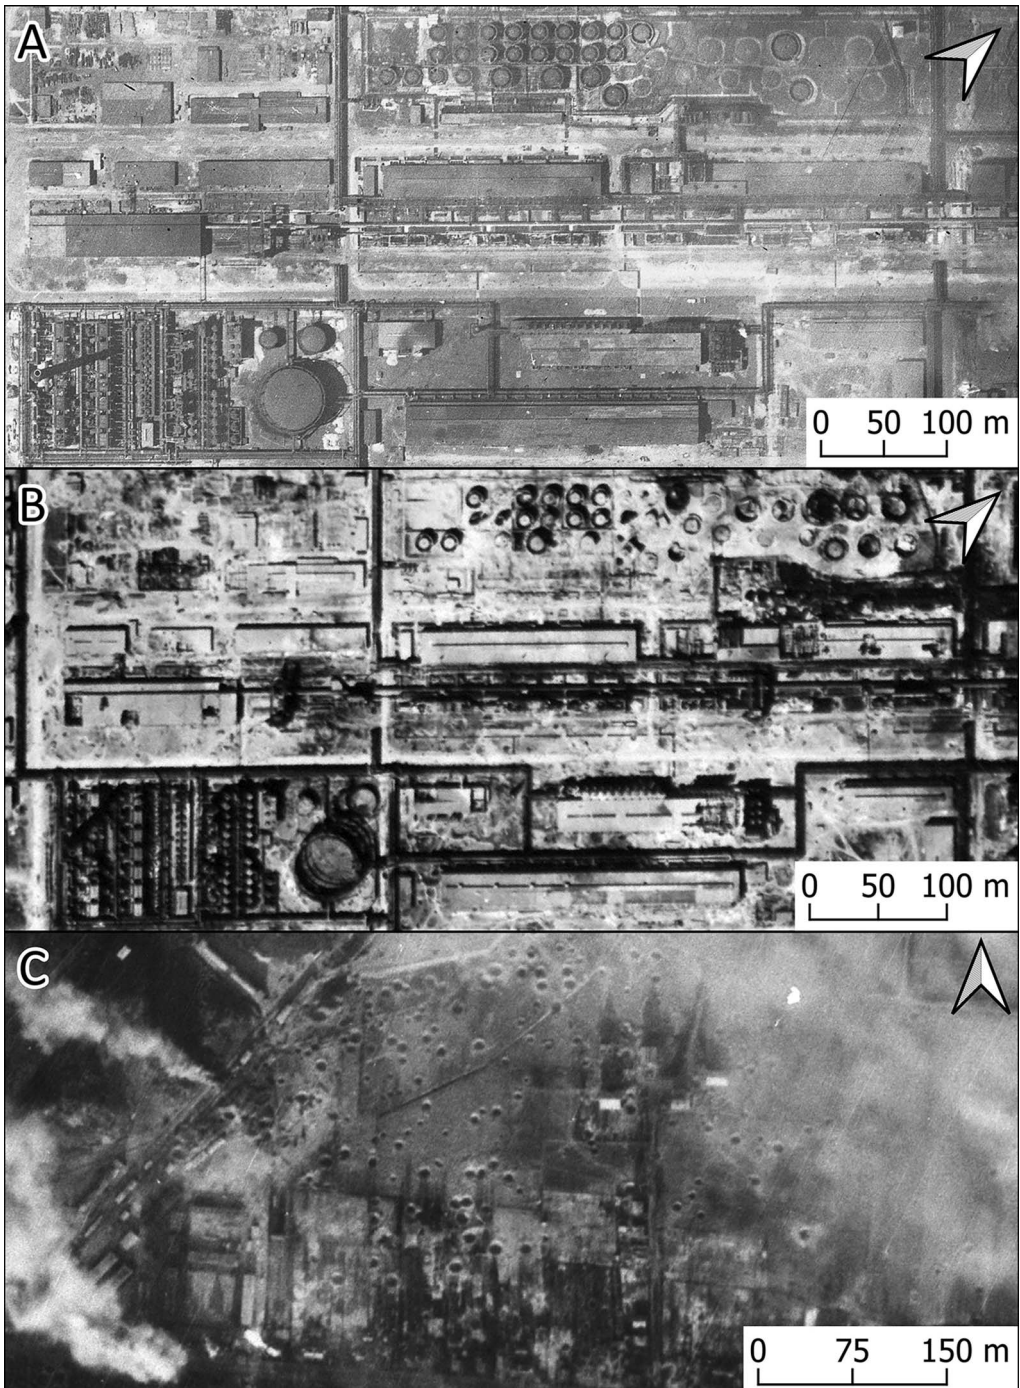
Figure 6. The destruction inflicted by the Allied bombing campaign: A) & B) the same area of the plant on 26 July 1943 and on 27 July 1944; C) devastation of the surrounding landscape caused by the bombing of the plant, 22 December 1944 (figure by G. Kiarszys).

Sustained Allied air raids caused severe damage to the Hydrierwerke and its surroundings. Analysis of the Second World War aerial photographs allows us to study the gradual destruction of the plant in great detail (e.g. Figure 6A & B). The photographs show both the growth in the intensity of the bombings and, sometimes, the desperate efforts to repair the damage and continue production. Due to their notorious inaccuracy, many bombs fell on nearby villages and fields (Figure 6C) causing casualties among the civilian population and destroying farms.

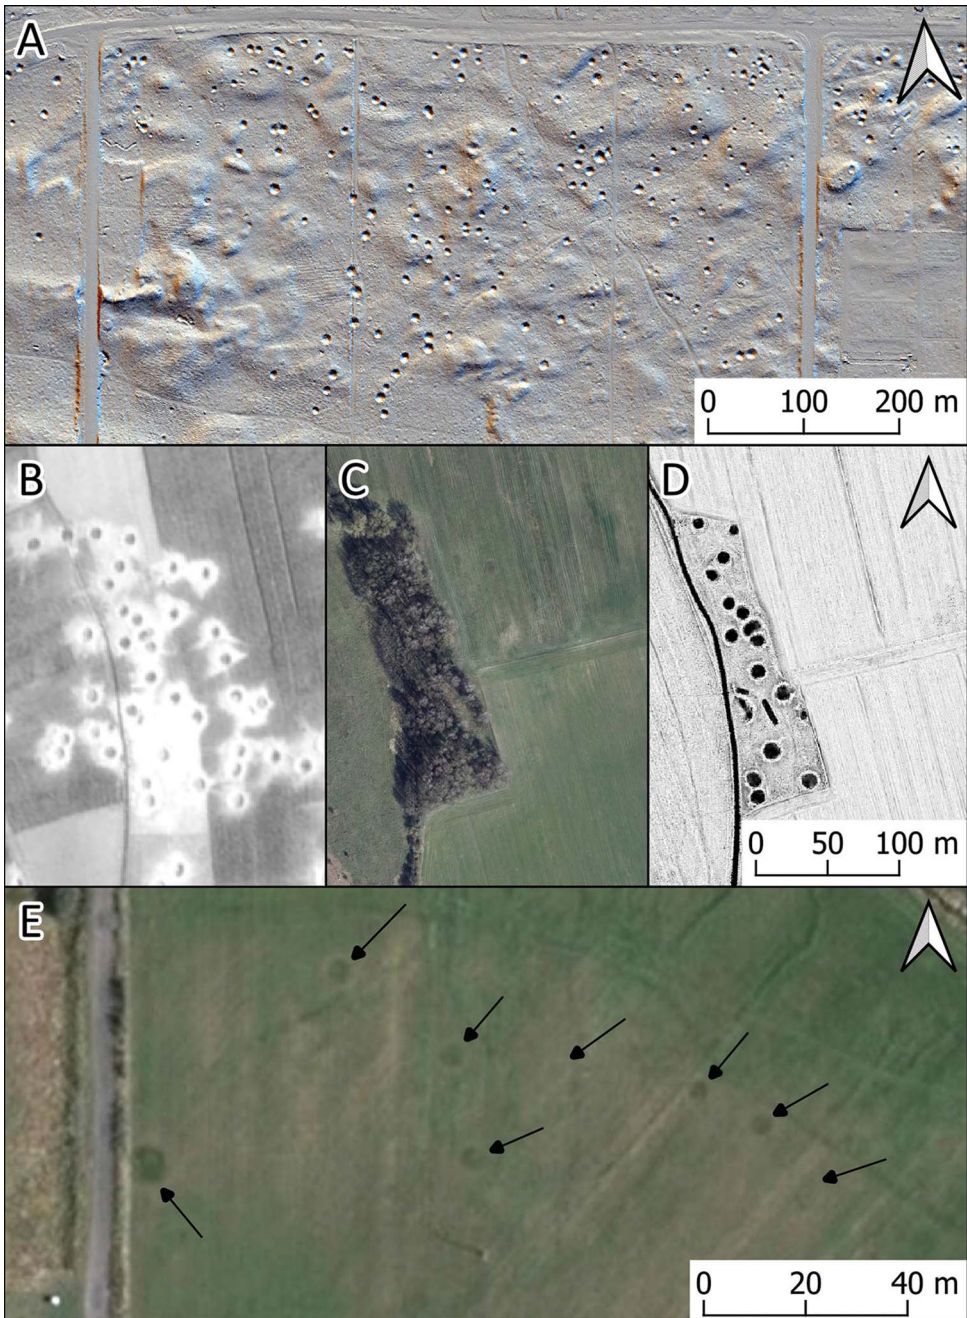
Figure 7. Bomb craters preserved in the contemporary landscape: A) forested area with numerous bomb craters adjacent to the southern edge of the plant (ALS, hillshading from multiple directions); B) the bomb craters on an aerial photograph taken in August 1944; C) the orthophotomap from 2015 of the same area as B shows arable fields and a small forest; D) ALS (openness-positive) shows that the bomb craters were preserved within the forest, while those in the field were backfilled; E) positive cropmarks on the orthophotomap from 2015 indicating the presence of the backfilled bomb craters (marked by the black arrows) (figure by G. Kiarszys).

The air raids left many bomb craters that remain imprinted in the present-day landscape. In the forested zone to the south of the plant, there are hundreds of these features (Figure 7A). The situation is quite different in cultivated areas, where craters survive only in the small pockets of forest and uncultivated areas among the arable fields (Figure 7B–D). Nonetheless, craters backfilled during post-war reclamation of arable land can still be recognised as positive cropmarks on aerial photographs (Figure 7E).

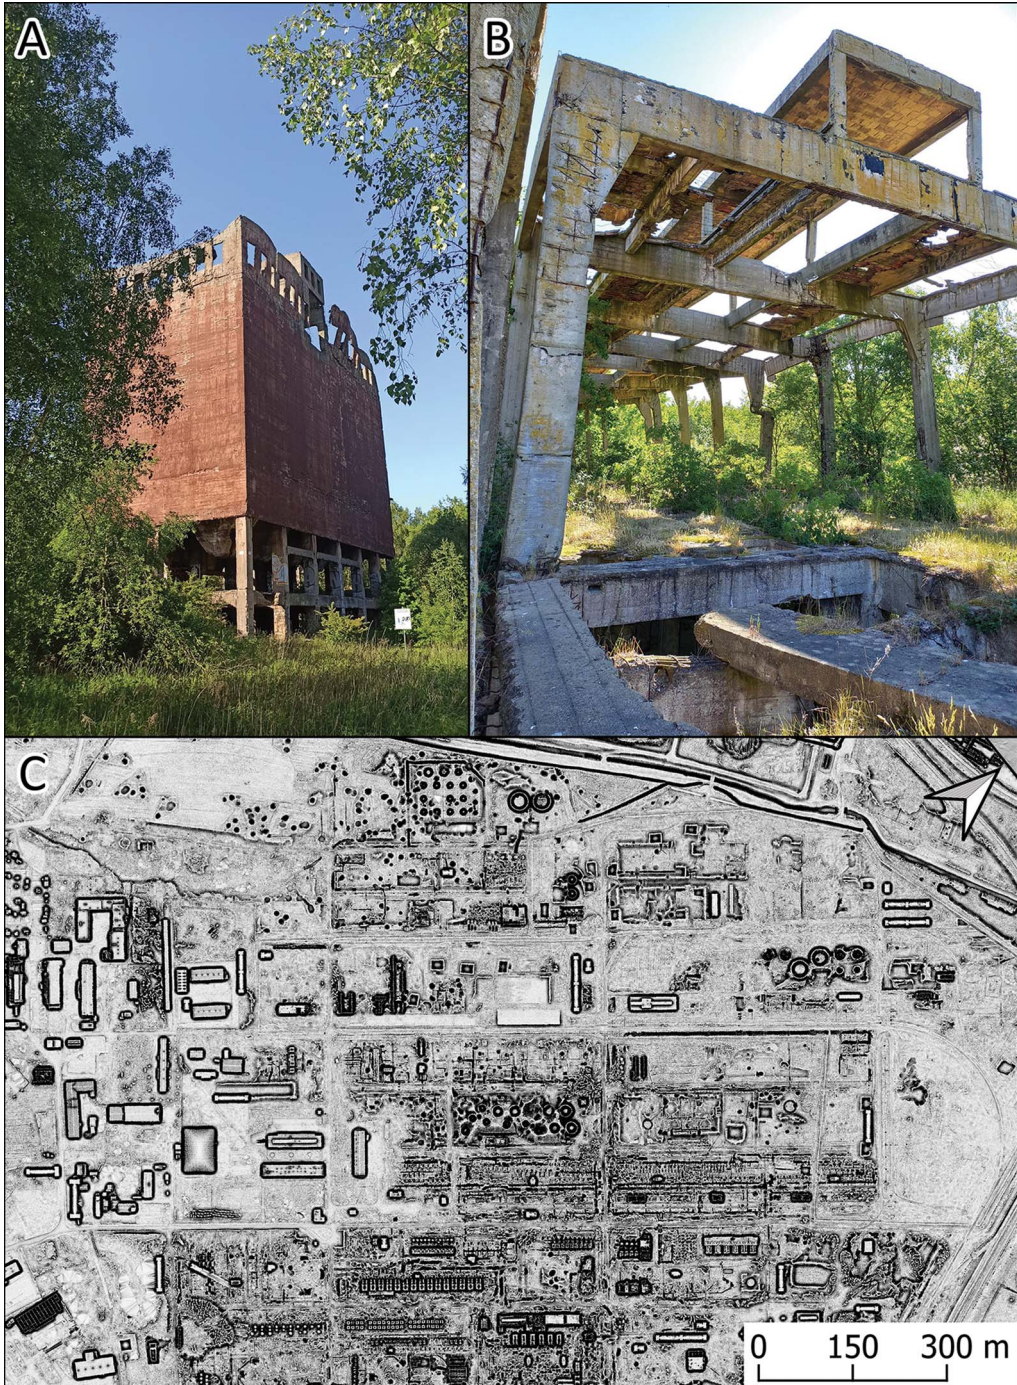
Figure 8. The ruins of the plant: A) the multi-storey coal mill; B) the concrete frame of the coal power plant; C) preserved relics of the plant registered by ALS (openness-positive) (figure by G. Kiarszys).

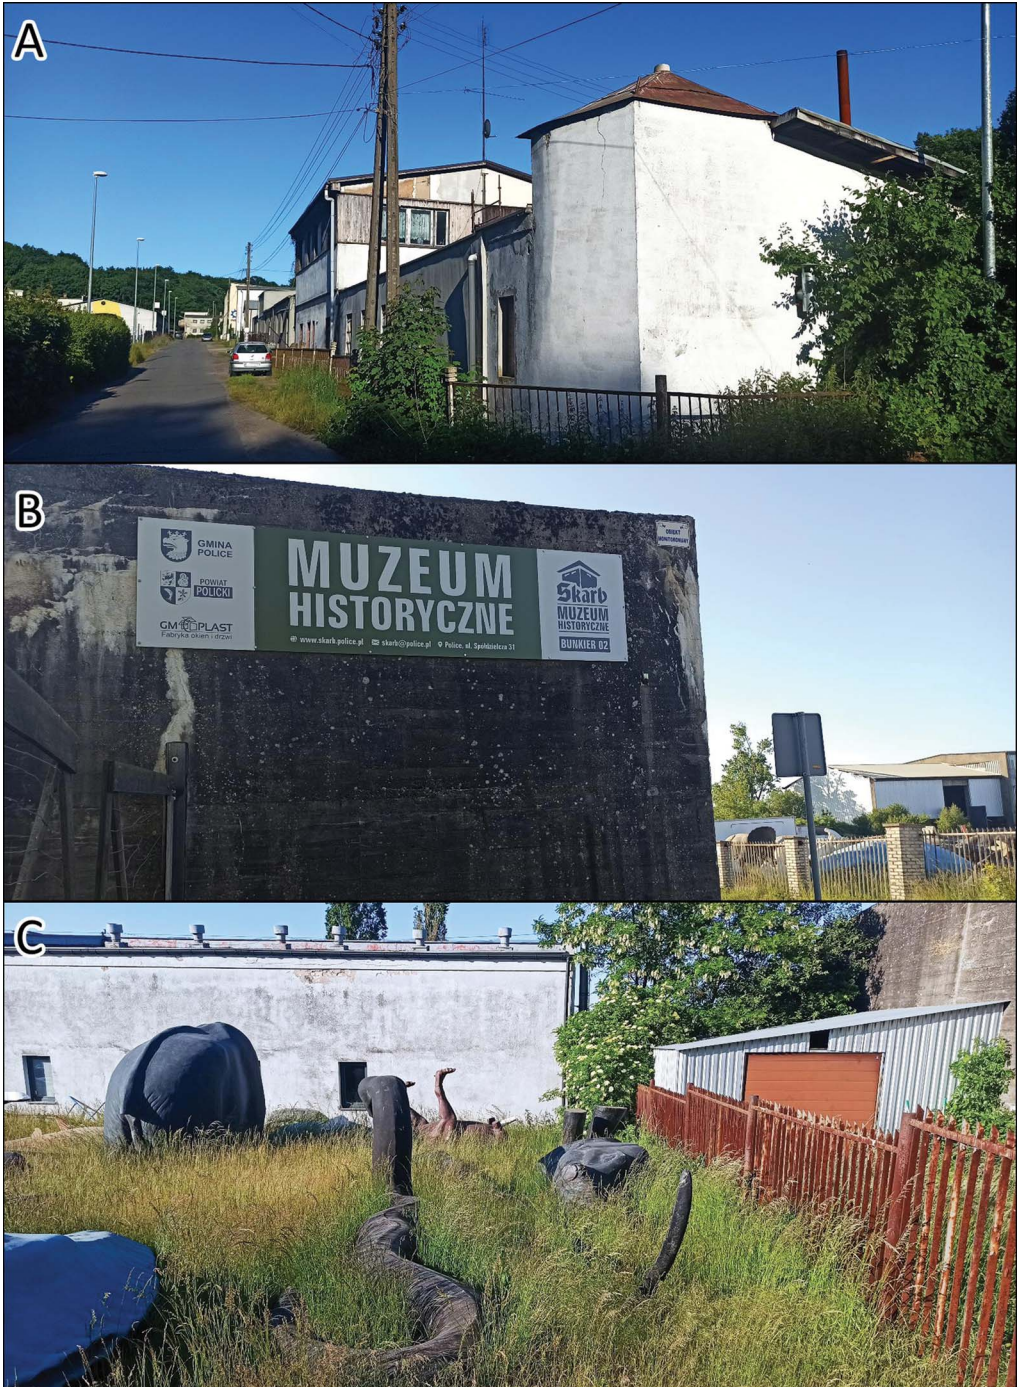
Figure 10. A) Barracks in the former joined concentration sub-camps of Stutthof and Ravensbrück repurposed today as workshops and warehouses; B) one of the air-raid shelters adapted for the SKARB Museum exhibition space; C) auxiliary buildings of the former Hydrierwerke Pölitz AG, now housing a workshop manufacturing life-sized plastic dinosaurs (photographs by Grzegorz Kiarszys).

While some of the locations directly related to the Hydrierwerke were abandoned and left unused, others underwent reconstruction to serve new purposes. In a perplexing turn of events, not long after the end of the war, the buildings of the former conjoined concentration sub-camps of Stutthof and Ravensbrück were repurposed into a pig farm. Even today, this site, once marked by the suffering of thousands of prisoners, functions as an industrial district with various workshops and warehouses (Figure 10A). Many of these buildings incorporate the original walls of the prisoners’ barracks, preserving the spatial layout of the camp with its internal roads. Only the stones bearing commemorative plaques beside the main gates inform visitors about the dark history of this compound.

As of now, the SKARB association rents two air-raid shelters as exhibition rooms (Figure 10B), showcasing military artefacts and information about the site. Part of the exhibition is dedicated to commemorating the fate of enslaved workers. This serves as yet another example of the appropriation of ‘violent infrastructure’, albeit in a more empathetic and historically aware manner than the case of the former concentration camps. Just beside the museum, there is a group of auxiliary buildings that survived the bombing campaign and which were restored after the war. Currently, some of these buildings serve as a workshop manufacturing life-sized plastic dinosaurs (Figure 10C). This amalgam of different functions and meanings creates an almost surreal atmosphere at the site, placed in the shadow of monumental concrete structures that resemble the ruins of some alien civilisation driven by irrational and cruel rules. Today, one may point out a growing need to strengthen the shift from an enclave of otherness/amusement towards the monument of war crime and victimhood. Although not excluding the aura of mystery, we may observe a gradual shift towards a more mature and empathy-orientated discourse, based on biographies and archaeological analyses, rather than imagination.
