The Role of the Materials Characterization Laboratory in a Flat Glass Producing Company: A Balancing Act

Scott D. Walck*

*PPG Industries, Inc., Glass Technology Center, P. O. Box 11472, Pittsburgh, PA 15238-0472

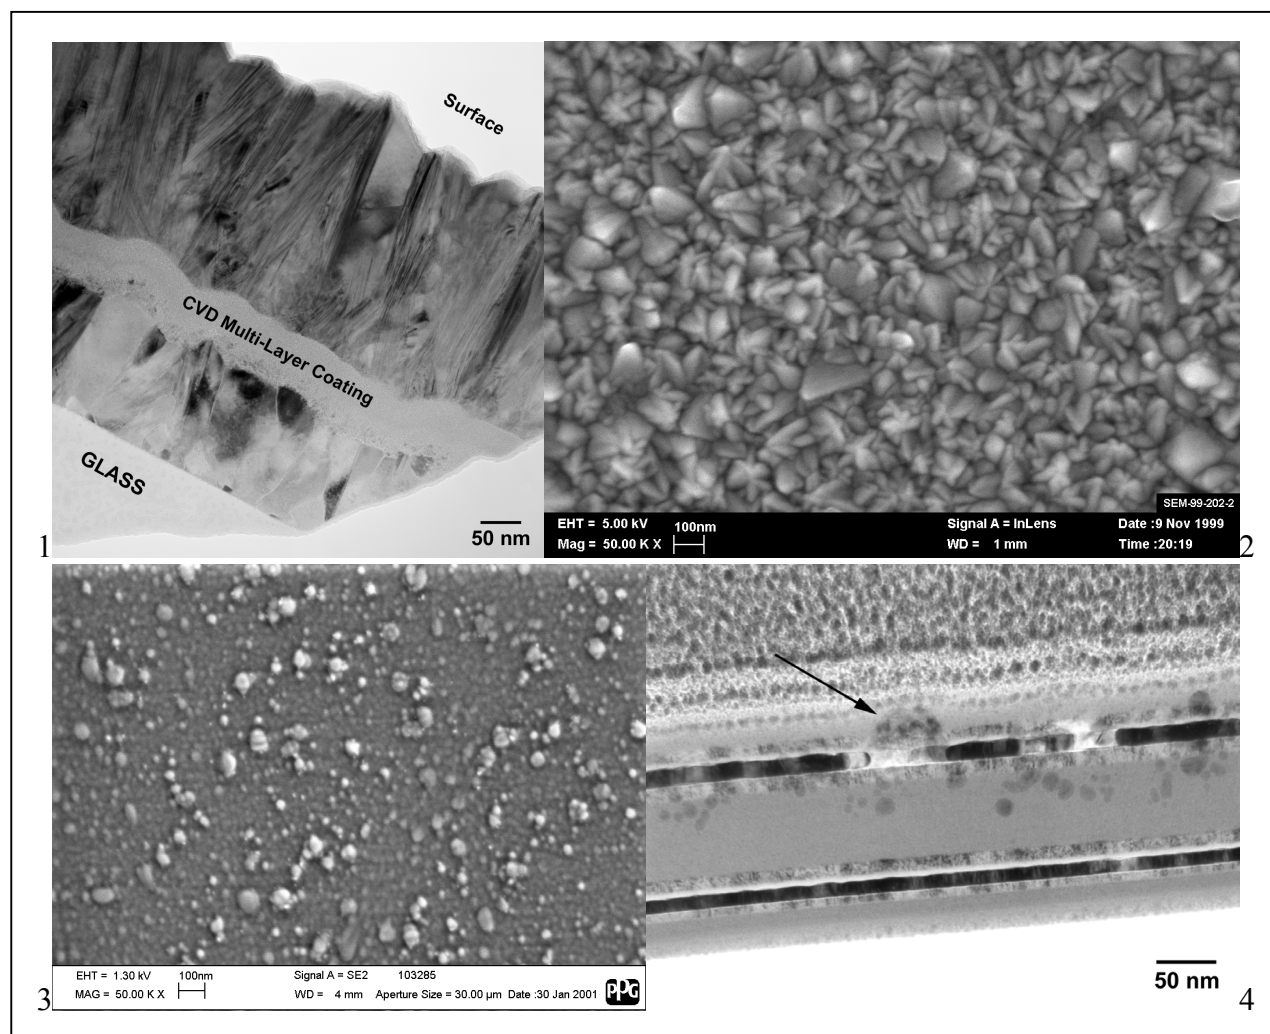
Fig. 1 and 2 illustrate an example where the use of TEM and a FESEM were critical to the development of a chemical vapor deposited oxide thin film on glass. To achieve both a low shading coefficient and low emissivity, a film stack consisting of a conducting SnO₂:F layer on top of a visible absorbing SnO₂:Sb layer with a combined thickness of about 4500 Å is required. However,

this arrangement produces a film that has unacceptable haze because of surface rugosity created by the uneven and faceted growth of large crystal grains through the thickness of the film.[1] To overcome this, an amorphous layer was found to interrupt the columnar growth and cause a re-nucleation of the $\text{SnO}_2\text{:F}$ layer with a much finer grain size which brought the haze to acceptable levels.
