The Immense Cost of Japanese Dams and Dam-Related Landslides and Earthquakes [Chinese text available] ダムと地すべりに浪費される巨費 まさのあつこ

Masano Atsuko

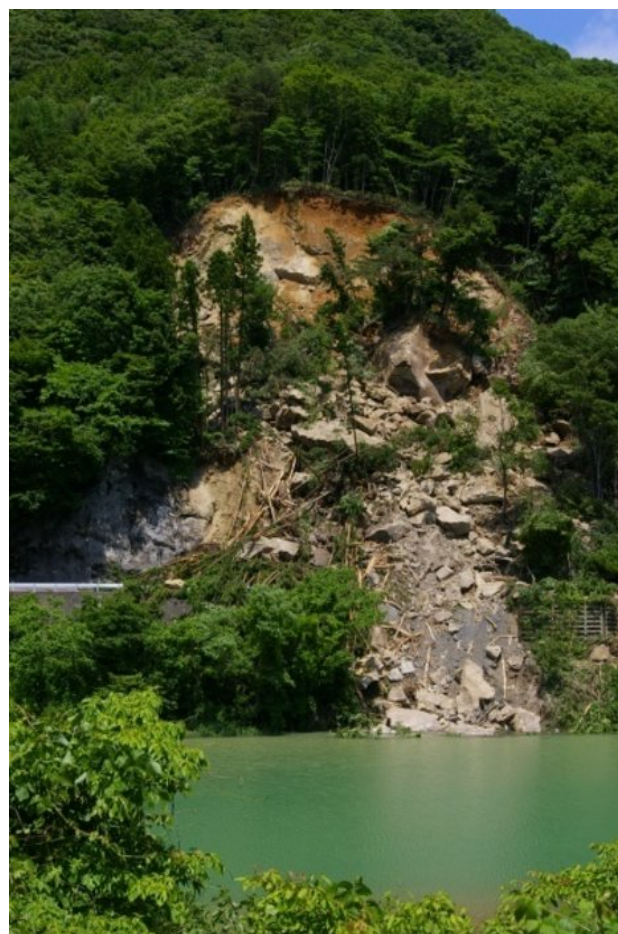
The Iwate-Miyagi Nairiku Earthquake

It had been three months since the Iwate-Miyagi Nairiku Earthquake struck northern Honshu on 14 June 2008, triggering a huge landslide above Aratozawa Dam. The area hit by a landslide has been further carved by snow and rain, and trees and other vegetation are in disarray. The site looks like the day after a wretched barber had just given it a bad haircut. For the earth, this must be an embarrassing appearance.

According to the National Institute for Land and Infrastructure Management (Kokudou gijitsu sou-kenkyuusho; NILIM), the epicenter of the 7.2 magnitude quake was near Mt. Kurikoma on the border between three prefectures--Miyagi, Iwate, and Akita--and in the close vicinity of 15 dams (one which is still under construction) including Aratozawa to the southeast.

In this landscape carved by rivers, a landslide with an average depth of 55 meters, a width of 810 meters, and a length of 1400 meters slid as far as 140 meters off the side of the mastiff and into the back of the lake formed by the dam.
