## Biodegradation assessment of a 16<sup>th</sup> century fresco from Southern Portugal

This work reports the study of the *frescoes* from the *Casa de Fresco dos Sanches Baena* in Vila Viçosa (Southeast Portugal) to allow their material characterisation, to identify the different microorganism populations and to assess their role in the deterioration of these paintings.

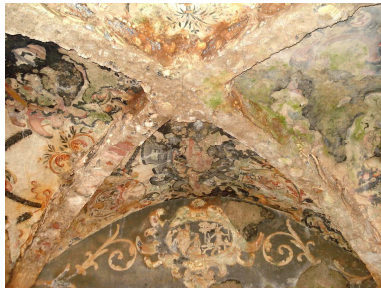
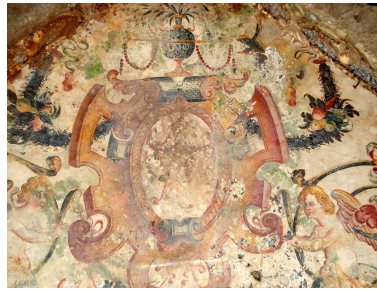
Fig.1. Details of the 16<sup>th</sup> century frescoes. The biological colonisations covering the frescoes are clearly visible.

The *Casa de Fresco dos Sanches Baena* is a small semi-underground building constructed in a Palace garden over a well and used as a cool refreshing place by the owners. The frescoes that cover the ceilings (composed of 4 panels) present rich mythological scenes and have other decorative elements, which make them an unusual example of this art form. Unfortunately, due to partial abandonment the paintings are in an advanced state of degradation exhibiting partial detachment of paint layers and mortars, salt efflorescences and abundant biological colonisations (Fig.1).

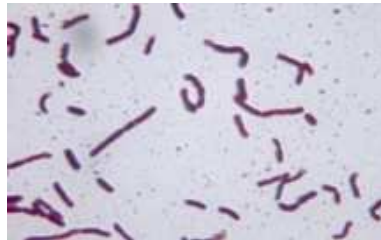
*Bacillus sp.*

Fig.2. Some bacterial strains identified by optical microscopy

For the microbiologic sampling, sterile cotton buds and chisels were used and the biological materials collected in sterile recipients. Colonies morphologies were evaluated by microscope preparations. Gram's stains and some usually tests followed by *Bergey's Manual of Systematic Bacteriology* [1] were used for bacteria identification. Fungal strains were identified following standard methods [2], based on its macro and micro-morphological characteristics, such as colony diameter, texture, colour, dimensions and morphology of hyphae and reproductive structures (for sporulating isolates). The microbiological study (fig. 2 and 3) by optical microscopy allowed the isolation of 34 fungi strains and 32 bacterial strains in the four painted panels that compose the frescoes. Panel 2 presented the highest microbial contamination with 19 fungi strains and 18 bacterial strains observed. The predominant bacterial strains were bacillus Gram+ and Gram-, from the genera *Bacillus* and *Pseudomonas*, respectively. Some strains of *Actinomycetes* were also isolated. The dominance of bacilli in the samples can be explained by their ability to survive for a long time as spores. As to the fungi populations, the dominant strains identified were from the genera *Cladosporium* and *Penicillium*, although others strains were also isolated, namely *Aspergillus* sp., *Acremonium* sp., *Sporotrix* sp., *Trichoderma* sp.. However, several isolated mycelia did not present reproductive structures and were designated as sterile mycelia.
