# The archaeology of conflict-damaged sites: Hosn Niha in the Biqa' Valley, Lebanon

Paul Newson<sup>1</sup> & Ruth Young<sup>2</sup>

**Keywords:** Lebanon, Roman settlement, conflict archaeology, looting, Cultural Resource Management, GIS

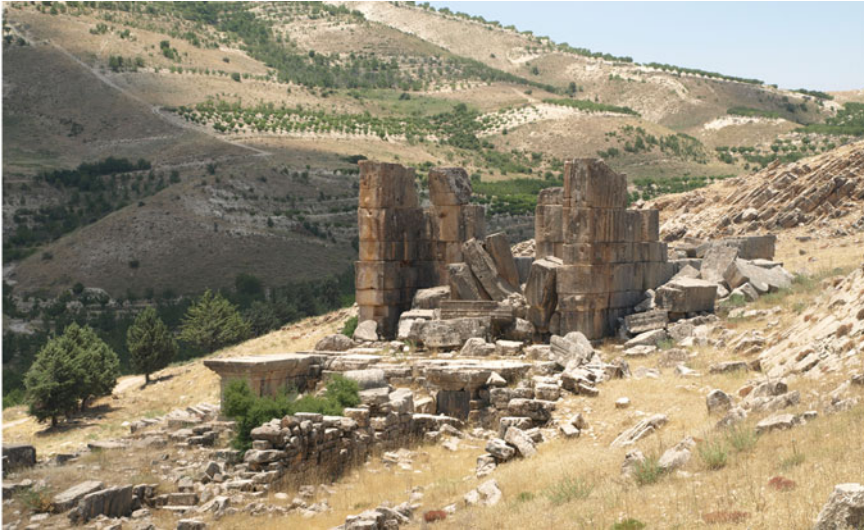
Figure 2. The remains of the second century AD monumental temple at Hosn Niha; looking south-west.

temple complex of the second century AD (Figure 2). Below this complex, yet inextricably associated with it, is the site of a village, much of which displays signs of heavy disturbance caused by military activity, opportune digging and agricultural encroachment. Due to the monumentality, dramatic setting and well-preserved nature of the temple, the site of Hosn Niha has been a destination for European travellers and scholars interested in its history and architecture since the early nineteenth century (e.g. Burckhardt 1822: 29–30; Warren 1870: 204–206). Interestingly, these early visitors barely comment on the site beyond the monumental temple. The earliest investigations of the temple-sanctuary complex were by Krencker and Zschietzschmann in the early 1900s (published in 1938); more recently, a detailed reassessment was completed by Jean Yasmine (2005, 2006, 2009). Krencker and Zschietzschmann (1938: 122) also took the time to record a further isolated religious site (HN001) to the south-west of the main temple-sanctuary, but they otherwise paid no attention to any other structures, with their only comment on the village structures being that “these provide a picture of complete ransacking, there is hardly a stone present which would provide a clue to an interpretation of the debris”.

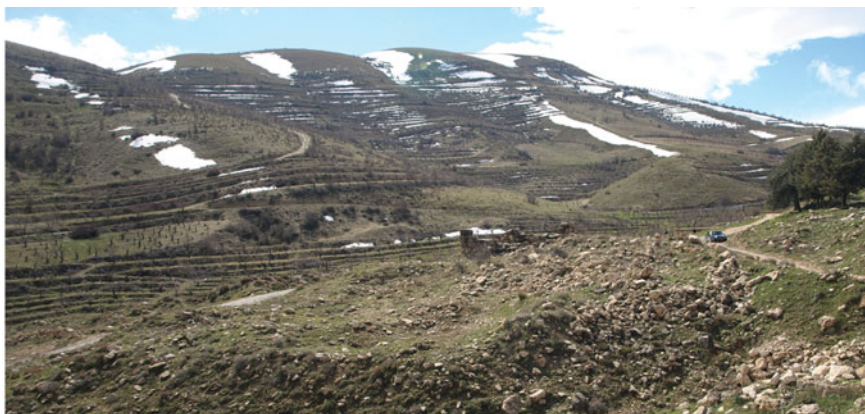
*Figure 3. The area south of the temple sanctuary, between HN003 and the Wadi Niha; this was once the core area of the village but is now bulldozed piles of rubble; looking south-west.*

During preliminary visits to the site, it was clear to us that large areas of the settlement below the main temple sanctuary had suffered substantial damage, if not outright destruction (Figures 3 & 4). Indeed, the impression gained from other scholars was that very little valuable information could now be obtained from the site outside of the two monumental temples (Aliquot 2009: 303) and, in a recent work on the temples of Lebanon, it was stated that “the criminals have also extended their misdeeds to the village area that extends to the south and on the side of the mountain to the west of the sanctuary where mechanical means were employed to bulldoze the stratigraphy across the entire site” (Nordiguian 2005: 65). The perceived state of damage to the site raised serious questions about whether attempting to study the destroyed village remains would be possible at all and whether useable information would even be recovered. In other words, should the condition, presented by extensively war-damaged and looted sites, such as Hosn Niha, force archaeologists to ignore them and conclude that important potential research questions cannot be addressed? We would argue the opposite—that with the correct research design, critical questions can be addressed; that with the appropriate field and analytical techniques, very useful data can be collected from badly damaged sites; and that a great deal can be learned from unpromising beginnings.

(Figures 3 & 4); clandestine excavations by pits with spoil heaps (Figure 5); agricultural land was ploughed and planted with vine and tree crops, or recently cleared (Figure 6). It seemed from these observations that while large areas had been heavily bulldozed, the displaced material had not been moved very far, certainly less than 50m in extent. During fieldwork, the spatial extent of these four types was mapped using plans and supplemented by Global Positioning System (GPS) measurements of specific features and then fed into the site GIS.

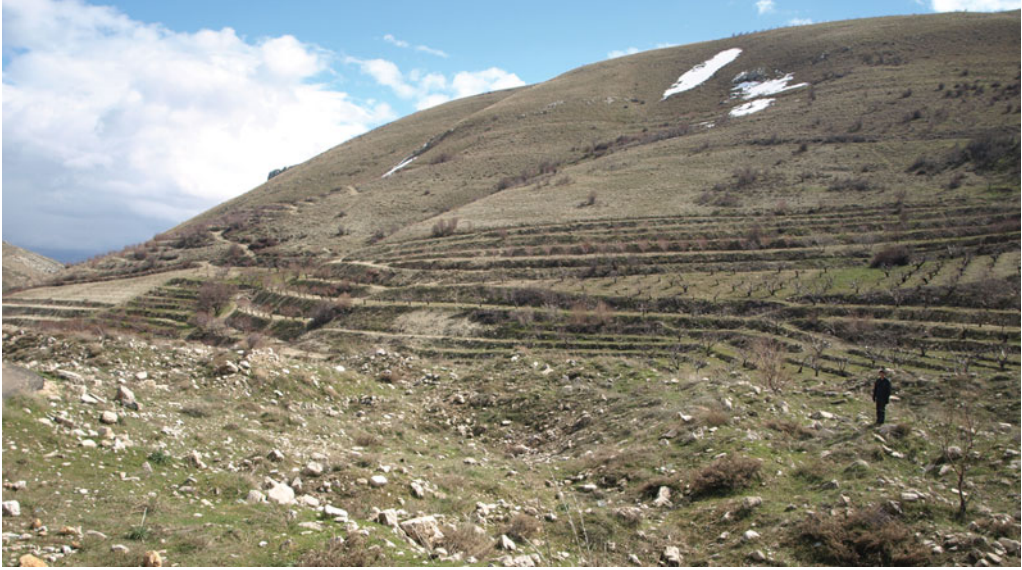
Figure 4. The area to the immediate south-west of HN003 (beyond the track seen on the left edge), which was bulldozed during the period of the Lebanese Civil War; looking south-east.

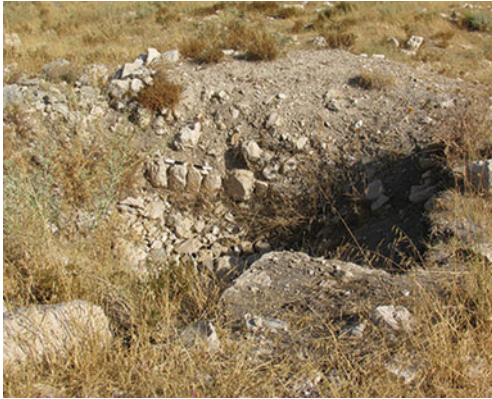
*Figure 5. An area of small-scale illegal excavation at location HN012, which has exposed structural walls.*

wall-enclosed spaces (e.g. HN012; see Figure 5). These *in situ* exposed walls (of which feature HN012 is a good example) indicate that on this steep slope below the main temple complex, walls are preserved, almost certainly belonging to buildings that lined an upper terrace. Beyond this central area, our results show that settled occupation was focused in the two small side valleys at either end of the site, which have evidence for dispersed dwellings (HN002, HN016, HN010 and HN011; Figure 1). These dwellings were probably discrete farmhouses, set within walled courtyards that took advantage of the flatter ground and more sheltered climate of the valleys.

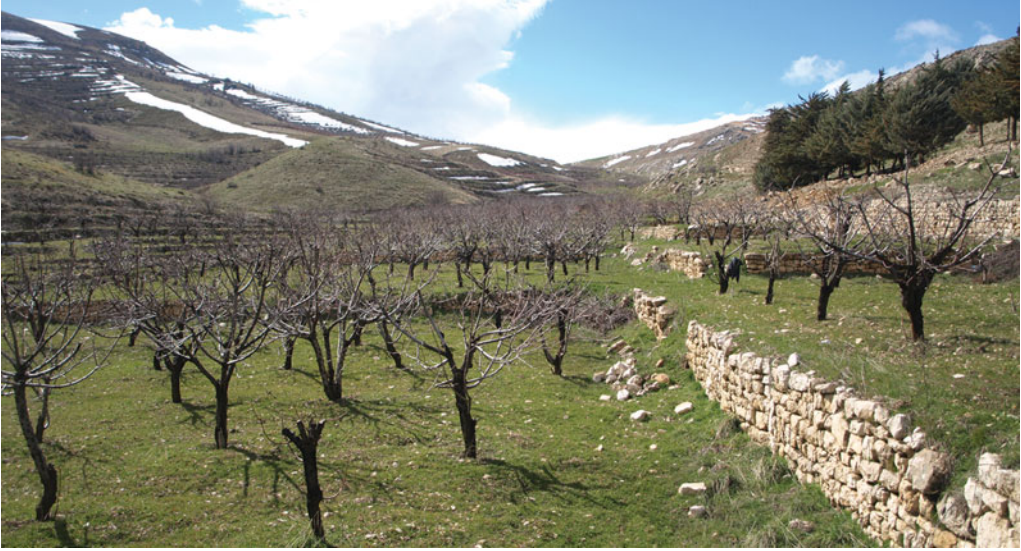
Figure 6. The area at the south-western edge of the site, landscaped and planted with fruit trees: the modern terrace walls have been constructed from remains of the Graeco-Roman settlement. Photograph taken looking west.

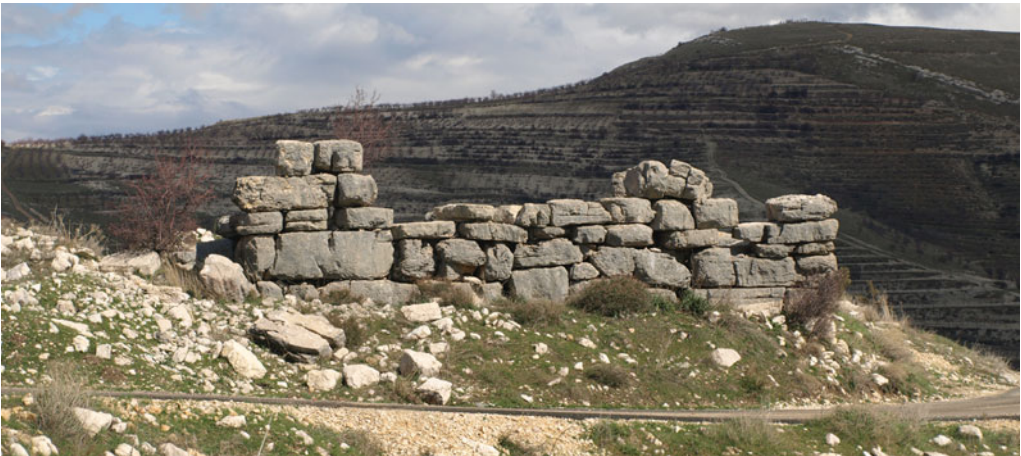
Figure 7. HN003: a substantial stone structure still standing in the core occupation area of the site; looking towards the north-east.

nuanced understanding of settlement occupation and the morphological development of the village over time. For example, glazed sherds characteristic of the early medieval period were collected in the vicinity of, and within, stone structure HN003, but nowhere else (Figures 1 & 7), and a number of interpretations can be suggested from this, both in general terms and of a more specific nature. The glazed sherd distribution points to spatial and chronological differentiation in terms of site development: there was a period of re-occupation of the site in the early medieval period, with HN003 being constructed as a fortified farmstead.

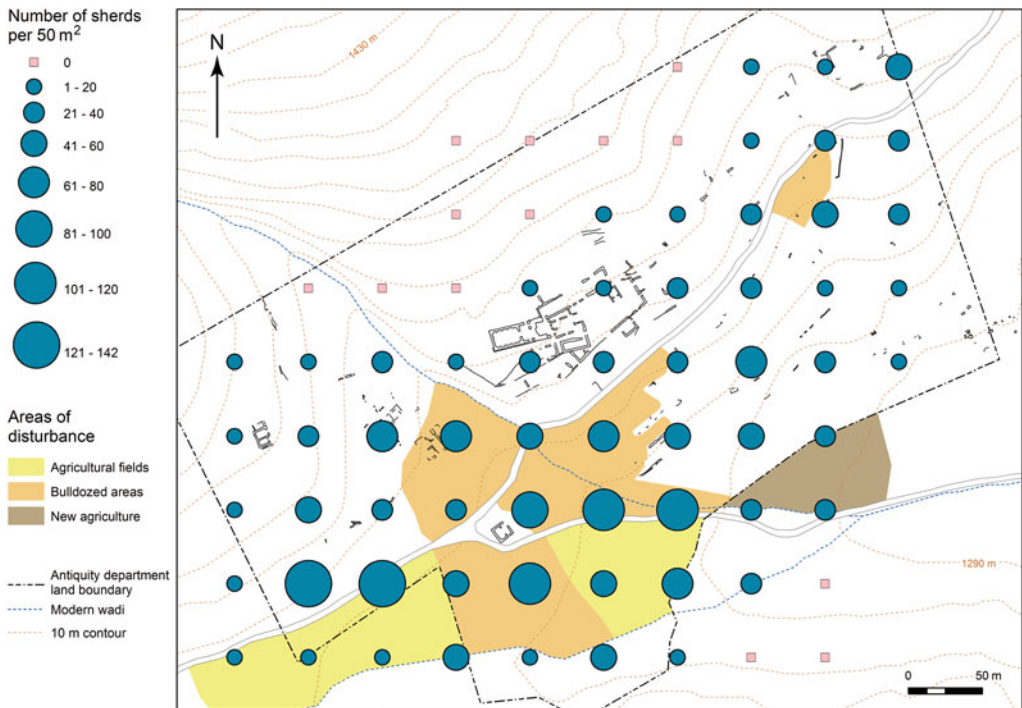
Figure 8. Map showing transect quantities of clicked sherds and mapped areas of damage across the site.

of the surface pottery was designed to help define the spatial limits of the settlement. The collection of diagnostics had two purposes: to obtain a representative sample of the variety of pottery from the site; and to provide a sample of pottery from which preliminary indicators of date and function could be assigned to the settlement site, and even provide some pointers to different activity zones within the settlement. As the data were collected they were immediately entered into the project GIS (Figure 8).
