Manganese in Black Crusts on Seneca Sandstone

Carol A. Grissom¹, Edward P. Vicenzi¹, Richard A. Livingston², Emily Aloiz¹, Nicole Little¹, Jennifer Giaccai³, and Willa Freedman²

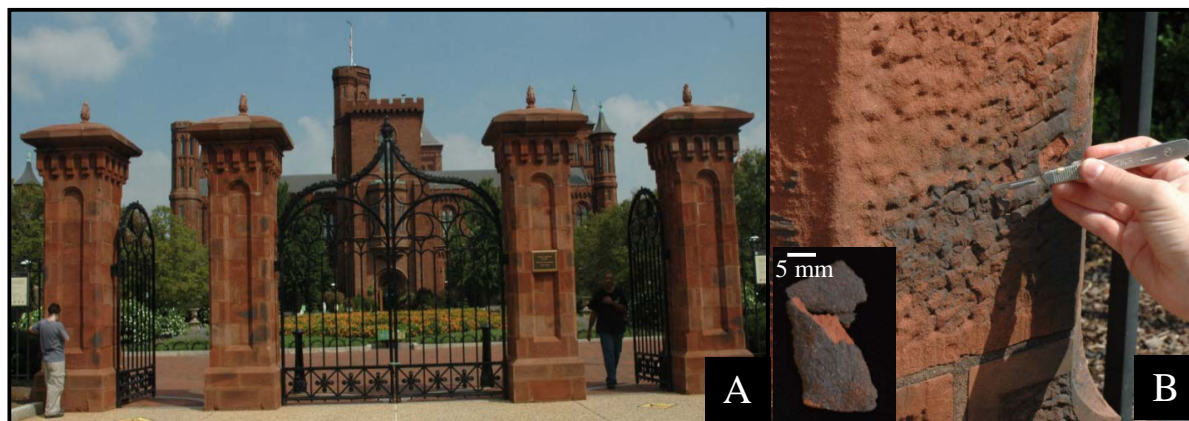
Figure 1 A) Gated entrance to Haupt Garden with Smithsonian Castle in background. B) Sampling black-stained areas on gatepost. Inset: fractured fragment taken from gatepost.

Introduction: Scattered black deposits are found on surfaces of the Smithsonian Castle (1849-1855) and Enid Haupt Garden Gateposts (1987), as seen in Figures 1A. The structures are made of Seneca sandstone, an arkosic micaceous sandstone quarried near Washington, DC. Photographs document that deposits have increased on the relatively new gateposts over the last six years. Generally, black deposits on sandstone are attributed to solubilized silica that incorporates dark particulate material [1]. XRF analysis of a sample taken from a gatepost (Fig. 1B) and in situ analysis of deposits on the Castle instead indicate that the deposits are manganese rich, likely colored by small amounts of manganese oxide. The deposits are thus comparable to desert varnishes on sandstone, which contain mineralized manganese and sometimes iron as a result microbial action [2, 3]. Normally soiling on buildings is associated with moisture and rainwater patterns, and the seemingly random locations of the manganese-rich deposits without a clear relationship to water remain a puzzle. Manganese-rich black deposits have not been reported on other sandstone buildings in temperate climates; it is not clear to what extent they are present elsewhere and may have been incorrectly identified. Correct characterization of such deposits is important from a conservation standpoint in order to determine the most effective method of removal, if required.
