THE ACROPOLIS BASILICA PROJECT, SPARTA: A PRELIMINARY REPORT FOR THE 2000 SEASON¹

INTRODUCTION

THE British School at Athens and the 5th Ephorate of Byzantine Antiquities at Sparta is undertaking a project of cleaning, recording, and planning the basilica church known as that of Osios Nikon, on the Acropolis of Sparta.² The basilica is located to the east of the hill that formed the Acropolis of ancient Sparta (FIG. 1), situated to the north west of the modern town and better known for the extensive remains of the theatre and Athena Chalkioikos' sanctuary.

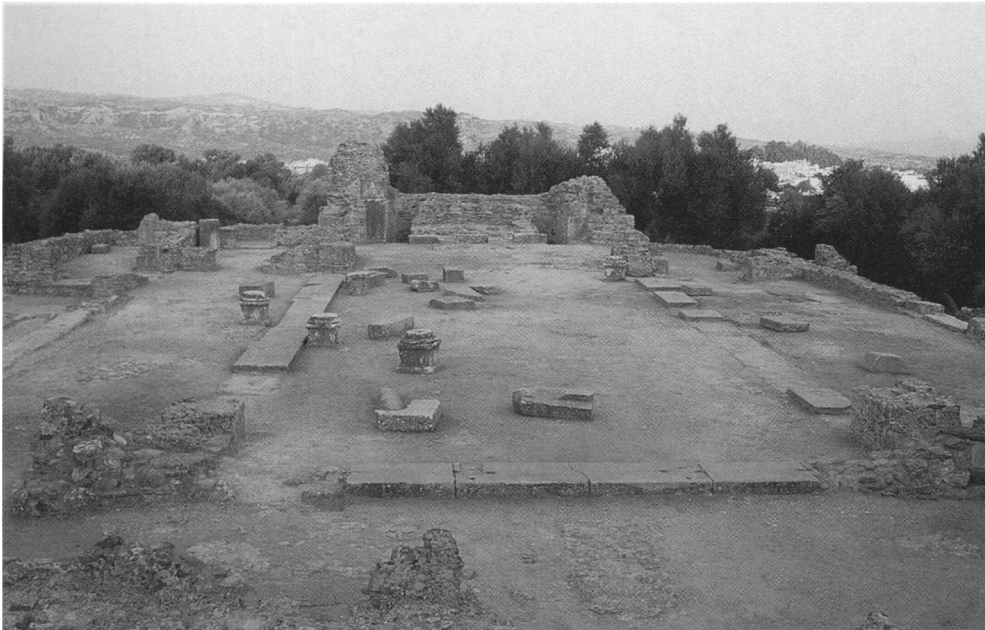
The monument is a three-aisled basilica with a triapsidal sanctuary projecting to the east (FIG. 2). On the west, there exist a narrow narthex and a porch (PLATE 39 *a*). Immediately to the

SWEETMAN AND KATSARA
THE ACROPOLIS BASILICA PROJECT, SPARTA: A PRELIMINARY REPORT FOR THE 2000 SEASON
(a) Acropolis basilica from west. (b) West Complex from east.

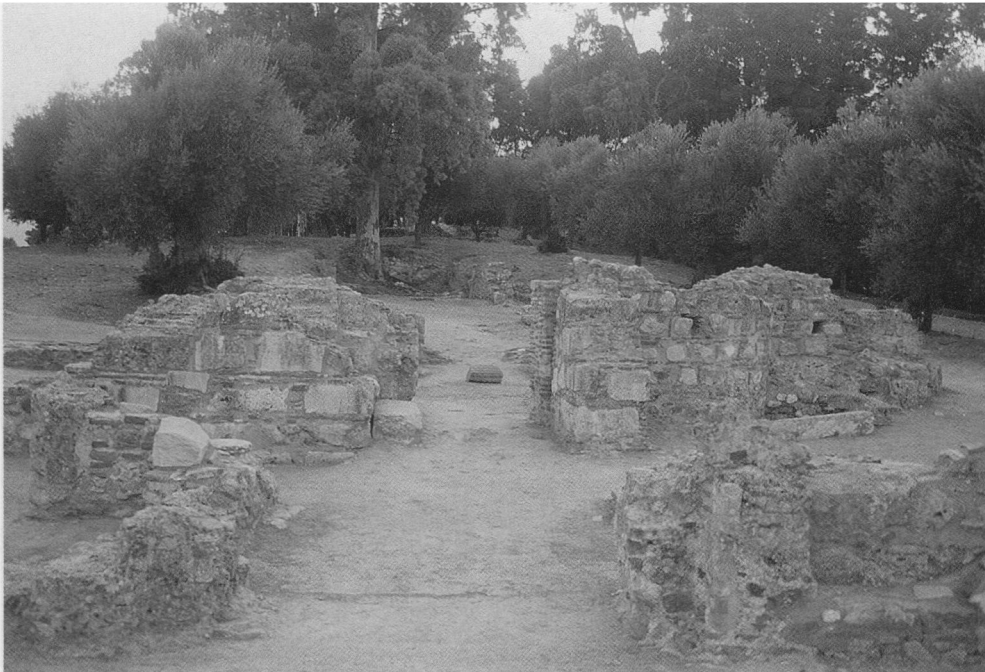
(b)

west of the basilica is a cruciform building (PLATE 39 *b*) with several annexes attached to its south side and a long narrow extension on its western side.

The issue of chronology is closely connected with discussions of the church's architecture and its attribution. It has been variously dated to the seventh⁴² and the tenth centuries,⁴³ while its adjacent buildings have been assigned to the eleventh century.⁴⁴ It would be extremely hazardous to attempt to date the monument on architectural or sculptural grounds alone,⁴⁵ as many of the architectural parallels drawn are with basilicas of uncertain date.⁴⁶ Some elements in the plan of the basilica are quite unusual (FIG. 2) and the masonry is not particularly identifiable as period-specific owing to the low height of the surviving walls (PLATE 39 *a*). An exception can be detected in sections of the west cruciform building that incorporate a crude cloisonné technique, implying a Middle Byzantine date (PLATE 39 *b*). Issues such as the

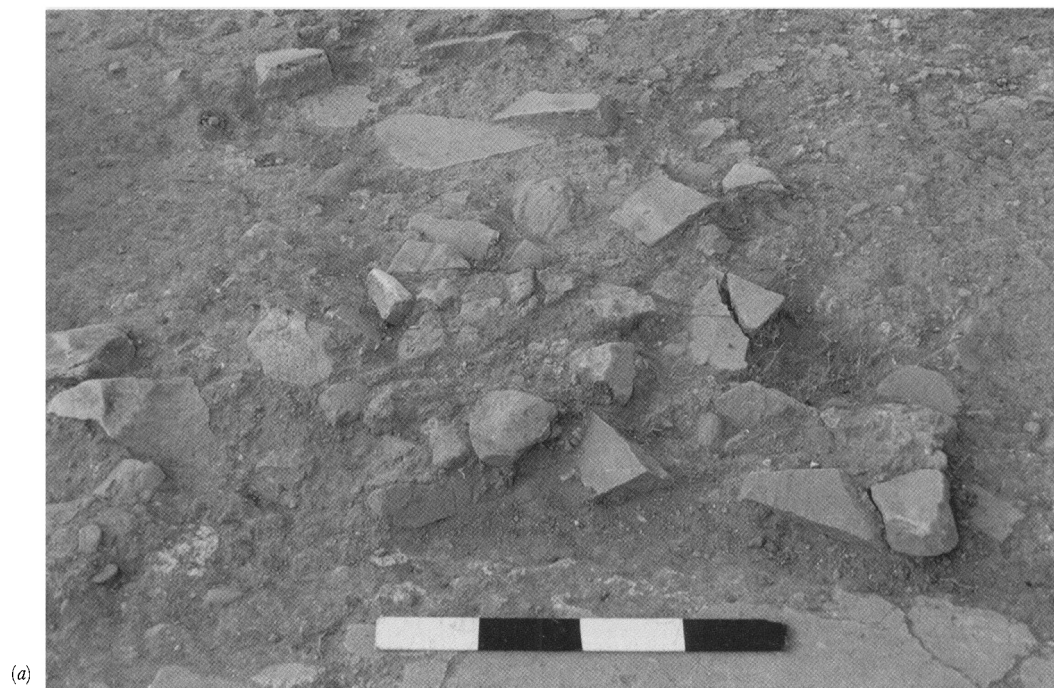
Although the surviving surface is mostly of loose brown soil, which may be the backfill of previous excavation, several contexts came to light in the eastern area. A photograph published by Soteriou⁷⁰ shows that some of the original stone slabs of the aisle floor survived in his time. These are now nowhere in evidence; instead, cleaning brought to light the smooth white cement we believe to have been the bedding for the stone slabs (PLATE 44 *b*). Below this layer can be seen a patchy layer of crumbly cement. This is likely to be the disintegrating bedding cement. Cut into this smooth cement just to the south of the stylobate is a layer of tile and marble tile identical to that in the nave (discussed above). In another section, between the two types of cement just mentioned, there is a level of red pebbly material (tiny sherd fragments ?) (PLATE 44 *c*) which lies below a layer of dark ashy soil. The latter, in turn, abuts the smooth cement level. This looks like the bedding level for a different type of floor, which may have been of mosaic or *opus sectile*. Cuttle mentions finding occasional clumps of tesserae. It may be the case that an earlier mosaic floor went into disrepair, was cleared, and then replaced by the slab floor. These tesserae fragments might alternatively represent fragments of wall mosaics; their poor survival rate suggests that they could have been part of a floor which had been deliberately cleared to make way for a new floor.⁷¹ It is also possible to say that there were at least two floor levels and that there had been a destruction at some time after the removal of at least some of the floor plaques (PLATE 40 *a*) (discussed further below).

SWEETMAN AND KATSARA
THE ACROPOLIS BASILICA PROJECT, SPARTA: A PRELIMINARY REPORT FOR THE 2000 SEASON
(a) Broken tile context. (b) Central apse from west with altar in foreground.

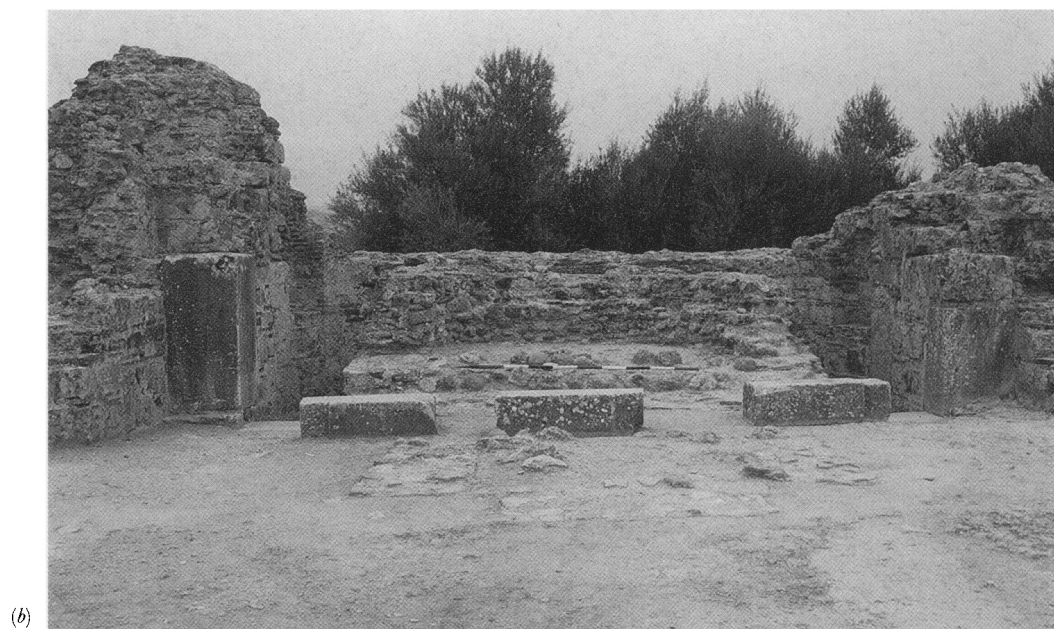
In 1926 the aim was to uncover the altar and the tempon screen. The east–west trench produced cement flooring which Cuttle considered to be the altar base (PLATE 40 *b*).⁶¹ No evidence of the screen being discovered, so Cuttle suggested that it had been made of wood. Levels were taken and a difference of 27 cm was found between the central apse and the western end of the nave. A pit to the south of Adamantiou's Stone was excavated and a wall was discovered consisting of dressed and unworked stones without mortar, together with tiles. The wall extended from the mid-point of the western edge of the bema northwards, ending around 7 cm from Adamantiou's Stone. The southern end of the wall was not found. Cuttle believed this to be the remains of a pre-church wall on the basis of its alignment and construction. The area along the wall was excavated to *stereo* but all he found associated with the church was a Greek lamp. This led him to connect the wall with a Hellenistic layer which he discovered in the south tower region (see later).

In the centre of the bema, the north and south foundation blocks for an altar were uncovered (PLATE 40 *b*). The interior space is filled with rubble and mortar. On the west side there is an extension (c. 1.35 m north–south and 0.70 m east–west), which may have been the foundation for a step up to the altar. Several contexts were exposed to the south of the altar, mostly consisting of floor and bedding levels.

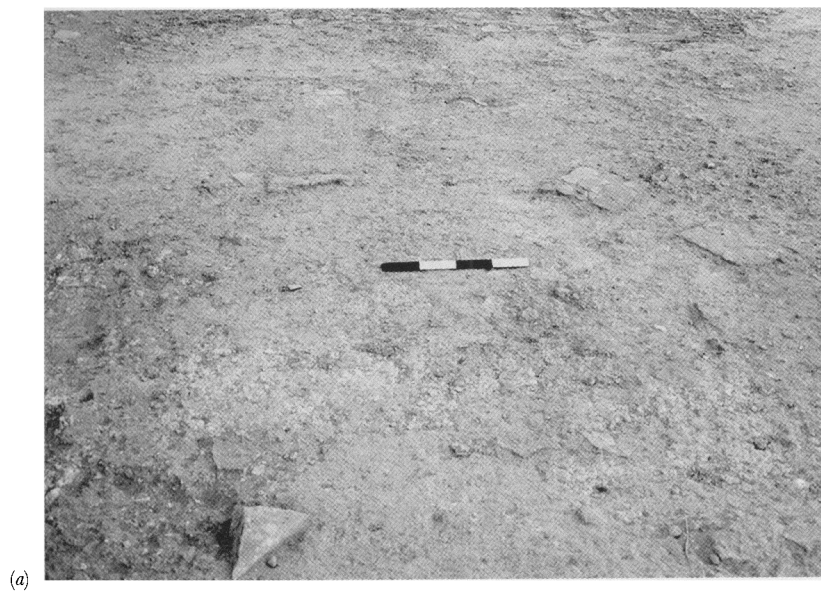
SWEETMAN AND KATSARA
 THE ACROPOLIS BASILICA PROJECT, SPARTA: A PRELIMINARY REPORT FOR THE 2000 SEASON
 (a) South Stylobate, showing dowel hole from west. (b) Remains of possible ambo in the nave.

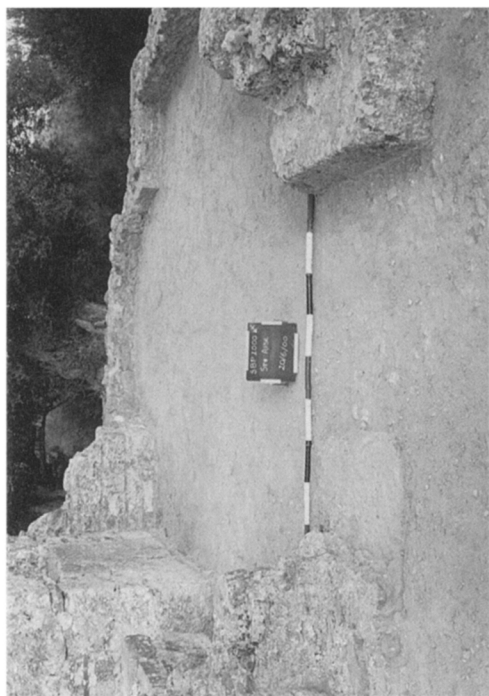
The walls of the south apse are constructed to the usual standard, with partly finished and unworked stones and brick with mortar (PLATE 44 *a*). Occasionally the brick is vertically aligned, but more often it is horizontal. The southern wall varies slightly in that rough cloisonné was used in its construction. The exterior of the apse is partially composed of well-worked squared blocks. Numerous reused blocks are found in its south and north walls and one large block is used to define the doorway between the two rooms of the south complex. Nothing remains of the threshold other than fragments of the bedding level. Two squared niches are cut into the south face of the north wall of the room. The westernmost one starts

SWEETMAN AND KATSARA
THE ACROPOLIS BASILICA PROJECT, SPARTA: A PRELIMINARY REPORT FOR THE 2000 SEASON
(a) South apse from west. (b) Flat smooth cement context. (c) Red pebbly bedding context.

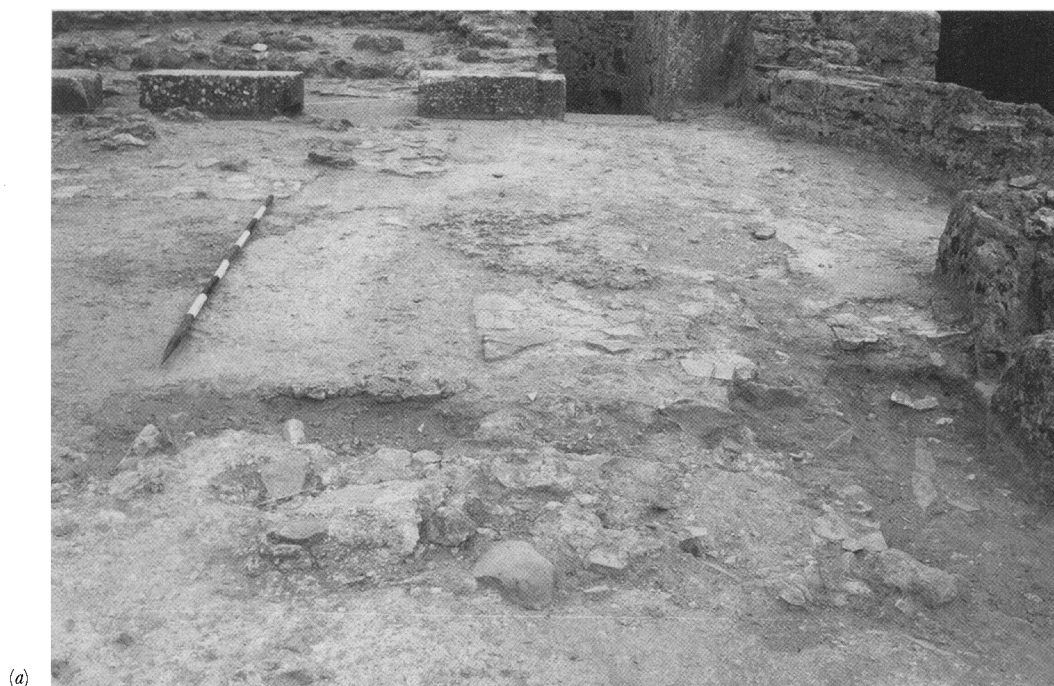
SWEETMAN AND KATSARA
 THE ACROPOLIS BASILICA PROJECT, SPARTA: A PRELIMINARY REPORT FOR THE 2000 SEASON
 (a) Central apse floor contexts. (b) Doorway into north room from central apse.

Cuttle believed there to have been at least two construction phases in the church, based on the evidence of the rebuilding of the floor, namely the evidence of the superimposed floors found in the area of the apse (PLATE 45 *a*). Below the lower floor was a layer of pottery of Roman date. Cuttle noted that the main apse was built with stones from the theatre's retaining wall. He also stated that the building was a basilica and that the number of columns along the length of the nave is exceptional. He tentatively suggested that the first church built on the site may have been a fifth–sixth century basilica, but then ruled out the possibility as he believed that the triple apse could not have been as early as this; he suggested further work to see if the apse is a later addition. He added that the earliest Greek basilicas had rounded and not angular apses but that the angular form occurs in other areas, such as in Constantinople. Cuttle was also worried that too few columns were preserved in the sanctuary walls to suggest such an early church.

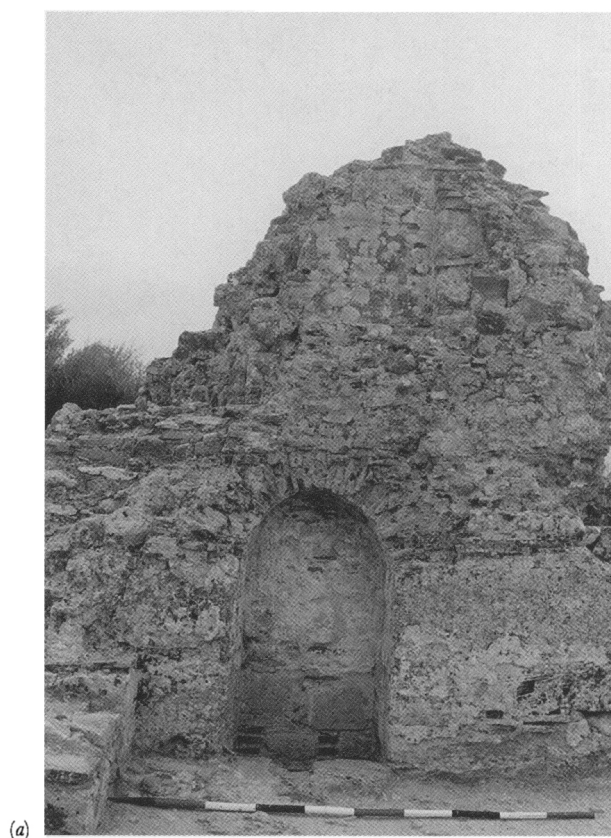
SWEETMAN AND KATSARA
THE ACROPOLIS BASILICA PROJECT, SPARTA: A PRELIMINARY REPORT FOR THE 2000 SEASON
(a) North apse, east recess. (b) North apse, wellhead.

The north apse proved to be an interesting area in terms of definition of function. The east niche, likely to have been encrusted with mosaic, and evidence for a well-head, suggest a room used by the clergy for ritual cleansing and preparation of the communion elements. It was common to have a well near the *prothesis* (or north apse) but not so common to have the well contained within the room. The presence of the pebbles gives further support to this explanation: as noted by Cuttle, they would have aided drainage from the area of the west wall.

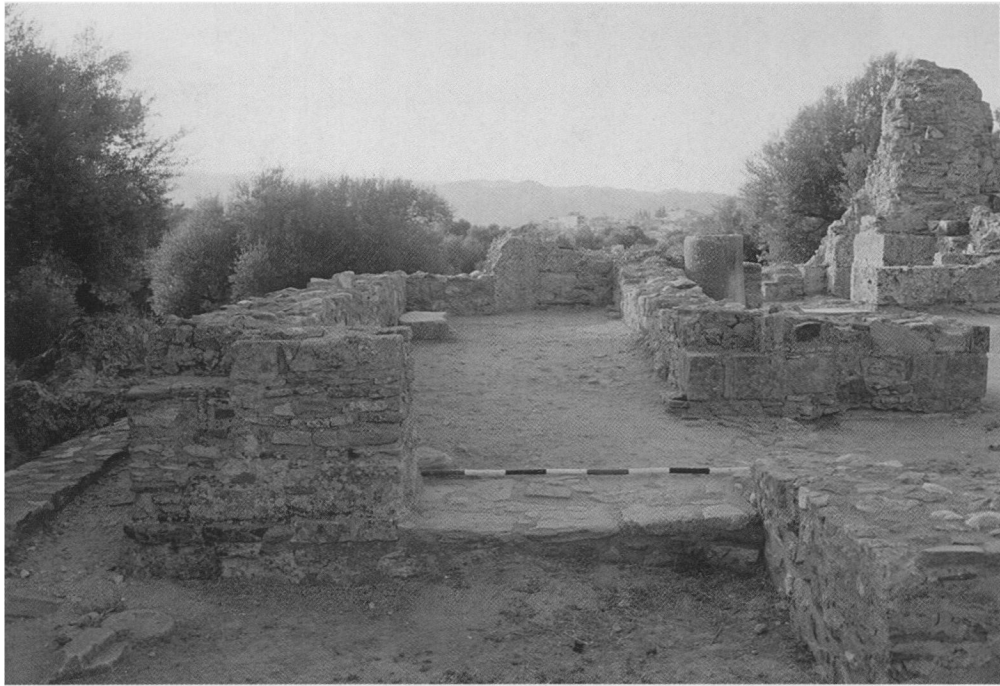
SWEETMAN AND KATSARA
THE ACROPOLIS BASILICA PROJECT, SPARTA: A PRELIMINARY REPORT FOR THE 2000 SEASON
(a) North annexe, showing extension. (b) North terrace, possible early entrance.

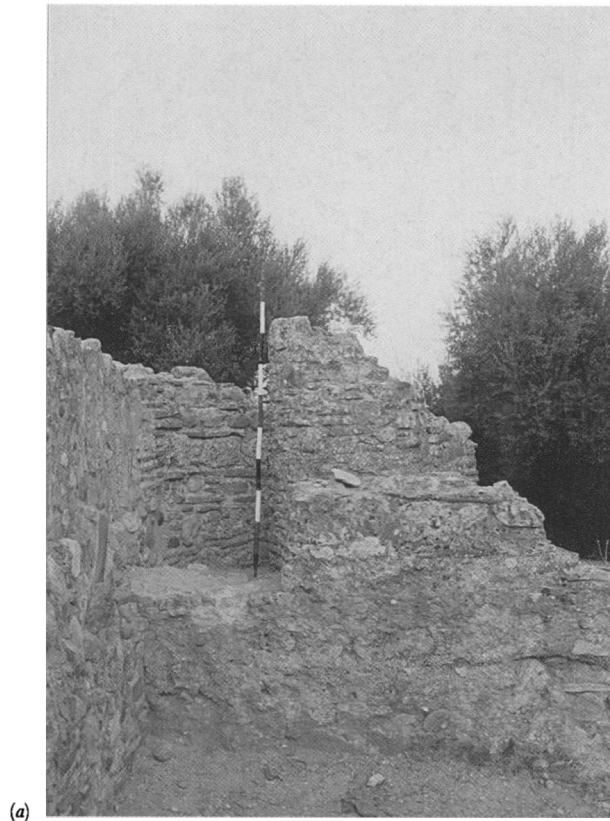
SWEETMAN AND KATSARA
THE ACROPOLIS BASILICA PROJECT, SPARTA: A PRELIMINARY REPORT FOR THE 2000 SEASON
(a) South tower from west. (b) West porch from north-west.

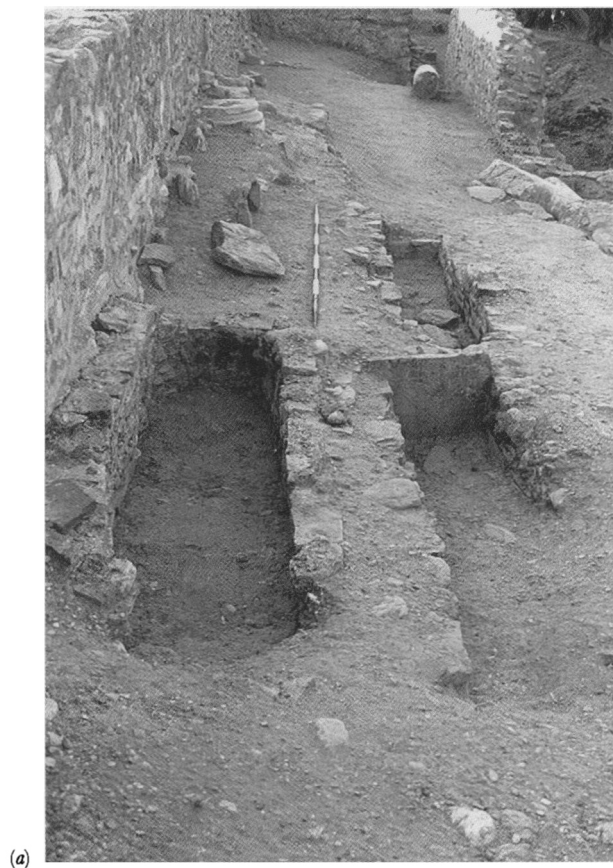
SWEETMAN AND KATSARA
THE ACROPOLIS BASILICA PROJECT, SPARTA: A PRELIMINARY REPORT FOR THE 2000 SEASON
(a) Graves in south terrace. (b) South wall—Cuttle's buttress.
