Using 3D Nanotomography to Visualize Defects in the Fabrication of Superconducting Electronics.

Aric W. Sanders¹, Anna E. Fox¹ and Paul D. Dresselhaus¹

¹- National Institute of Standards and Technology, Boulder Colorado, USA.

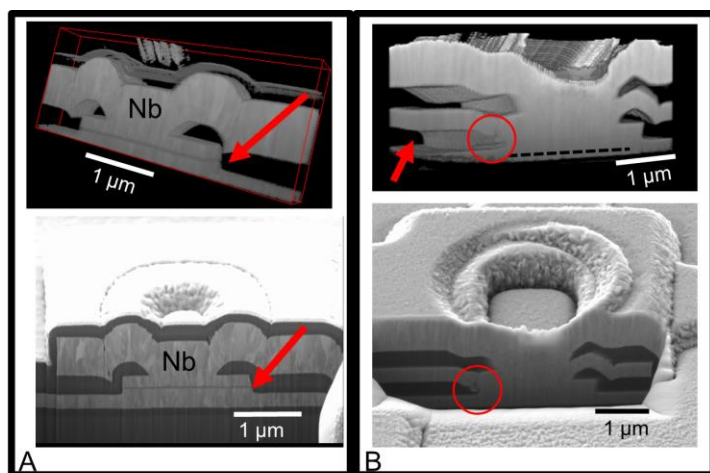
Figure 1. Sloped etch profile and short visualized by FIB nanotomography A) A raw slice illustrating a sloped device wall resulting from photoresist etch mask residue (red arrow), and the 3D tomogram (top) showing that it propagates along the device. B) A raw slice with an area circled for reference and the 3D tomogram (top) showing a buried short (red arrow).

Variations in the development and treatment of photoresist based etch masks can cause important variations in the geometry of devices. In Figure 1 A, the presence of residual resist has caused a sloped etch profile in the device layer. As with any multi-level electronics microfabrication process, each layer has the potential to introduce defects and reduced device yield in a multitude of ways. The layer to layer alignment or registration is a critical parameter. Misalignments of layers can cause shorts, improper etch masking and other device failures. In figure 1 B, a 3D rendering of a short is shown, along with a typical 2D electron micrograph. This short is caused by a registration error and effectively bypasses the circuit's active element, a Josephson junction. If the material coverage and edge profiles of each layer are not optimal underlying layers can be attacked by subsequent etching steps. In figure 2, the first and last image frames of a tomographic series are shown. In this series, extended defects at the interface of Nb, SiO₂ and Si are highlighted in 3D reconstructions by isolating the material of interest through brightness and repeatedly reconstructing the data to show the effect of the defects on different layers. In summary, we will present the methods and results of using FIB nanotomography in superconducting electronics for post fabrication 3D visualization.

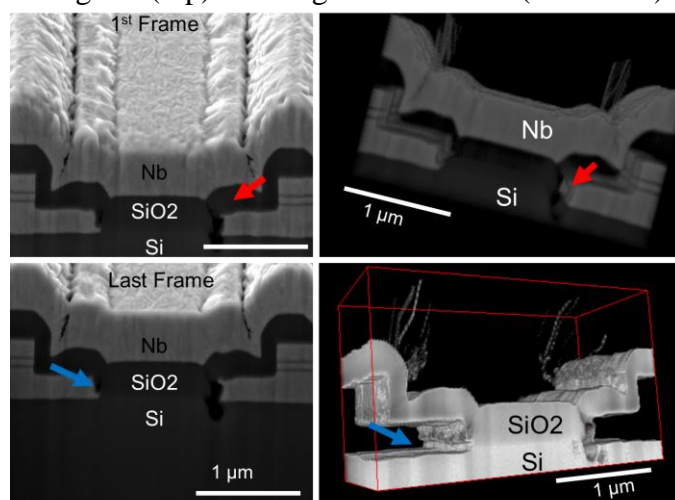
Figure 2. Extended defects at complex interfaces highlighted by brightness based material selection. Left, the first and last raw image processed to create the 3D tomogram. A void left by etching at the interface of a metal device layer, an oxide layer and the Si substrate (red arrow) is seen to extend into the device structure (top right). A similar etch defect is seen on the interface of only the oxide and metal (blue arrows) as shown in the 3D tomogram on the bottom right.
