Helicopter Operations in the Persian Gulf

By A E BRISTOW, A R A C S

*A Paper presented to The Helicopter Association
of Great Britain in the Library of The Royal
Aeronautical Society, 4 Hamilton Place,
London, W 1, on Friday, 9th March, 1956,
at 6 p m*

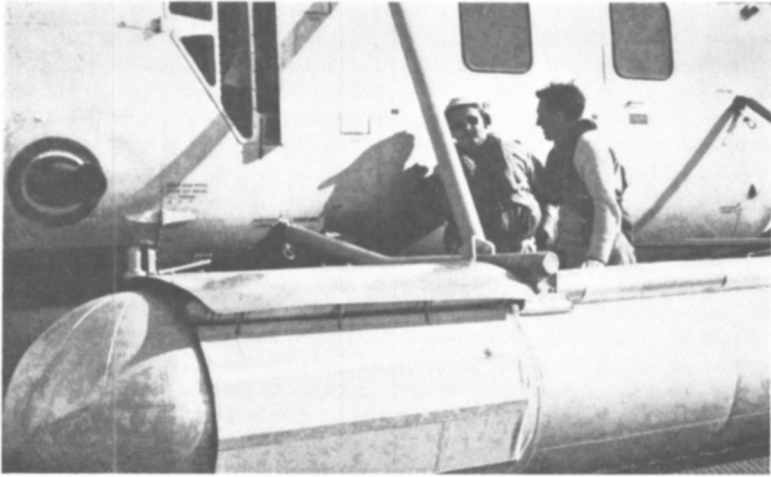
The protective guard fitted over the forward end of the pontoon to prevent deterioration of the adhesive in the hot exhaust gases

Simultaneously, a test was made on a specimen piece of fabric and, again, the adhesive showed signs of weakening at 80°C. After these tests, work was put in hand to make a protective guard (a photograph appears on page 18) but, unfortunately, a second failure occurred before the guard was ready to be fitted.

The absence of any reports of similar failures from other operators using the same equipment still puzzles us, but at least we have overcome our difficulties with the guard. To reduce temperatures near the floats further, a small deflector lip has been welded to the exhaust to push the exhaust gasses upwards away from the float, and this is proving very effective.
