## Complementary Atom Probe Tomography and Electron Microscopy of Oxidation of Ni-base Alloys in High-Temperature Water Environments

Daniel K. Schreiber, Matthew J. Olszta and Stephen M. Bruemmer

Energy and Environment Directorate, Pacific Northwest National Laboratory, Richland, WA, USA

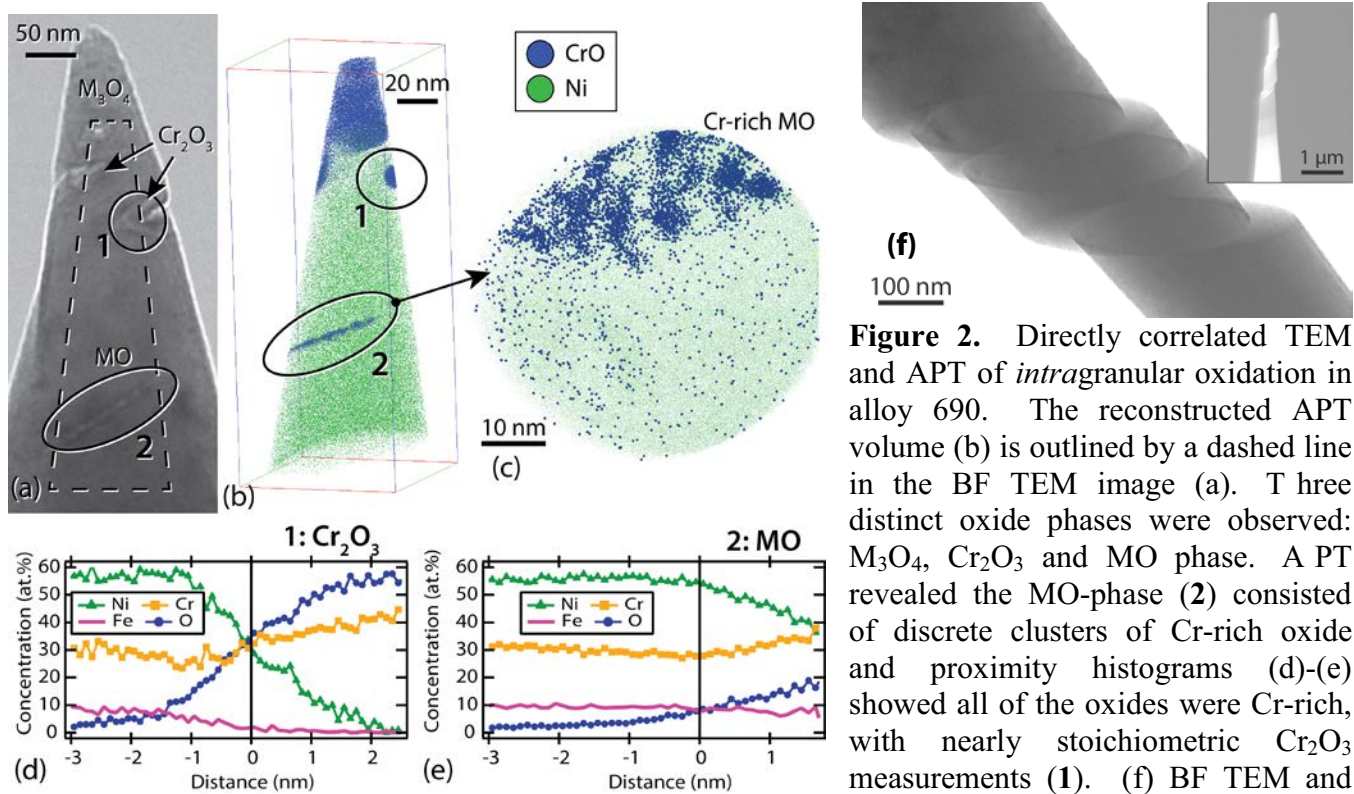
**Figure 2.** Directly correlated TEM and APT of *intragranular* oxidation in alloy 690. The reconstructed APT volume (b) is outlined by a dashed line in the BF TEM image (a). Three distinct oxide phases were observed:  $M_3O_4$ ,  $Cr_2O_3$  and MO phase. APT revealed the MO-phase (2) consisted of discrete clusters of Cr-rich oxide and proximity histograms (d)-(e) showed all of the oxides were Cr-rich, with nearly stoichiometric  $Cr_2O_3$  measurements (1). (f) BF TEM and (inset) SEM images of a Ni-5Al binary alloy APT specimen that sheared along slip planes during APT testing without fracturing. This suggests catastrophic fracture can be preceded by severe specimen deformation that typically goes undetected.

Additional analyses have been performed using directly correlated TEM/APT examinations. This approach is beneficial as it permits direct correlation of the oxide crystal structure (TEM) with the 3D oxide morphology and composition (APT) while also improving the accuracy of the APT reconstruction scaling. A representative analysis is presented in Fig. 2 of *intragranular* oxidation in alloy 690 (Ni-30Cr-9Fe). [3] Electron diffraction identified 3 distinct oxide phases:  $M_3O_4$  at the apex,  $Cr_2O_3$ , and a deep linear penetration of oriented MO, possibly following a matrix dislocation. In contrast to the interconnected finger-like oxides in alloy 600, the MO penetration in alloy 690 consisted of discrete clusters of Cr-rich oxide (Fig 2c,e) that did not extend throughout the cylindrical volume of material. This difference in oxide morphology suggests that the oxidation mechanism may be different for the two materials systems and requires additional investigations.
