Using *in-situ* TEM Triple Ion Beam Irradiations to Study the Effects of Deuterium, Helium, and Radiation Damage on TPBAR Components

Caitlin Taylor¹, Brittany Muntifer¹, Clark Snow¹, Khalid Hattar¹ and David Senor²

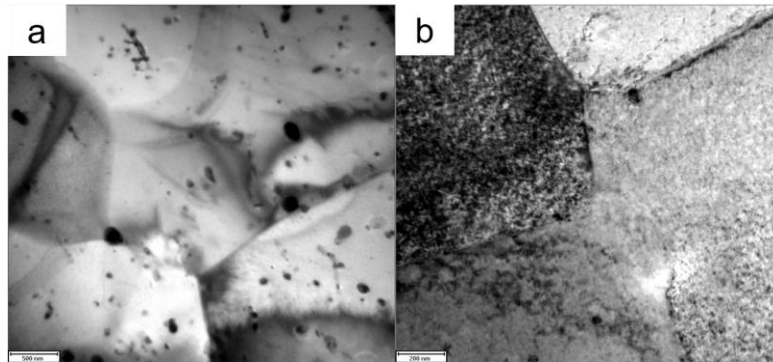
Figure 1. a) Before irradiation and b) after Zr ion irradiation into Zircaloy-4 TEM samples to ~7 dpa.

In this study, black spot damage was identified after irradiating Zircaloy-4 with 3 MeV Zr (Fig. 1). Due to the nature of the damage, no specific dislocation loop types were identified. No cavities were observed after irradiating Zirlo with 10 keV He after 3 MeV Zr ion irradiation. Helium bubbles were, however, observed in the sample after natural aging for 30 days after the *in situ* test. The same phenomenon was observed in samples, which were bombarded in the sequence of Zr ions first, followed by He ions, indicating that the order of the irradiations does play a significant role in this system during sequential studies. Gas diffusion in zirconium alloys has been thoroughly studied in the past due to gas/cladding interactions and is being explored with respect to natural aging in these systems. A Zirlo sample was irradiated with 3 MeV Zr, 10 keV D_2 , and 10 keV ^4He overnight. No cavities were observed immediately after irradiation. The samples were imaged 30 days later, and large bubbles up to 15 nm in diameter were present (Fig. 2). Finally, similar initial *in situ* TEM accelerated aging tests on LiAlO_2 pellets will be presented [4].

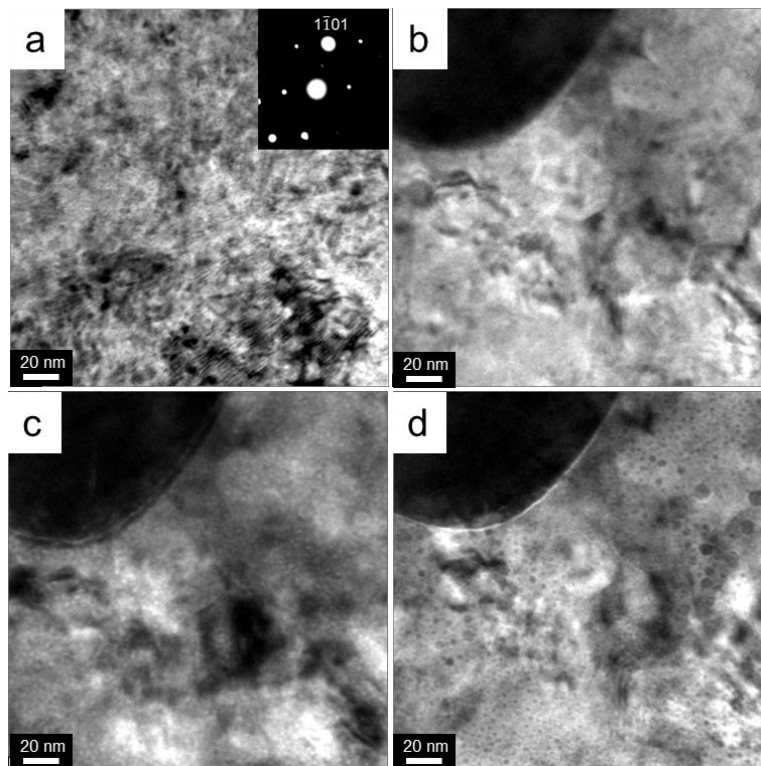
Figure 2. Concurrent Deuterium, Helium, and Zirconium ion irradiation into Zirlo. a) immediately after irradiation. A high density of black spot damage is visible, but no bubbles are seen. b) in-focus image 30 days after irradiation. c-d) over and under focus image 30 days after irradiation shows the presence of helium bubbles ranging from nanometers to over 15 nm in size.
