ERRATA

A COMPLIANT WALL, SUPERSONIC WIND TUNNEL E. H. Dowell

The author wishes to make the following corrections to his technical note published in the October 1978 issue of the *Aeronautical Journal*, pages 448-451:

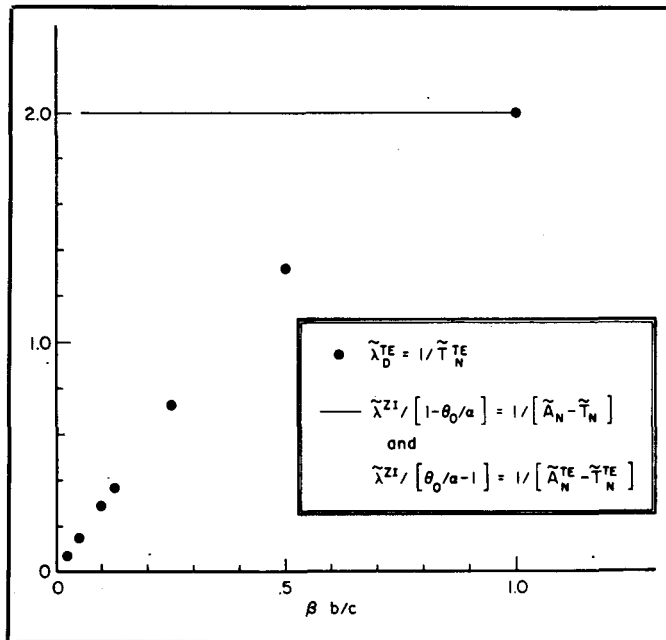
Figure 3. Aeroelastic coefficients required for zero wall interference; divergence aeroelastic coefficient shown for reference.

Figure 3 should be replaced by the figure shown below.
