Fatigue Analysis of AISI 8620 carburized steels using SEM

Marco Antonio Doñu Ruiz¹, Noé López Perrusquia¹, Pablo Cruz Carmona² and Victor Jorge Cortéz Suarez²

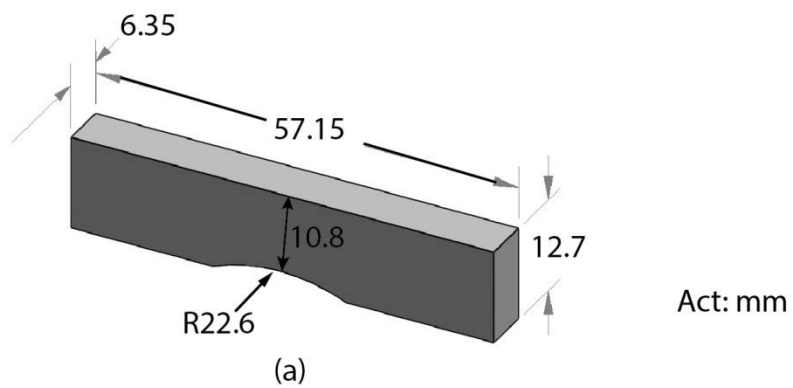
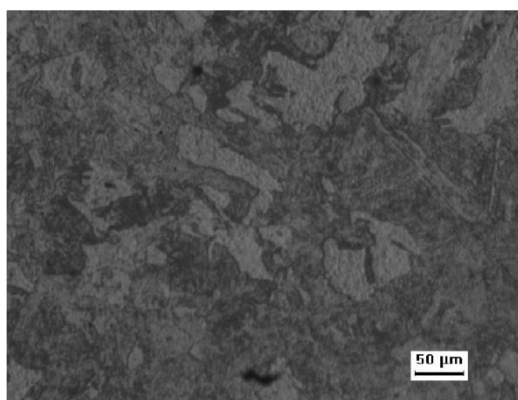
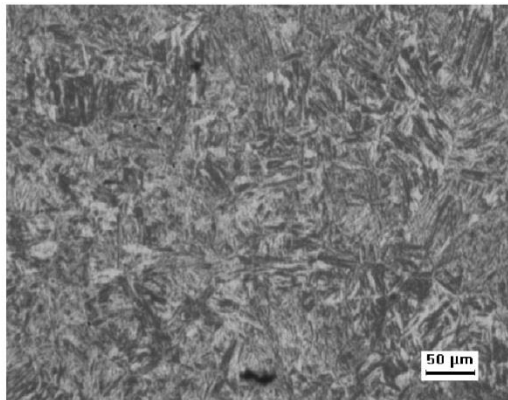
Figure 1. Specimen condition a) Fatigue test specimen by bending test b) microstructure as received, and c) AISI 8620 steel with C+QT.

AISI 8620 steel is used in machine elements, which are subjected to variable loads. The behavior of the materials under this type of load is different from that under static loads; while a part supports a large static load, it can failure with a much smaller load if it is repeated a large number of times [1]. Due to this, it is possible to increase its service life using thermochemical and heat treatment techniques [2]. AISI 8620 steel specimens were used as shown in Figure 1a. The thermochemical carburizing treatment was carried out at 950°C for 5 h, the composition of the carburizing (C) mixture with 10% BaCo₃+30% graphite+60% carbon. Then, the carburized specimens were subjected to quenching and tempering (QT) at 950°C for 1 h and 316°C for 1 h, respectively. Both processes were carried out in a conventional muffle. Low cycle fatigue tests on 8620 steel with C+QT were performed with an Instron model 8502 Universal Mechanical Testing Machine at 0.25 mm, 0.5 mm, and 1.00 mm cycle amplitude to failure conditions. After the surface fracture, fracture images were analyzed by scanning electron microscopy using a JEOL JSM-6010L. The received specimen has a microstructure with ferritic matrix and pearlite islands as shown in Figure 1b, after (C+QT) a carburized layer with a thickness of 823 μm was observed with annealed martensite Figure 1c. On the other hand, Figure 2a shows the maximum stresses (S) and the number of cycles (N) obtained in the three cycle amplitude conditions of 0.25, 0.5 and 1 mm as a result of a decrease of 2186, 1531 and 423 cycles. The trend equation of the S-N curves was obtained to estimate the mechanical behavior of AISI 8620 steel with C+QT exposed to low cycle fatigue. Figure 2b to d, the fractography is observed in the 5 mm amplitude condition. Figure 2b shows that the crack pattern is river. Zone A represents the vicinity of the low-cycle fatigue crack nucleation, where the carburized zone is located. Zone B is a crack propagation zone where the carburized zone is located and the predominant fracture is intergranular (Figure 2c). In the crack propagation zone, in this section, it is observed that the transgranular fracture predominates since there is little cleavage because pores and ductile tearing are observed in Figure 2d. Thermal and thermochemical treatments to AISI 8620 steel showed the change in performance under fatigue conditions, which describe the cycle displacement amplitude increases, the number of cycles supported by the steel decreases.

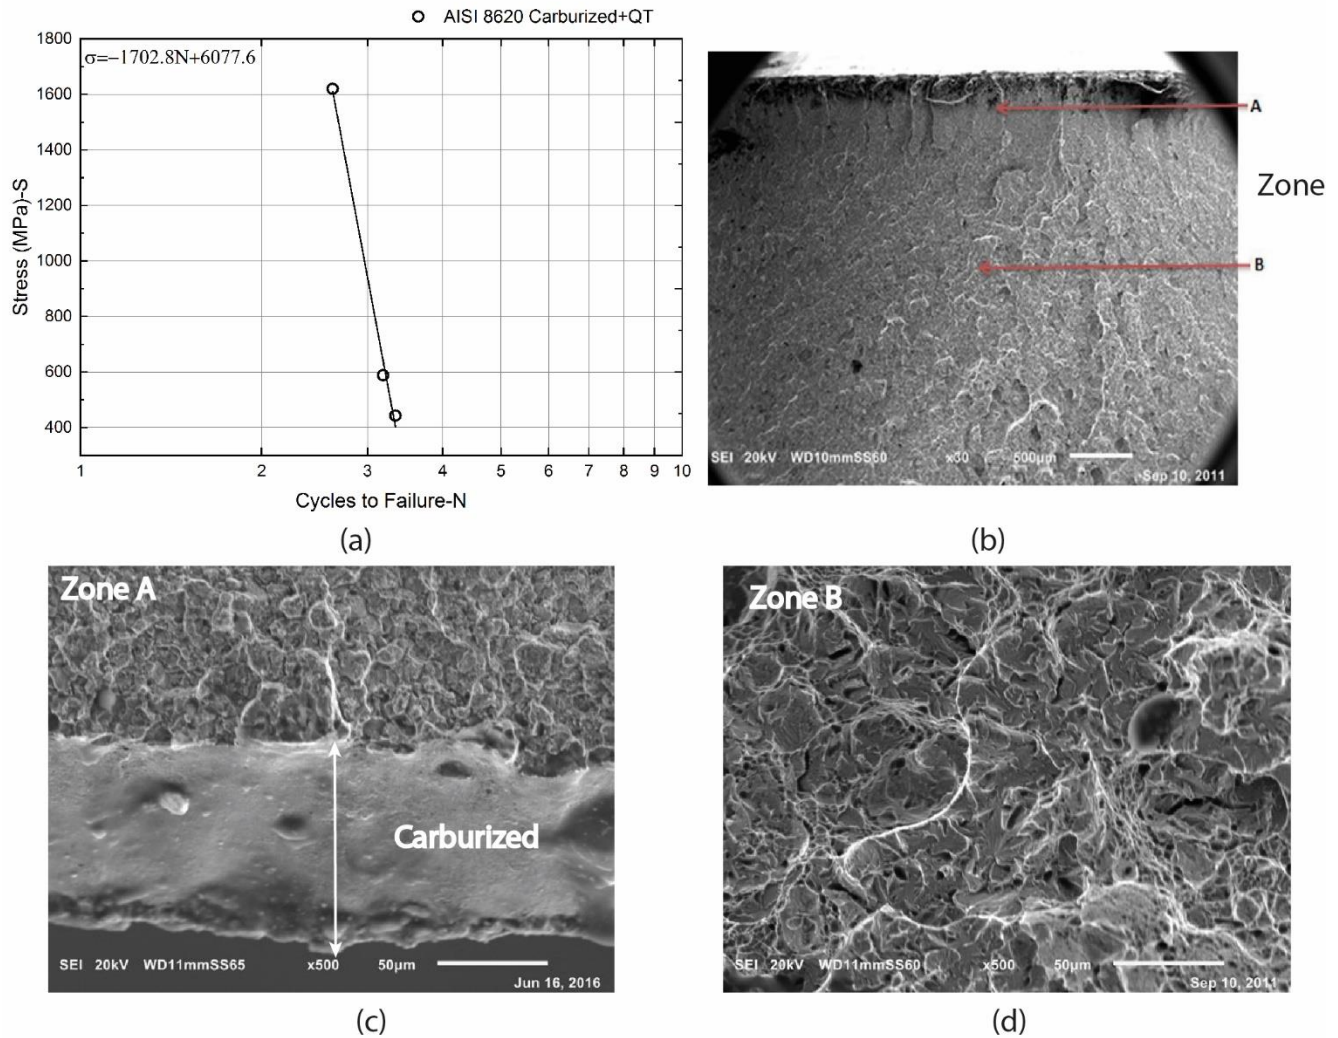
Figure 2. Fatigue test a) Fatigue curve on AISI 8620 steel with C+QT, and b) SEM fractography of amplitude 0.5 mm c), zone A, and d) zone B.
