Effective Degradation of Humic Acids in Water by Zero Fenton Process

Santos, N.O.¹, Spadotto, J.C.¹, Solórzano, I.G.¹, Campos, L.C.², Teixeira, L.A.C.^{1,3}

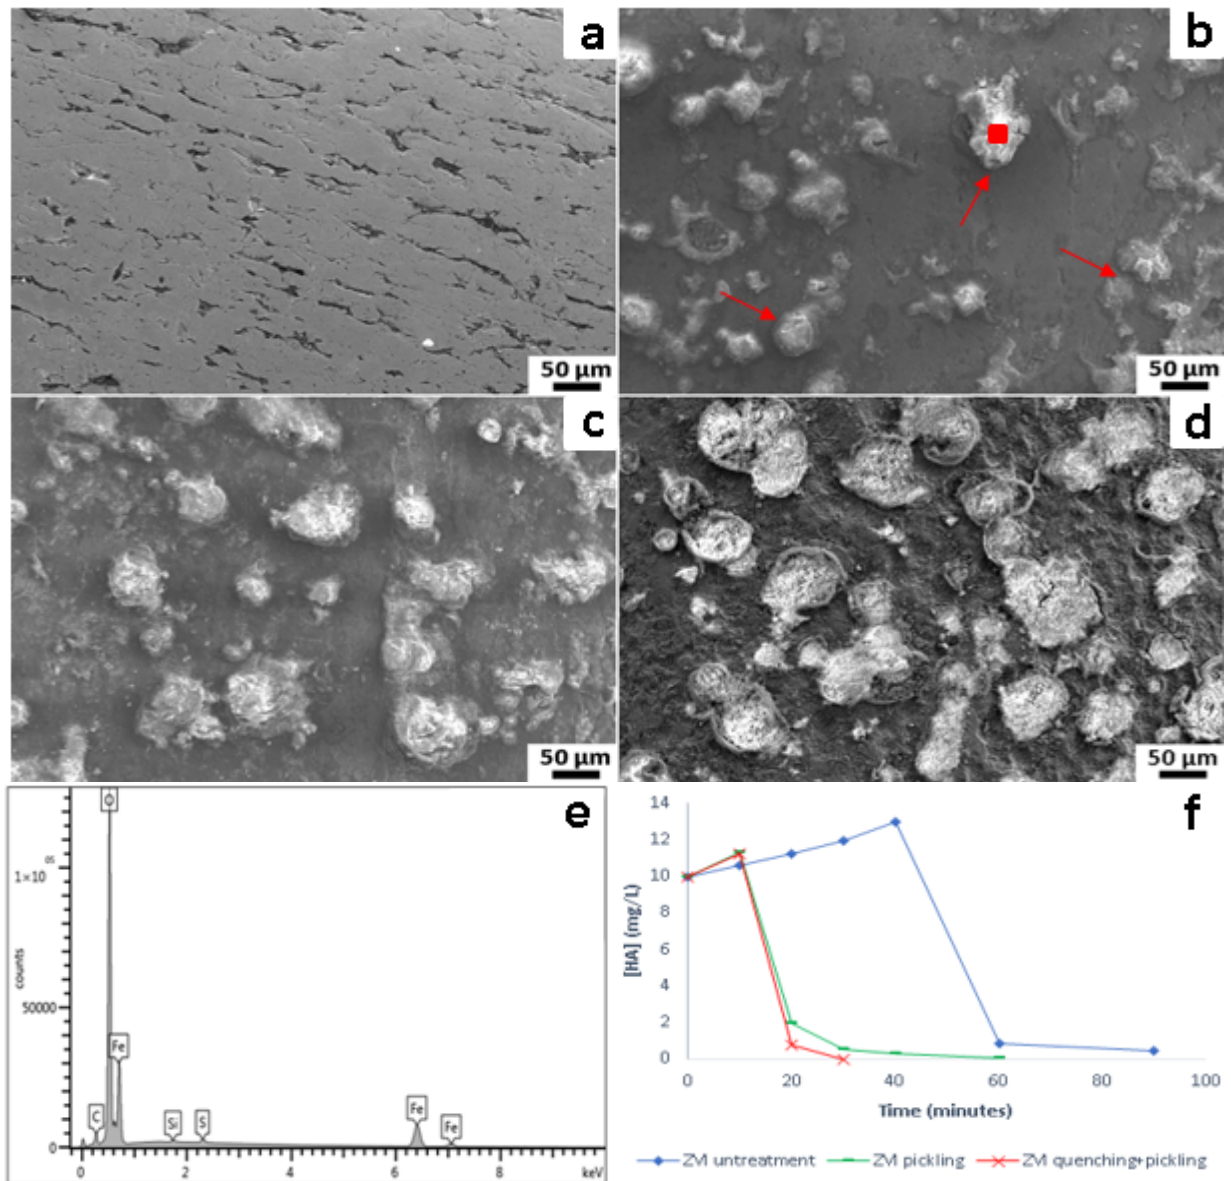
Figure 1. SEM images of iron cut. (a) in the as-received condition; (b) in the as-received condition post-reaction Zero Fenton; (c) in the after pickling condition; (d) in the post-heat treatment condition after pickling; (e) EDX spectra obtained from the region indicated by red square in (b); (f) HA degradation by Zero Fenton Process in the different treatment conditions.

The SEM image shown in Figure 1a presents the ZVI surface in the as-received condition (untreated). It's observed that the surface in this condition does not show oxidation. After the reaction (Figure 1b) the formation of small oxidation sites (indicated by arrows) have been verified and these have been confirmed by EDS spectra (Figure 1e). Meanwhile, when the ZVI was chemically treated the reaction led to increased oxidation on the material surface, as shown in Figure 1c. However, when the ZVI pre-treated followed by water quenched and pickling was applied in the reaction, a significant increase in the oxidation area on the surface was observed (Figure 1d). Figure 1f presents the HA degradation during the Zero Fenton process. As shown in this figure, HA degradation achieved within 60 minutes of reaction 91.5% and 100% using untreated ZVI (blue line) and ZVI after pickling (green line), respectively. However, Zero Fenton process using ZVI submitted to heat treatment followed by water quenched and pickling showed 100 % of HA degradation within 30 minutes of reaction (red line). Results indicate that the degradation of HA using iron wire cuts after heat treatment followed by water quenched and pickling was slightly faster when compared to the process using ZVI pre-treated by pickling. This difference in the degradation rate is probably due to the microstructural transformation of the iron wire cuts. In the as-received condition (Figure 2a) the microstructure is constituted of ferrite (white) and perlite (dark). On the other hand, the iron wire cuts post-heat treatment presents a martensitic microstructure (Figure 2b). Such drastic cooling introduces high surface tensile residual stresses, which are probably responsible for the higher oxidation observed in the surface of the material [3, 4].

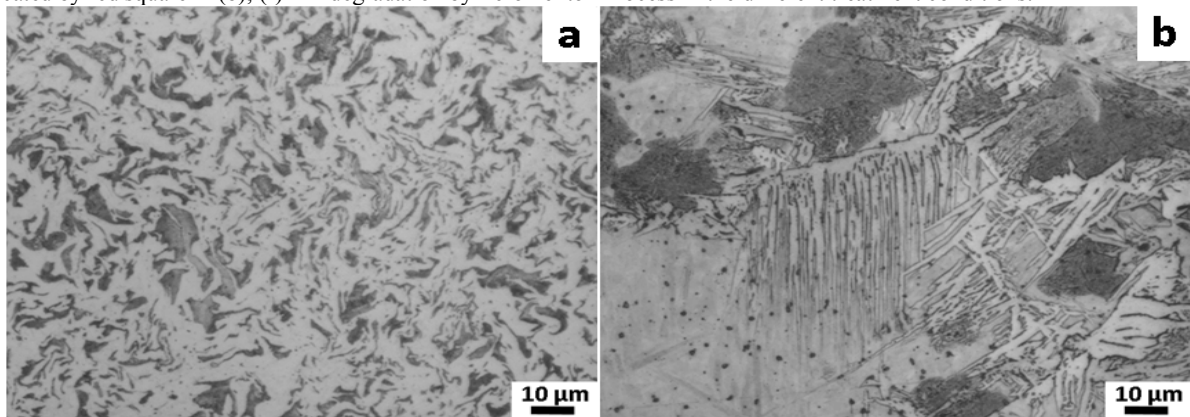
Figure 2. Light optical micrographs of iron cuts microstructure (a) in the as-received condition and (b) in the post-heat treatment at 950 °C for 30 minutes followed by water quenched.
