Evaluation of Defect Structures from *In Situ* Dielectric Breakdown of SiO₂-Based Gate Dielectric Layers

C.S. Bonifacio * and K. van Benthem*

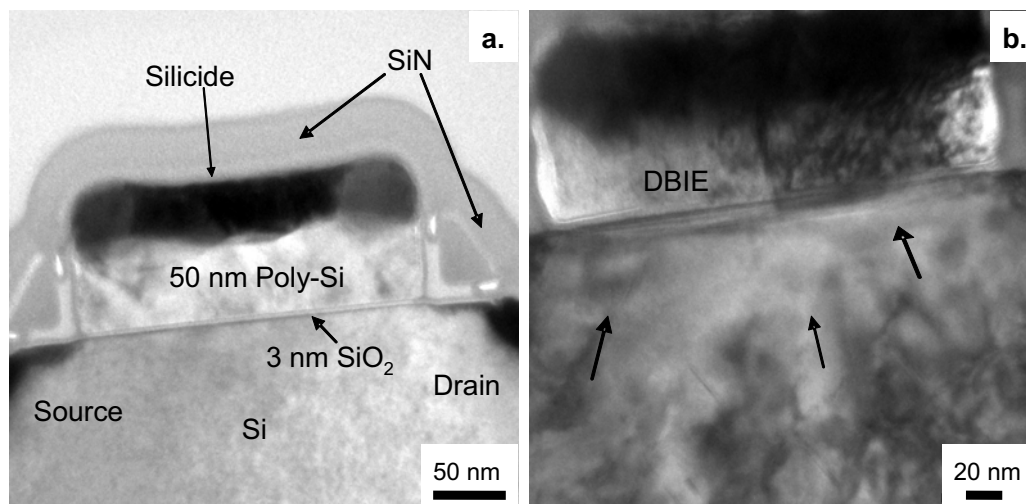
Figure 1. Co silicide/Poly-Si/SiO₂/Si device structure before (a) and after (b) dielectric BD [3].

HRTEM image acquisition during time-dependent leakage current measurements positively identified three stages of dielectric BD, i.e. wear-out, soft breakdown at +6.5 V and hard breakdown at +10.5 V [3]. Figure 1 shows conventional TEM micrographs of one device structure before and after dielectric breakdown induced during the STM-TEM experiment. Electrical stress-induced modifications of the gate electrode, the dielectric layer and the silicon substrate can be observed through changes in the diffraction contrast. Within the dielectric layer, local dielectric breakdown sites were identified through HRTEM and EELS observations of dielectric breakdown induced epitaxy correlated with locally reduced oxygen stoichiometry, respectively [3]. Furthermore, damaging to the substrate (wavy structure in Figure 1b) and Co migration from the gate electrode to the SiO₂ layer were observed (Figure 2). EELS spectrum imaging revealed oxygen diffusion from the SiO₂ layer into the substrate (Figure 2) due to a reduction-oxidation reaction at the SiO₂/Si interface that was activated by the applied electrical stress [3].

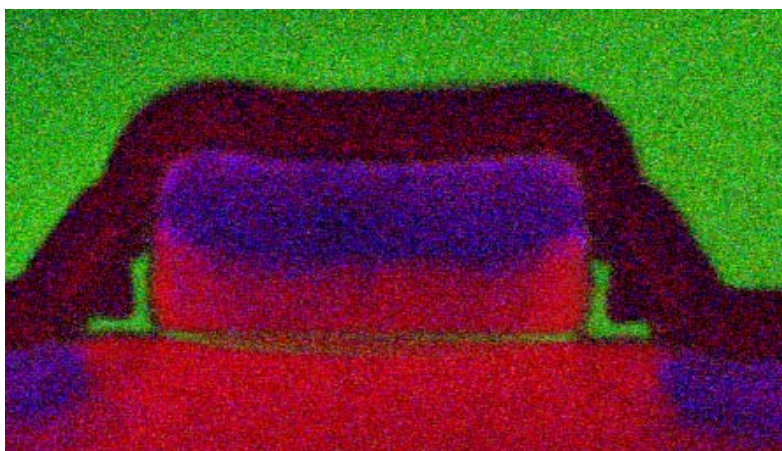
Figure 2. Elemental distribution map from integrated EELS intensities for the Si L_{2,3} (red), O K (green) and Co L_{2,3} (blue) absorption edges.
