Stable room-temperature micron-scale crack growth in single-crystalline silicon

Martin Guillermo Mueller,^{a)} Goran Žagar, and Andreas Mortensen

Laboratory of Mechanical Metallurgy, Institute of Materials, École Polytechnique Fédérale de Lausanne (EPFL), Lausanne CH-1015, Switzerland

DOI: 10.1557/jmr.2017.238

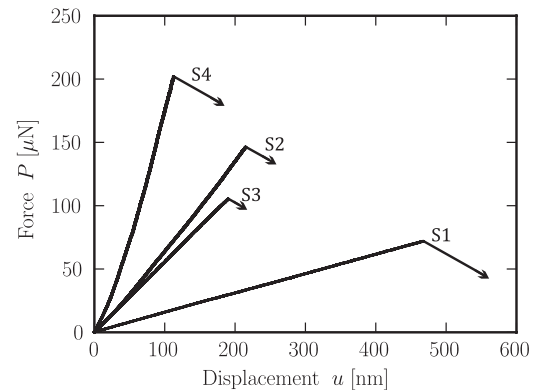
FIG. 2. Force–displacement response of micro-cantilevers with STNs (STN Samples S1–S4, Table I). All data are corrected for additional displacement caused by tip indentation into the cantilevers.

The load–displacement responses corrected for indentation of the STN or CN cantilever beams are shown, respectively, in Figs. 2 and 3. STN curves are linear until the point of sudden fracture, defined by a sudden large load drop and displacement jump (Fig. 2). Predictions of the finite element model were validated for all four STN samples in that the measured compliance and the

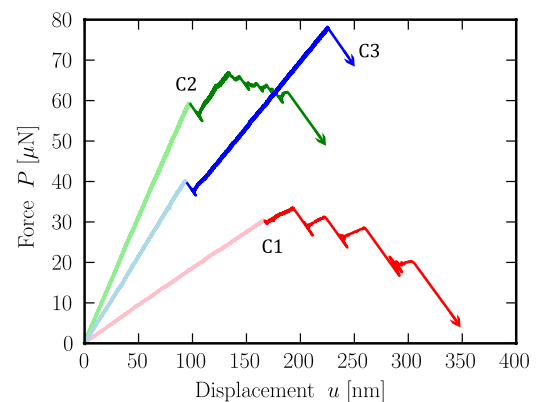
FIG. 3. Force–displacement response of micro-cantilevers with chevron notch (CN Samples C1–C3, Table I). All data are corrected for displacements due to relative tip indentation into the cantilevers. Region of the response of chevron-notched cantilevers where the crack is growing is indicated with bold lines.

With CN specimens (Fig. 3), loading curves are only linear up to a point where a first, small “pop-in” (load drop and displacement jump) is observed: this is the moment of crack initiation. During pop-ins, displacement of the sample is sudden and rapid; load–displacement

The portion of the load–displacement curves that stretches between crack initiation and final fracture is indicated in bold for each CN sample in Fig. 3. The measured compliance as a function of the displacement in that region is plotted in the top row of Fig. 4. As seen, the compliance increases significantly with each pop-in in Samples C1 and C2, while it only increases slightly between pop-ins. Changes in compliance are signatures of crack growth; thus, pop-ins are sudden crack extensions followed by crack arrest and periods of crack growth at a much slower rate under increasing load. The bottom row of Fig. 4 shows how the strain energy release rate G (or stress intensity factor K_I in the right-hand axis) varied during the crack growth process in each of Samples C1, C2, and C3; as seen, the data vary significantly from sample to sample.

The response of Sample C3 is altogether different. Here, other than at crack initiation, there is no succession of jump-like crack advances (Fig. 3); rather, the load and the associated apparent compliance increase continuously after crack initiation [Fig. 4(c) top row; this can also be seen directly on Fig. 3 using a ruler]. This increase in compliance can be interpreted in two possible ways. In the first interpretation, the compliance increase is attributed to stable crack growth, which progresses smoothly at a slow rate. The corresponding variation in strain energy release rate is over the range $G_{Ic(111)} \approx 2.5 - 10.3 \text{ J/m}^2$, ending with the latter value before the onset of rapid crack growth [Fig. 4(c) bottom row]. In a second interpretation of the C3 test, the apparent change in compliance is caused by drift in the displacement measurement (note that the drift rate is assessed prior to loading but its instantaneous value during a test is unknown). One can then evaluate the fracture toughness using the crack length calculated from the compliance right after the crack was initiated [Fig. 4(c)] and the measured forces corresponding to the initial crack arrest and to the final fracture events; this gives $G_{Ic(111)} \approx 2.5 \text{ J/m}^2$ and $G_{Ic(111)} \approx 10.7 \text{ J/m}^2$, respectively. As seen, regardless of whether stable crack growth took place or not in Sample C3 (after crack initiation), one obtains similar extreme values of $G_{Ic(111)}$; the reason for this is the weak dependence of g_F with crack length near the minimum of g_F in this specimen [see Fig. S6(b)]. We note in passing that the toughness value at crack arrest is close to $2\gamma_{(111)}$.

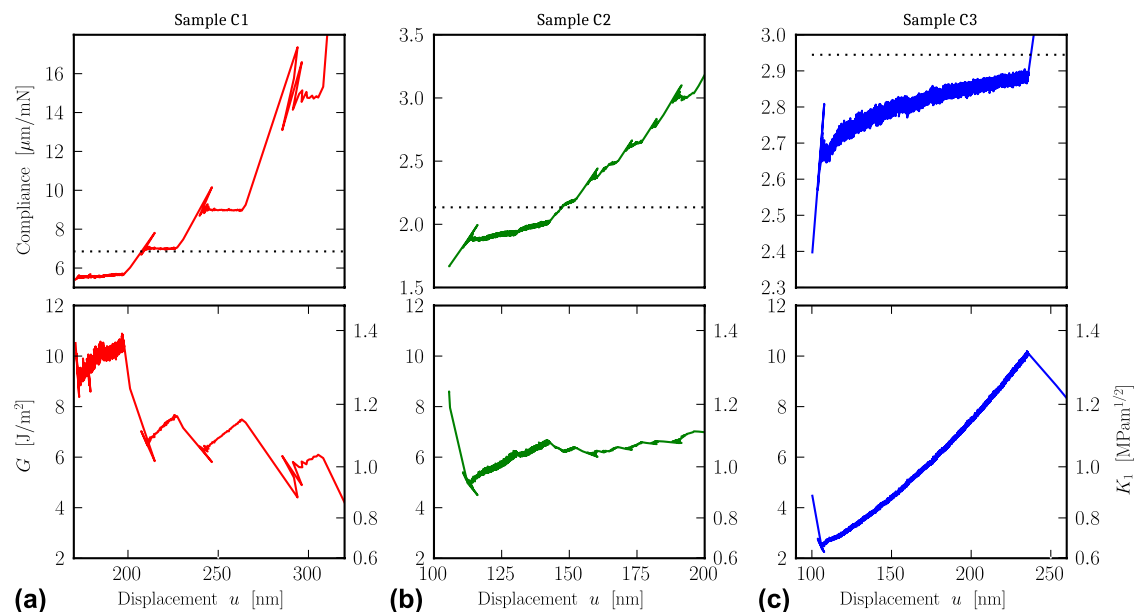
FIG. 4. (Top row) Linear elastic compliance $C = u/P$ versus displacement u obtained from CN cantilever responses shown in Fig. 3 (only data indicated with a bold line are considered). (Bottom row) Calculated elastic strain energy release rate G versus measured displacement u . For convenience, right-hand scale corresponding to the stress intensity is indicated according to, $K_I = \sqrt{GM_{(111)}}$, where the elastic fracture factor of SC Si for (111) plane $M_{(111)} = 178$ GPa.¹⁶ The dotted line indicates the critical compliance that corresponds to the critical crack length of the chevron-notched geometry.

The test data for the silicon CN samples of this work, however, show deviations from this expected behavior. Namely, Samples C1 and C2 show that stable crack growth occurred also beyond the critical point at $a > a_c$ (see Fig. 4, where dotted lines indicate the compliance corresponding to the critical crack lengths) and that instability was reached at a lower load after passing the maximum value (Fig. 3). Moreover, Samples C1 and C2 also feature several pop-ins, which are indications of sudden crack extension followed by crack arrest. Close examination of the load as a function of time in these tests reveals that after each pop-in, the load immediately dropped and the set point in load was re-sought very slowly by the nanoindenter, indicating an over-damped machine response. Such sluggish load-control most likely allowed the crack to immediately lose its driving force after a pop-in and hence to arrest, such that, due to the imperfect load control, the present tests have characteristics of displacement-controlled tests. Now, as seen in Fig. 4 bottom row, neither the values of G at which the crack suddenly extends nor the G values at which the crack arrests are the same across successive pop-ins; rather, values are scattered over the range $G_{Ic(111)} \approx 5 - 7.7 \text{ J/m}^2$ (excluding the first crack extension of Sample C1 at 10.8 J/m^2). These values are about twice the theoretical fracture energy of (111), $2\gamma_{(111)} = 2.94 \text{ J/m}^2$.¹⁶
