Utilizing Low-Dose Transmission Electron Microscopy for Structure and Defect Identification in Group III – Nitride Electronic Devices

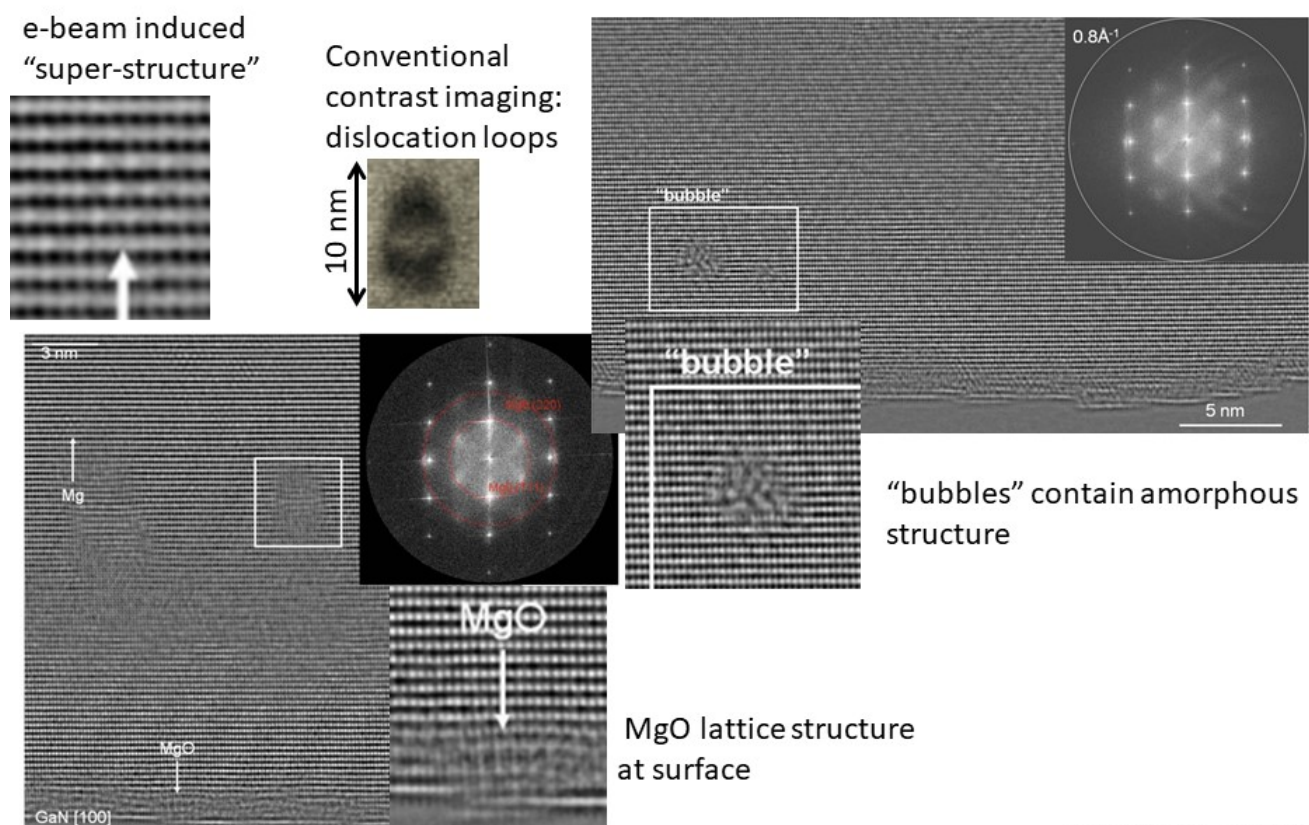
Figure 1. Mg implanted GaN quasi-bulk substrate, double annealed in a multi-cycle RTA mode. Left, bottom: phase image of an exit wave (approx. $100 \text{ e}^- / \text{\AA}^2\text{s}$) with an e-beam induced varying dark/bright “super-structure”, a MgO nano-cluster at the edge of the TEM sample and a dislocation loop (white square) depicted. Right: phase image of the same material showing a nitrogen bubble, approx. 3 nm wide, electron dose for this image series was approx. $30 \text{ e}^- / \text{\AA}^2\text{s}$. Insets show the corresponding FFTs, also some areas are magnified for better visibility. Top, middle shows one of the typical dislocation loops of this sample as it is imaged in conventional contrast imaging.

Using dose rates between 30 and 300 $\text{e}^-/\text{\AA}^2\text{s}$ image series with varying foci were obtained and exit wave reconstructions calculated. The phase images of the exit waves show after the second annealing step a number of extended defects, including bubbles, likely filled with nitrogen, dislocation loops and small MgO particles. Figure 1 displays those images. A “super-structure” in the GaN lattice was observed which forms under the electron beam in both, single and double annealed Mg-implanted GaN. The aforementioned “bubbles” move under the electron beam, the image shown in Figure 1 therefore was shot “in the dark”, with only 30 $\text{e}^-/\text{\AA}^2\text{s}$ dose rate which kept the defect in place. If one wants to obtain original, not e-beam induced defect structures, the use of low electron doses is mandatory in such material structures [2].
